**Retirement Village at Dundalk Stadium  
Amended Louth Draft County Development Plan 2021-2027**

## Condition Survey Report

**Summary:** Condition Survey Report  
for Original Bar and Stables  
Dundalk Stadium.

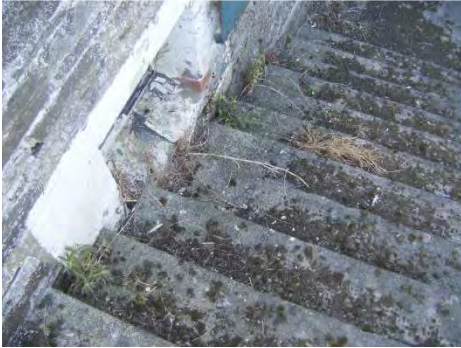
Ref No:	Condition:	Picture:	Repair:	Priority:
4.1.1	The steps leading up to the front entrance door are unsightly and in need cleaning.

All rubbish and debris to be removed, steps to be washed down and all gaps between the steps joints are to be re-pointed with cement.	High
4.1.2	Dividing flower bed between staircases damaged at corner possibly from vehicle.

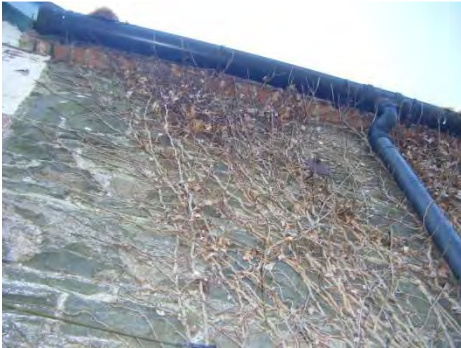
<ol style="list-style-type: none"><li>1. Remove flower bed and create clear walk path</li><li>2. Remove dirt from centre, shutter and repair with similar material.</li></ol>	Optional
4.1.3	Over grown vegetation blocking gutters and expanding over windows.

Remove all weeds and vegetation in order to curtail further damage. All of the over growth to be removed off site.	High

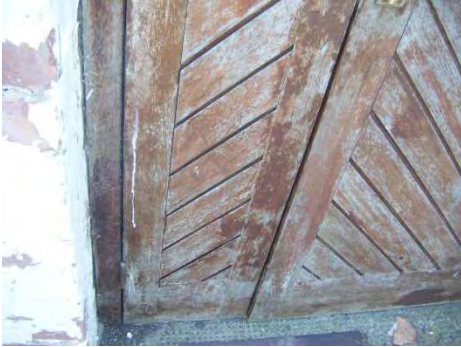
As Above	High
4.1.8	The door is in poor condition and is in need of immediate repair. The base of the door does not reach the floor inside leaving a passage for moisture and vermin.

Should the door be refurbished then the door should be sanded down, any cracks sealed with suitable wood filler and the door to be re-painted. The door should also be draught proofed. Alternatively the front door could be replaced at the discretion of the client.	High
4.1.9	The brickwork beside entrance door is in very poor decorative condition and requires re-painted.

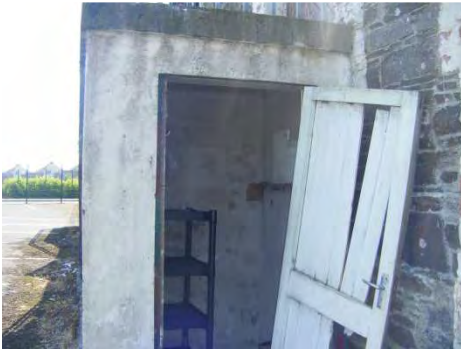
Ref No:	Condition:	Picture:	Repair:	Priority:
4.1.10	Storage area access door is in very poor condition. The walls surrounding are dirty and unsightly and are in relatively poor decorative condition.

Replace door. Clean down all walls in this area. Remove any loose or flaky paint. Repaint with approved exterior paint.	High
4.1.11	Debris surrounding entrance

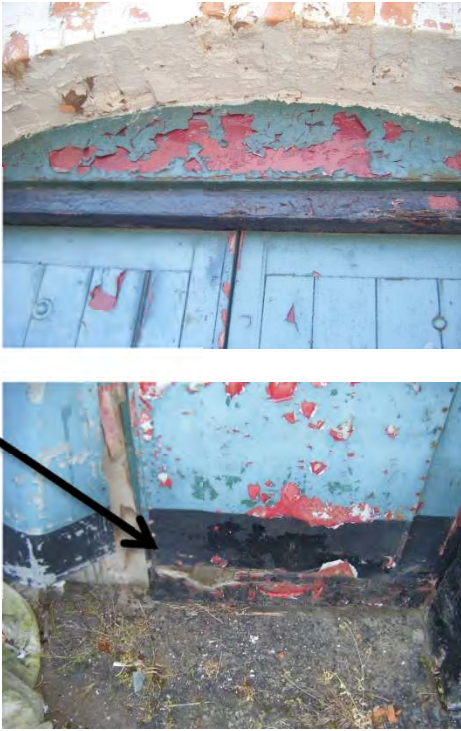
Ref No:	Condition:	Picture:	Repair:	Priority:
4.1.12	Exterior entrance door in poor condition, with evidential peeling of paint work, corrosion of steel support and severely damaged in areas at bottom.

Repair and repaint or remove and replace depending on budget outlay. Trying to repair this door may cost as much as replacement altogether.	High
4.1.13	Guttering does not discharge directly into drainage area.

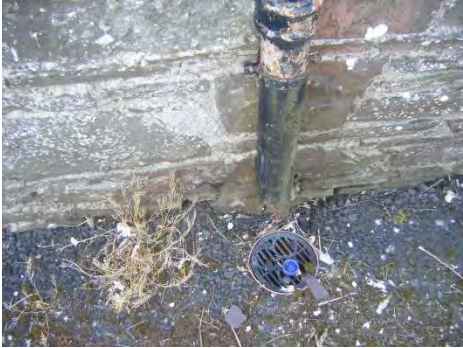
Ref No:	Condition:	Picture:	Repair:	Priority:
4.1.14	Guttering is in poor condition and is leaking which may have attributed to the ingress of moisture and damp.

Down pipe and guttering needs to be partly replaced in this area to eliminate progressive damp penetration.	High
4.1.15	Opening and surrounding area damaged during partial demolition of structure and boarded up using plywood which has a 2 inch opening at top allowing a passage for moisture and vermin. Continuous deterioration is visible as a result of neglect.

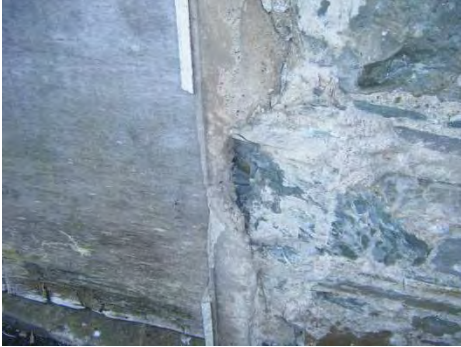
Ref No:	Condition:	Picture:	Repair:	Priority:
4.1.16	As Above. Picture illustrates damaged as a result of demolition works.

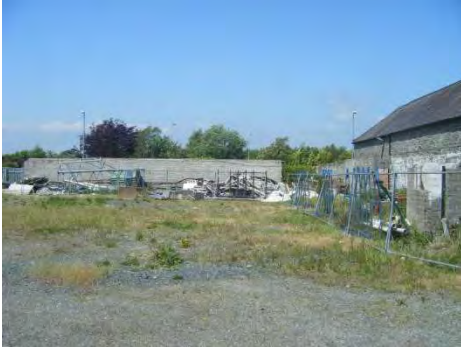
Ref No:	Condition:	Picture:	Repair:	Priority:
4.2.1	Accumulation of waste materials, rubbish and weeds in area.

Waste material to be removed off site.	Med
4.2.2	The fire escape to is not accessible due to extensive over growth.

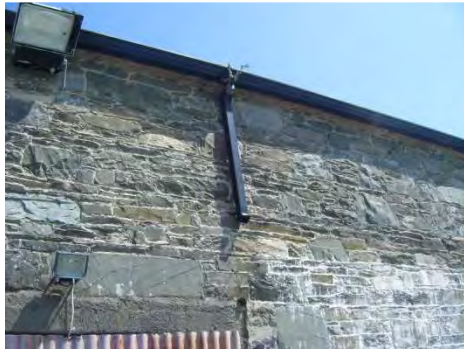
Ref No:	Condition:	Picture:	Repair:	Priority:
4.2.3	<p>The gutter and downpipe has been replaced recently with new Upvc guttering. However it seems to be unfinished as it fails to reach adequate drainage point, which can cause the ingress of moisture and damp within the elevation walls.</p>

<p>Clean guttering and complete works.</p> <p><b>Note:-</b> Due to the age of this main building circa 1820 There is no damp proof course, it may be necessary to inject the walls with a damp proof resin or install an electrical osmosis system to help mitigate rising damp.</p>	High
4.2.4	<p>Again partial demolition of area. Unsightly and requires extensive repair works.</p>

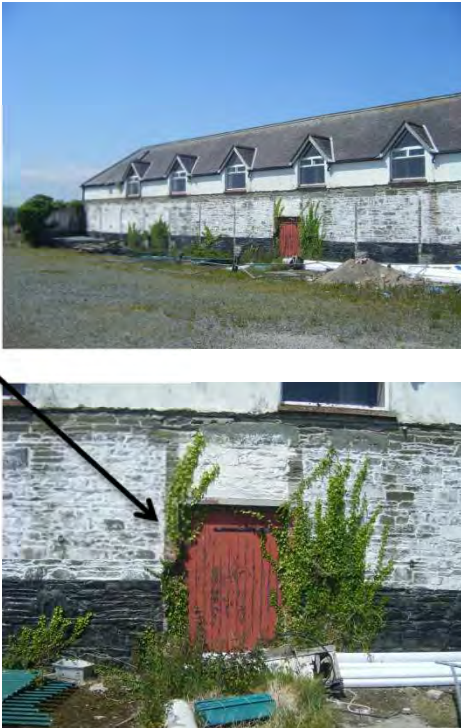
Ref No:	Condition:	Picture:	Repair:	Priority:
4.3.1	Accumulation of waste materials, rubbish and weeds in area.

All of the saplings, trees and over growth to be removed off site and a clear escape pathway to be maintained.	Med
4.3.2	The existing painted surface of the walls and window sills to the front elevation are in poor decorative condition.

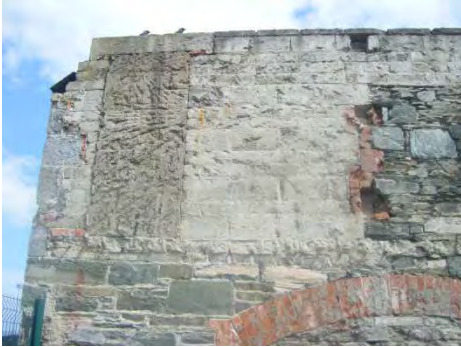
Ref No:	Condition:	Picture:	Repair:	Priority:
4.4.1	Partially damaged during demolition of structure with continuous deterioration has led to poor condition of certain areas along this elevation.

Clean down walls, remove loose cement and re-point with approved mortar.	High
4.4.2	Again previous opened areas have been blocked up

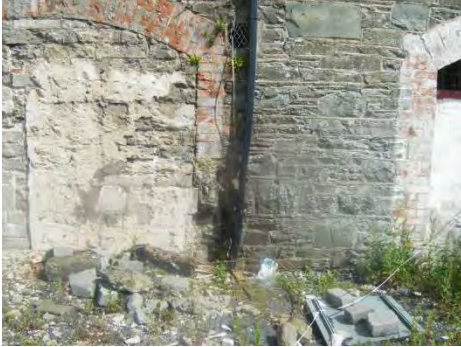
Ref No:	Condition:	Picture:	Repair:	Priority:
4.4.4	Insufficient drainage. Over grown vegetation and debris surrounding structure.

Lay new surface drainage to allow correct disposal. Remove debris and overgrowth and lay 100mm of 804 stone base to facilitate movement	High
4.4.5	<p>The integrity of the door frame is relatively good, however wear and tear marks and scrapes are evident. There is also a multitude of door locking mechanisms that need attention.</p> <p>The paintwork surrounding is in poor condition.</p>

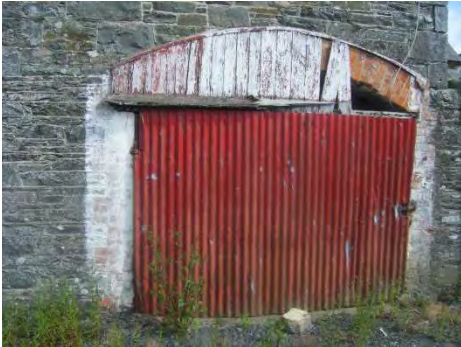
As Above	High
4.4.8	Existing steel correlated door is unsightly.

Remove timber and replace with new. Strip door and Re-paint and finish or remove existing and replace with matching stone mirroring surrounding area.	High
4.4.9	Existing timber shutter windows in poor condition. Large areas are missing pieces.

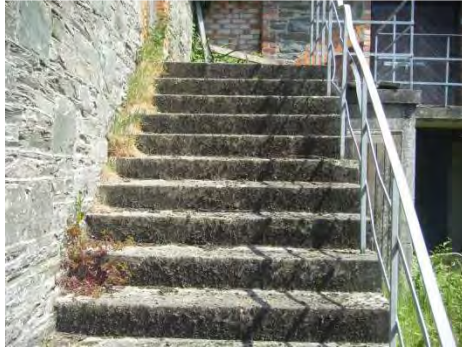
Ref No:	Condition:	Picture:	Repair:	Priority:
4.5.1	The steps leading up to the entrance door are unsightly and in need cleaning.

All rubbish and debris to be removed, steps to be washed down and all gaps between the steps joints are to be re-pointed with cement.	High
4.5.2	The door is in poor condition and is in need of immediate repair. The base of the door does not reach the floor inside leaving a passage for moisture and vermin.

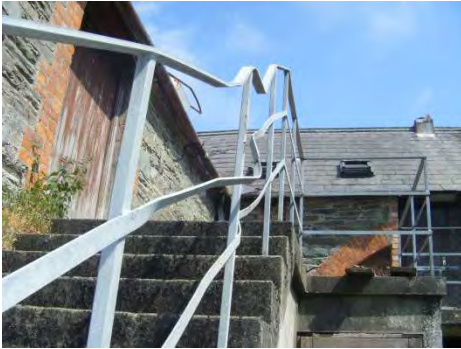
Should the door be refurbished then the door should be sanded down, any cracks sealed with suitable wood filler and the door to be re-painted. The door should also be draught proofed.	High
4.5.7	Consideration will need to be given to the very poor condition of the existing handrails.

Handrails to be removed and replaced with new approved rails.	High
4.5.8	The wall surface looks grubby and unsightly.	 	Clean down walls and if desired painted with breathable emulsion exterior paint.	Low

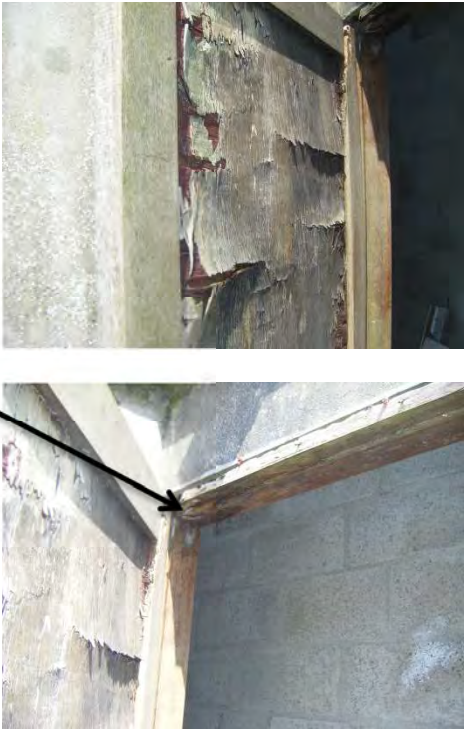
Ref No:	Condition:	Picture:	Repair:	Priority:
4.5.9	This door is in extremely poor condition. It does not open or close properly with evidence of wet rot on the part of the door and frame.

Remove and cart away existing doors and frames. Replace with new door and frame and paint.	High
4.5.10	Accumulation of rubbish and weeds.

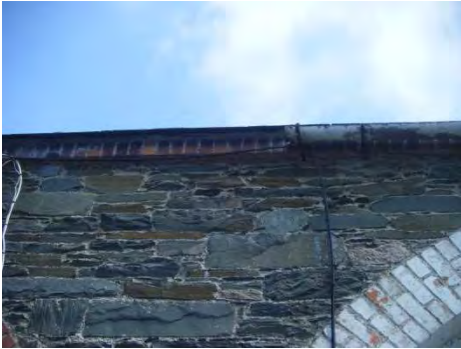
4.5.12	Guttering is missing many places.

<p>Following cleaning of all the guttering this section of guttering should be fixed / replaced by a competent person.</p>	High

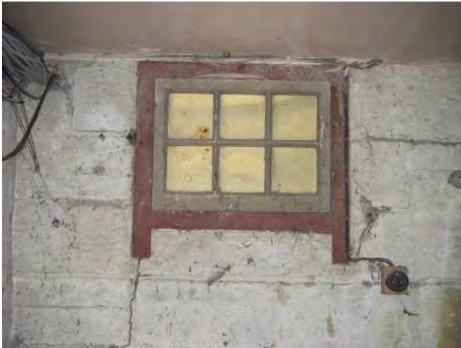
4.5.13	Original timber windows are in poor condition.

<ol style="list-style-type: none"><li>1. Window need to be cleaned inside and out. Require sanding down and re-painting with a new under coat and 2 Nr. Finishing coats to prolong lifespan of the window frames. OR</li><li>2. Replace with new Upvc double glazed window units.</li></ol>	High

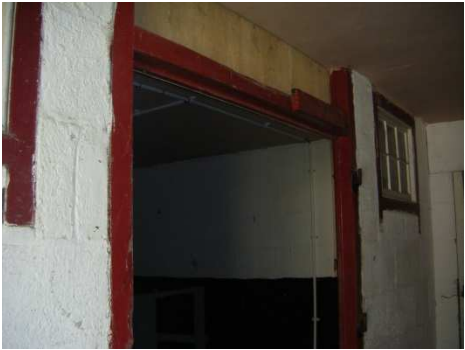
Ref No:	Condition:	Picture:	Repair:	Priority:
4.5.14	Stable doors are in poor condition with a vast amount missing altogether in places

Existing external doors and frames need to be replaced and painted.	High
4.5.15	This door does not open or close properly. Rear external exit doors are in very poor condition with wet rot on the lower part of the door and frame.

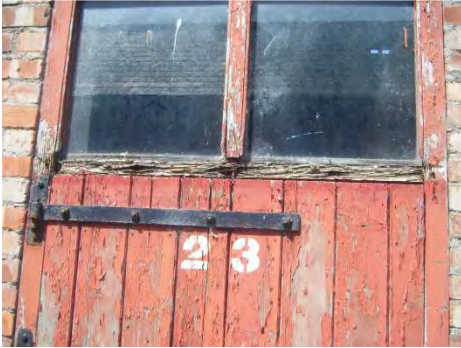
Ref No:	Condition:	Picture:	Repair:	Priority:
4.5.19	Picture illustrates poor condition of doors.

Existing external doors and frames need to be replaced and painted.	High
4.5.20	Over grown vegetation blocking gutters and expanding large area. Cast iron gutters showing signs of deterioration.

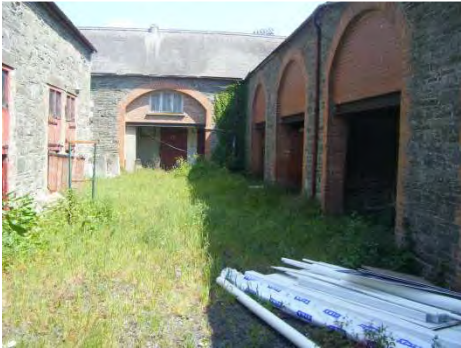
Remove existing overgrowth, clean down walls and replace cracked down pipe. These cast iron gutters need to be replaced immediately with either Upvc or extruded aluminium guttering and downpipe.	High
4.5.21	Over grown vegetation and debris surrounding structure.

Remove debris and overgrowth and lay 100mm of 804 stone base to facilitate movement	High

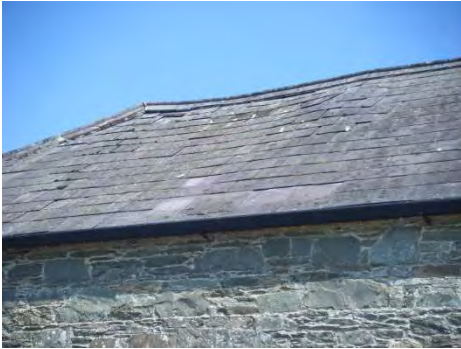
<p>These cast iron gutters need to be replaced immediately.</p> <p>Further investigation will be necessary to determine the extent of any deterioration of the main roof timbers within the vicinity of the leaking guttering.</p>	High
5.1.8	<p>Clear indication that there is a serious defect of the Roof as it is starting to sag/bow in areas.</p>

<p>Further investigation will be necessary to determine the extent of any deterioration of the main roof timbers.</p>	High
5.1.9	<p>Upon closer examination it was found that there is extensive deterioration of roof timbers.</p>

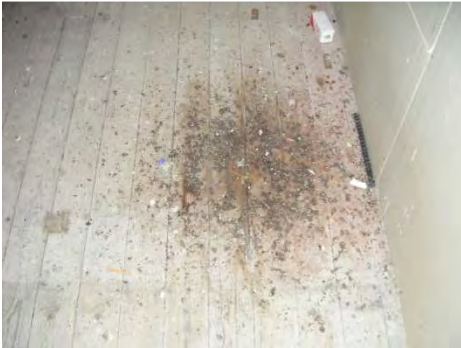
Replace old roof vent with a modern pvc unit.	High
6.1.3	Resulting damage from roof vent above.

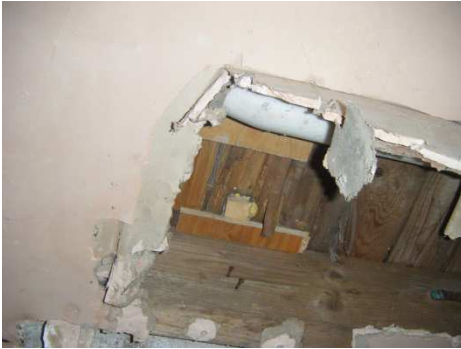
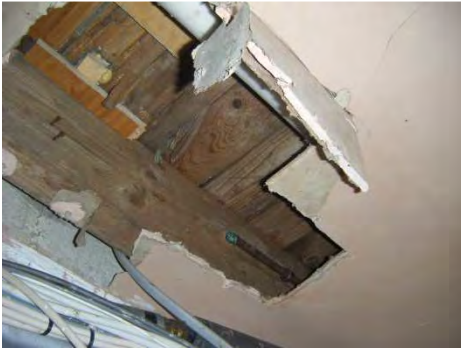
As Above	High
6.1.19	There are holes in the ceiling caused by the construction team.

Slab the underside of the joists with 12mm plasterboard to form new ceiling. Tape joints, add plaster skim and paint	High

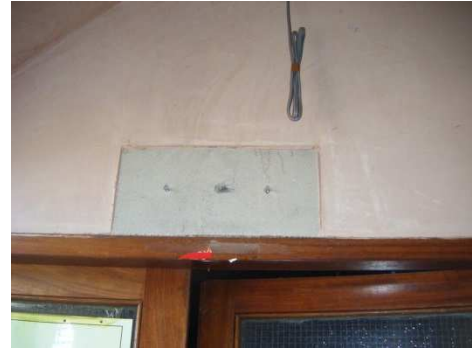
As Above	High
7.1.5	Emergency Escape lighting missing.

All emergency lighting, both internal and external, to be checked replaced or repaired and tested.	High
