**Declaration**

| Name of Building: | 1 and 2 Paradise Place | National Grid co-ordinates: | | |

Section 57 Declaration – Works to a Protected Structure

Reference No: S57 DB23-02

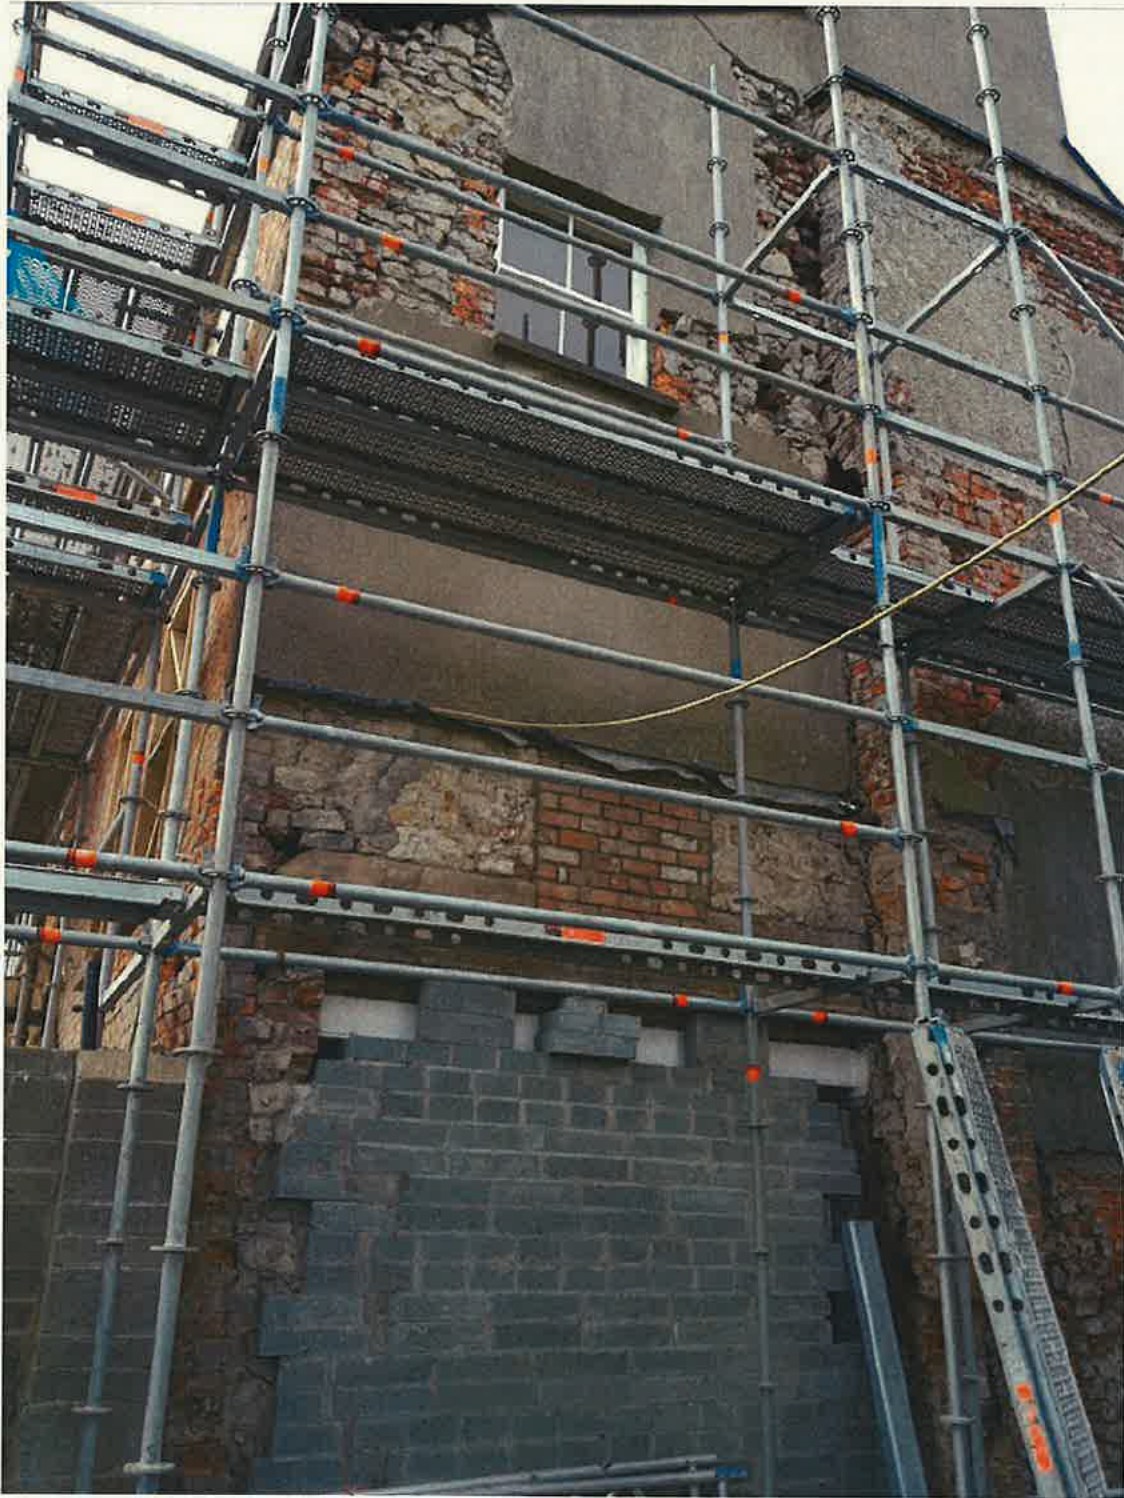
Figure 1 Southeast corner and gable wall

- As part of the investigation and repair works, the builder has removed further sections of render at the southeast corner of the building and between the corner and the chimney projection, see Figure 1 below.

- The brickwork supporting the timber beam in the gable wall is cracked and failed. This is most likely due to overloading from the timber beam.
- There are large cracks in the gable wall over the timber beam, these have been filled over the years.

- There is a section of render on the gable wall between first and second floor. Based on other observations, it is likely that the wall structure at this location is in poor condition, the render may be acting as a "structural" repair.

- The gable wall has several different forms of construction, this discontinuity in construction materials has created a relatively weak structure. There are built-in timbers which are not continuous across the wall but have created weak spots exasperating the poor condition of the gable wall.

- Overall, it is our view that large sections of this gable wall should be considered as "Failed". The current condition of the wall is dangerous.
- The gable wall and front wall at the corner have been moving over the years and several repair measures were carried out to make good.
- The brickwork has failed in the vicinity of the timber beam due to overloading.
- Other brickwork is crumbling, possibly due to freeze-thaw water damage.
- The corner is out of line by more than 100mm; this is causing a "tearing" stress in the gable wall and is leading to further cracking and movement.
- Unless extreme intervention measures are taken, the gable wall and front wall at the southeast corner will continue to move and crack. This will eventually lead to sections of the wall collapsing.

- We recommend taking down the failed section of gable wall and the front wall at the southeast corner and reconstructing them.
- The built-in timbers which are not tying the wall together but weakening the arrangement should be removed as part of this work.
- We recommend correcting the out of line (bulged) corner – reconstructing it to make plumb.
- The materials used for this reconstruction work could be new blockwork / brickwork or alternatively salvage brickwork could be used.

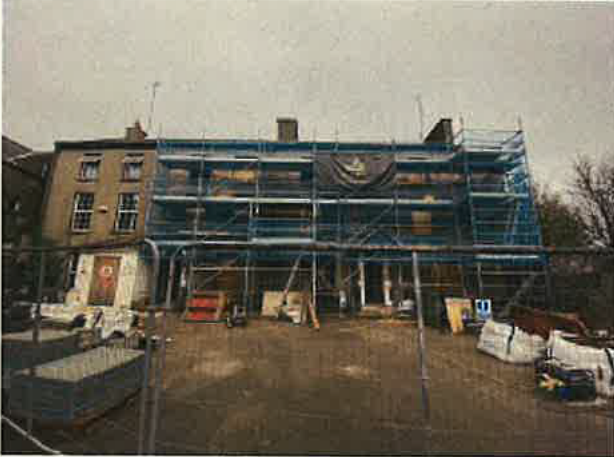
008 / 001

General Photograph of Front of Site

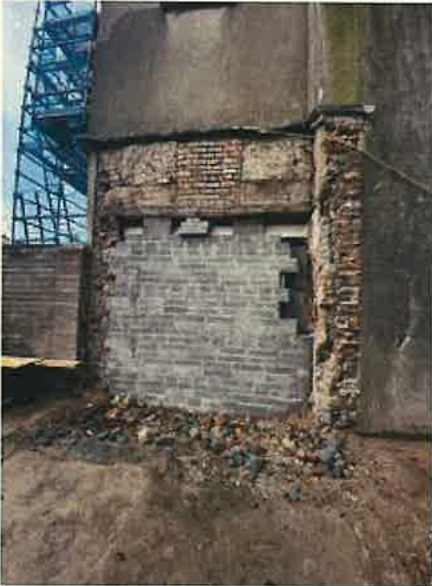
008 / 002

Gable Works

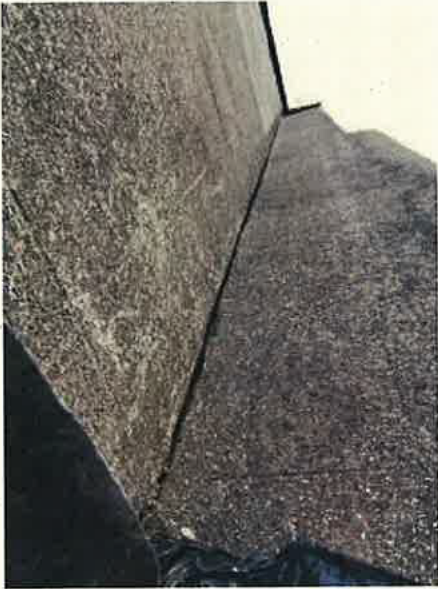
008 / 003

7. The front face of the projection at ground floor level has several cracks in the render indicating the brickwork beneath is in very poor condition.
8. Remedial works to retain and make safe the chimney breast projection was reviewed on site.

Cracking in render at Chimney Projection

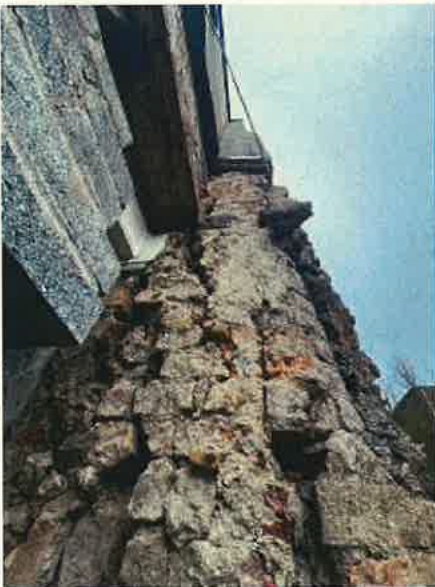
008 / 004

Brickwork has failed due to load from timber beam and / or wall settlement

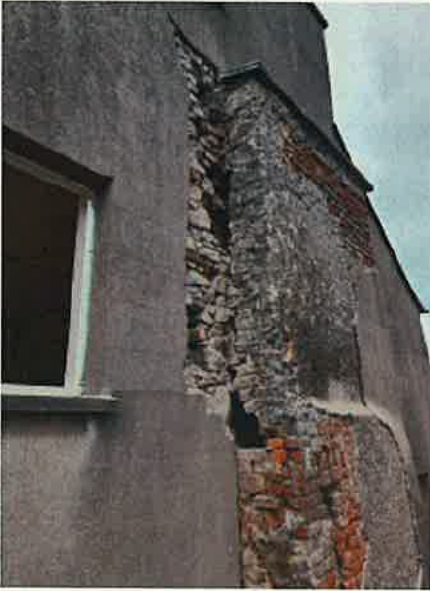
008 / 005

5. The chimney projection is separating from the gable and is at risk of collapsing - ground , first and second floor levels.
6. The condition of the chimney projection brickwork at ground floor level is extremely poor - the brickwork has failed on the LHS.

Brickwork not keyed into gable wall
Arrangement is dangerous and needs immediate
repair works

9. As a minimum - reconstruction of brickwork is required at ground floor level and strapping and crack stitching is required at first and second floor levels with some reconstruction.

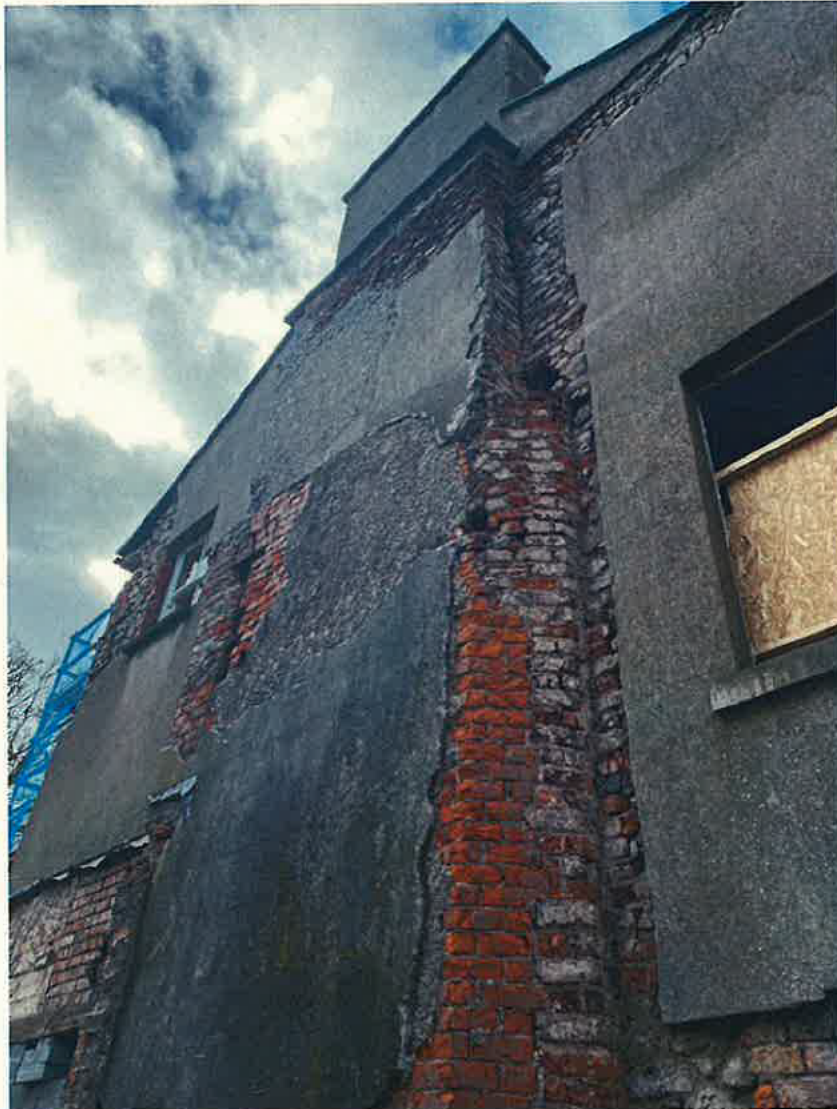
Figure 2 - View of the top of the Gable Wall (East – North)

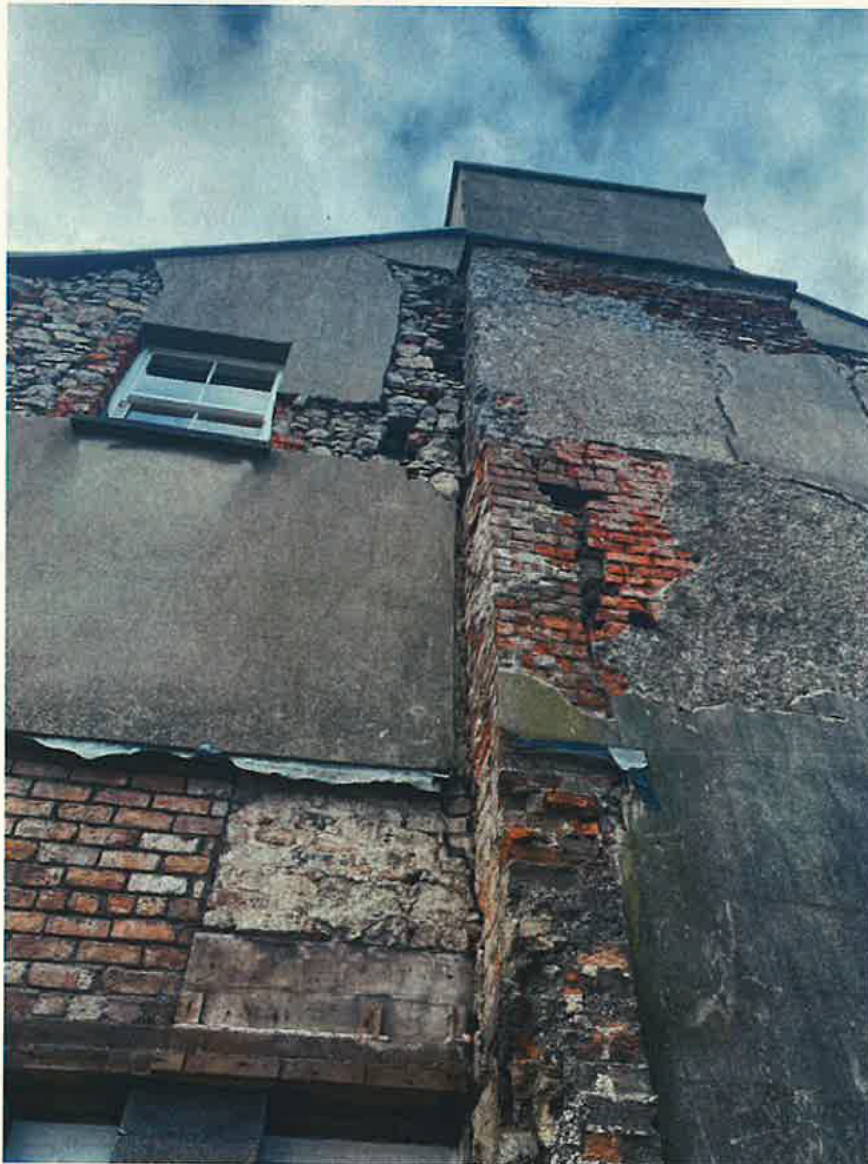
Figure 1 – View of the top of the Gable Wall (East – South)

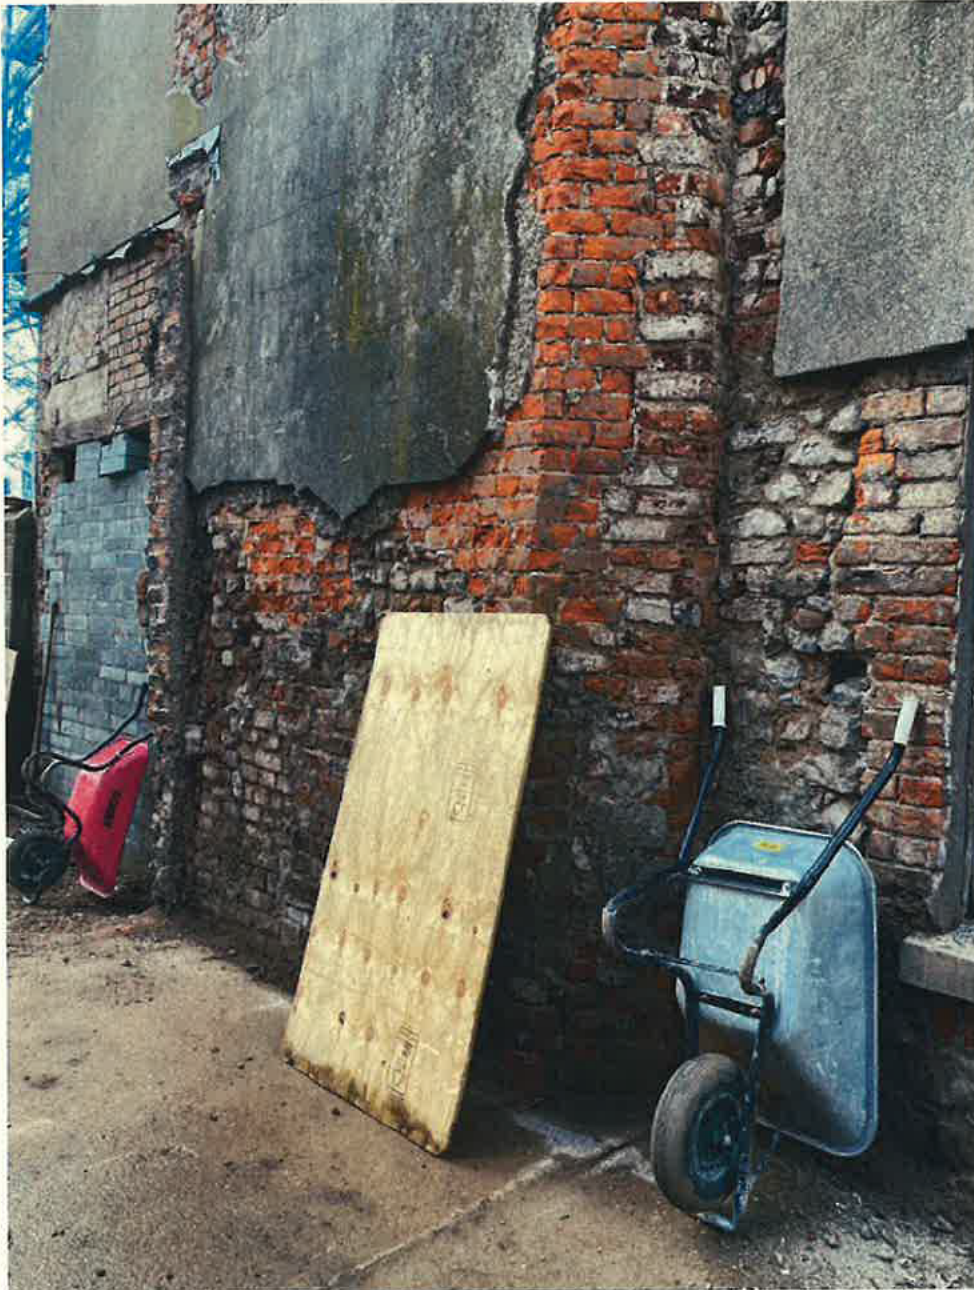
Figure 3 - View of the base of the wall (East – North)

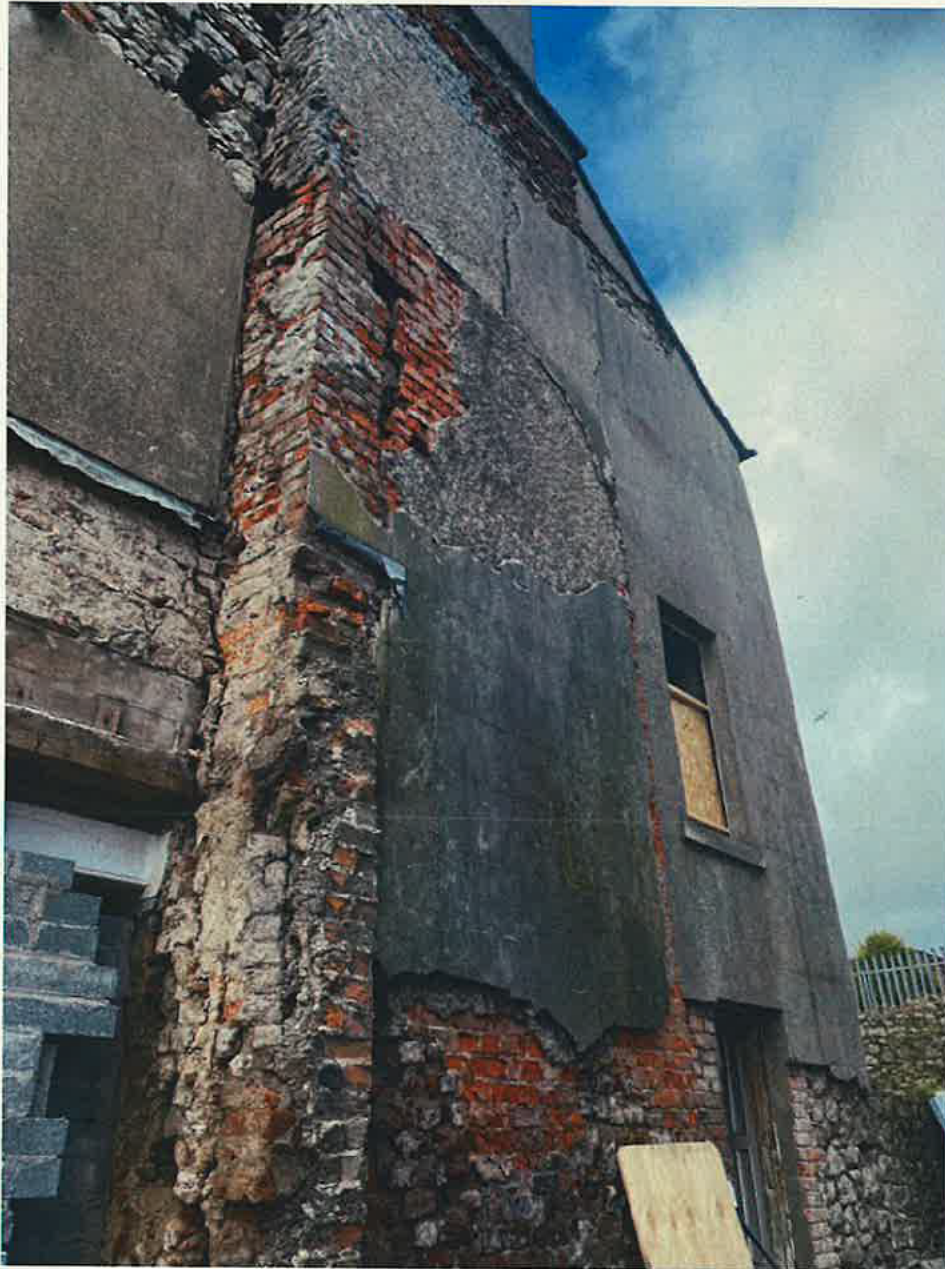
Figure 4 - View of the gable wall (East - South)

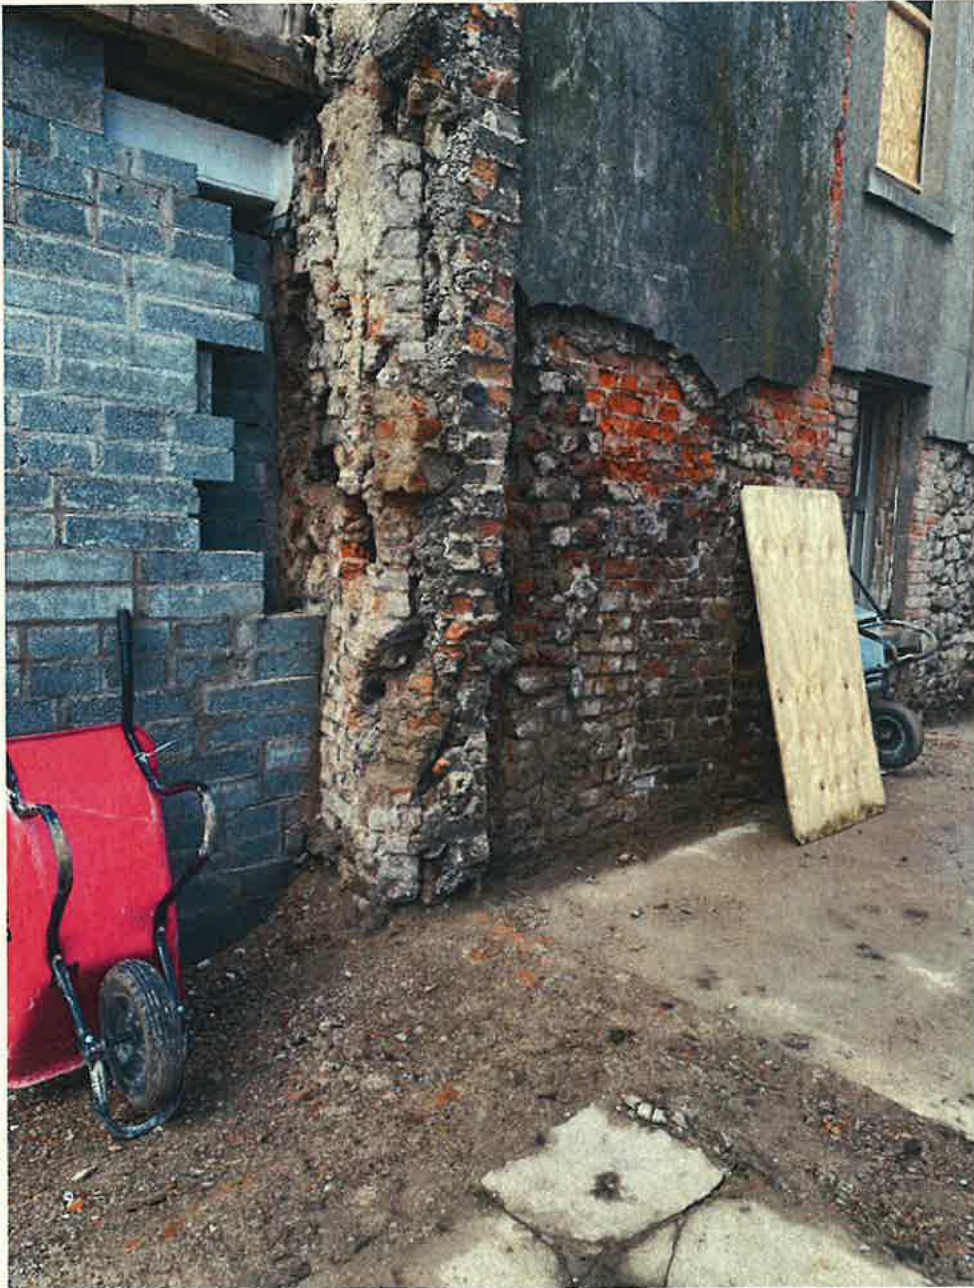
Figure 5 - View of the base of the wall(East – South)
