**Declaration**

Address:		Location:	E	N
Name of Building:	1 and 2 Paradise Place	National Grid co-ordinates:		
Address 1:	William Street	O.S. Map Type:		
Address 2:	Drogheda	Map Sheet:		
Address 3:	Co. Louth	Site Number:		
Eircode:	A92 FF10

Repair to Paradise Place Gable Wall with the following Methodology.

Section 57 Declaration – Works to a Protected Structure

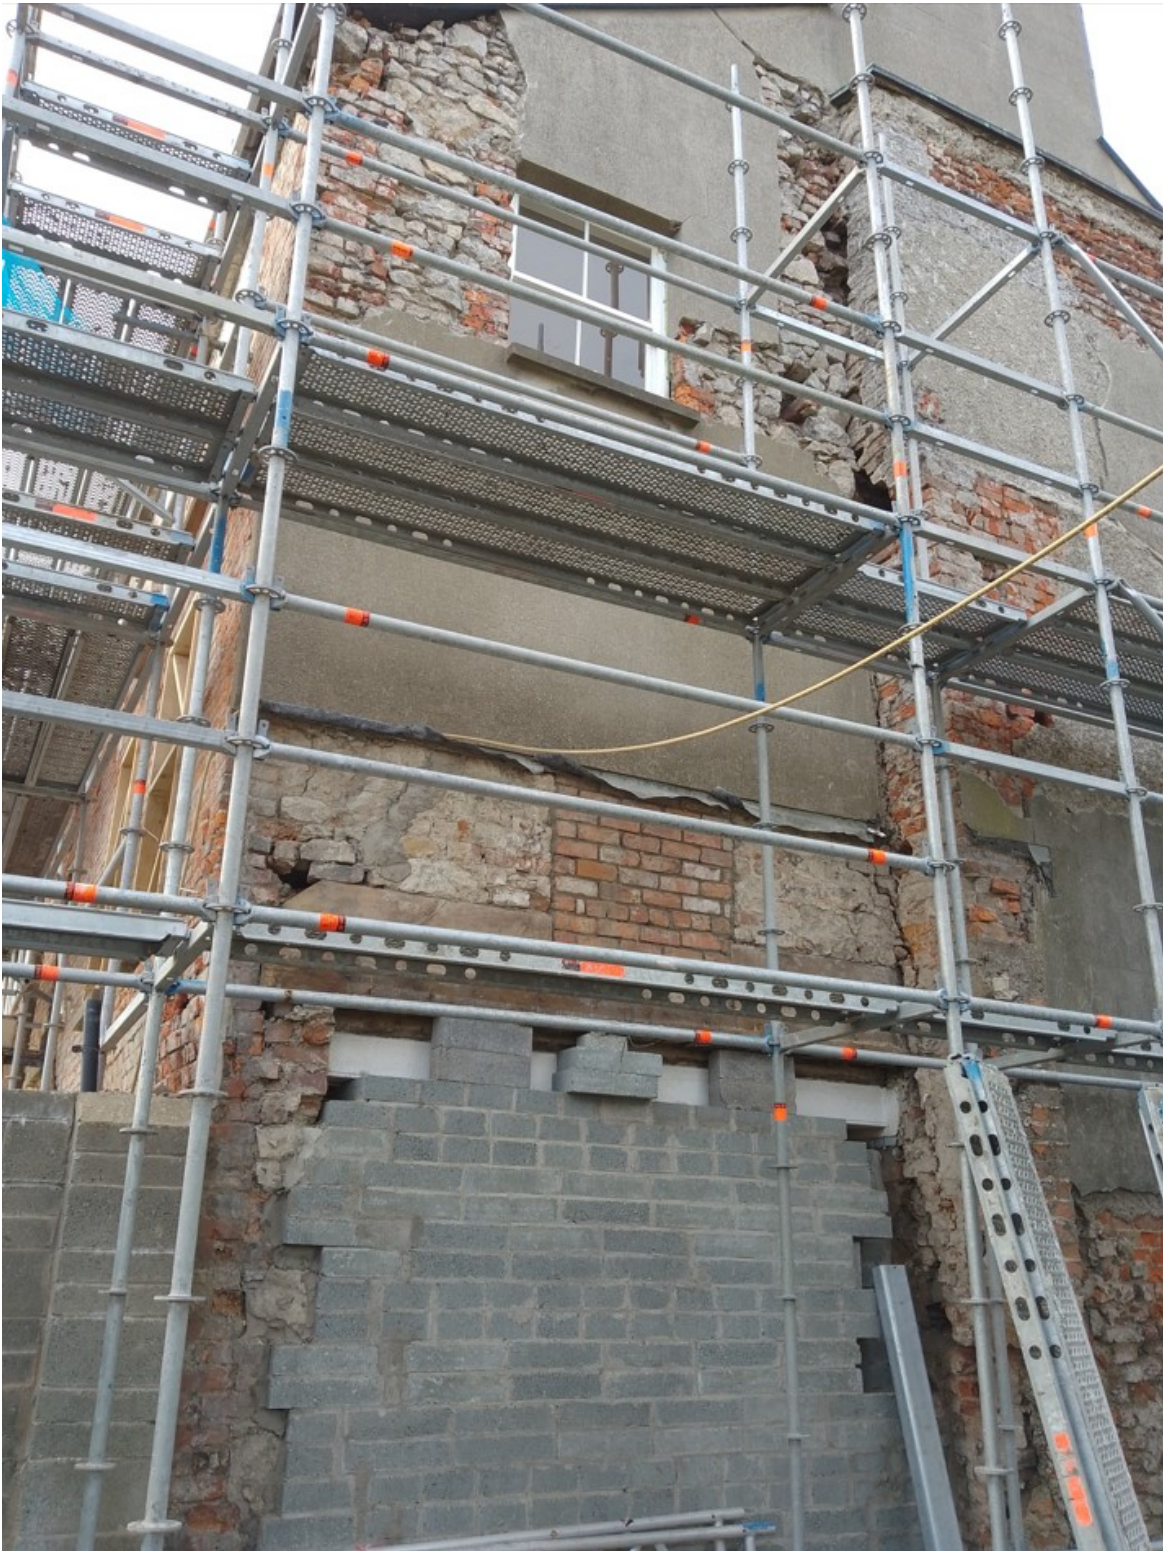
Figure 1 Southeast corner and gable wall

- As part of the investigation and repair works, the builder has removed further sections of render at the southeast corner of the building and between the corner and the chimney projection, see Figure 1 below.

- The brickwork supporting the timber beam in the gable wall is cracked and failed. This is most likely due to overloading from the timber beam.
- There are large cracks in the gable wall over the timber beam, these have been filled over the years.

- There is a section of render on the gable wall between first and second floor. Based on other observations, it is likely that the wall structure at this location is in poor condition, the render may be acting as a “structural” repair.

- The gable wall has several different forms of construction, this discontinuity in construction materials has created a relatively weak structure. There are built-in timbers which are not continuous across the wall but have created weak spots exasperating the poor condition of the gable wall.

- Overall, it is our view that large sections of this gable wall should be considered as “Failed”. The current condition of the wall is dangerous.
- The gable wall and front wall at the corner have been moving over the years and several repair measures were carried out to make good.
- The brickwork has failed in the vicinity of the timber beam due to overloading.
- Other brickwork is crumbling, possibly due to freeze-thaw water damage.
- The corner is out of line by more than 100mm; this is causing a “tearing” stress in the gable wall and is leading to further cracking and movement.
- Unless extreme intervention measures are taken, the gable wall and front wall at the southeast corner will continue to move and crack. This will eventually lead to sections of the wall collapsing.

- We recommend taking down the failed section of gable wall and the front wall at the southeast corner and reconstructing them.
- The built-in timbers which are not tying the wall together but weakening the arrangement should be removed as part of this work.
- We recommend correcting the out of line (bulged) corner – reconstructing it to make plumb.
- The materials used for this reconstruction work could be new blockwork / brickwork or alternatively salvage brickwork could be used.

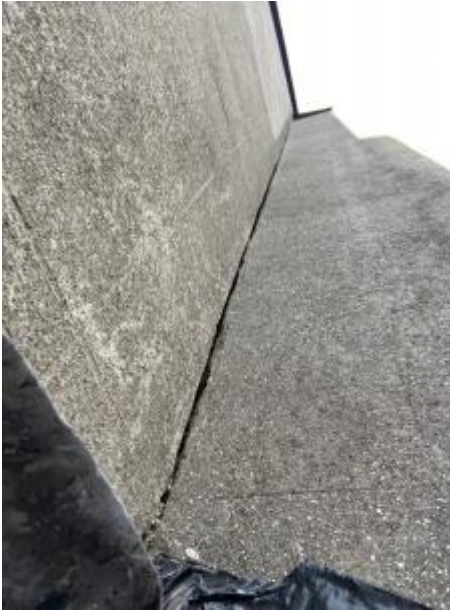
008 / 003

7. The front face of the projection at ground floor level has several cracks in the render indicating the brickwork beneath is in very poor condition.
8. Remedial works to retain and make safe the chimney breast projection was reviewed on site.

Cracking in render at Chimney Projection

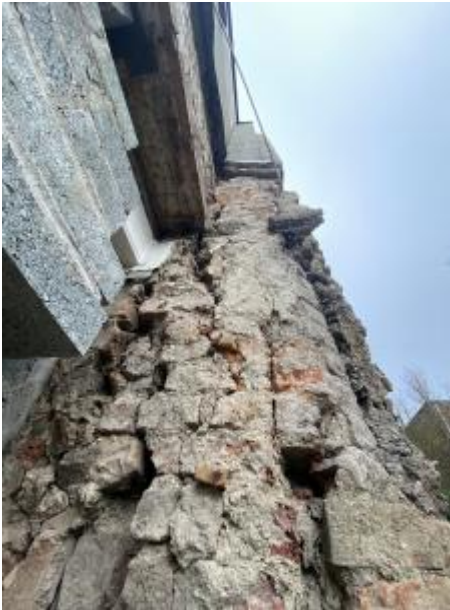
008 / 004

5. The chimney projection is separating from the gable and is at risk of collapsing - ground , first and second floor levels.
6. The condition of the chimney projection brickwork at ground floor level is extremely poor - the brickwork has failed on the LHS.

Brickwork has failed due to load from timber beam and / or wall settlement

-
9. As a minimum - reconstruction of brickwork is required at ground floor level and strapping and crack stitching is required at first and second floor levels with some reconstruction.

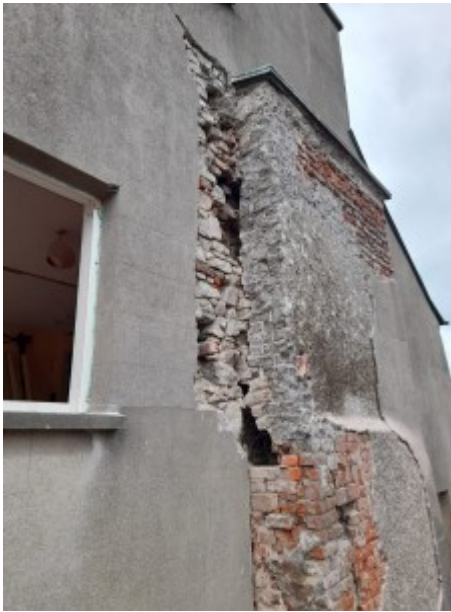
008 / 005

Brickwork not keyed into gable wall
Arrangement is dangerous and needs immediate
repair works
