Declaration

Louth County Council:

Address:		Location:	
Name of Building:	Corn Exchange	National Grid co-ordinates:	E N
Address 1:	Fair Street	O.S. Map Type:	
Address 2:	Drogheda	Map Sheet:	
Address 3:	Co Louth	Site Number:	
Eircode:	A92 P440

The referrer has sought a Section 57 declaration as per the Planning and Development Act 2000 (as amended) in respect of works to a protected structure known as the Corn Market at Fair Street, Drogheda.

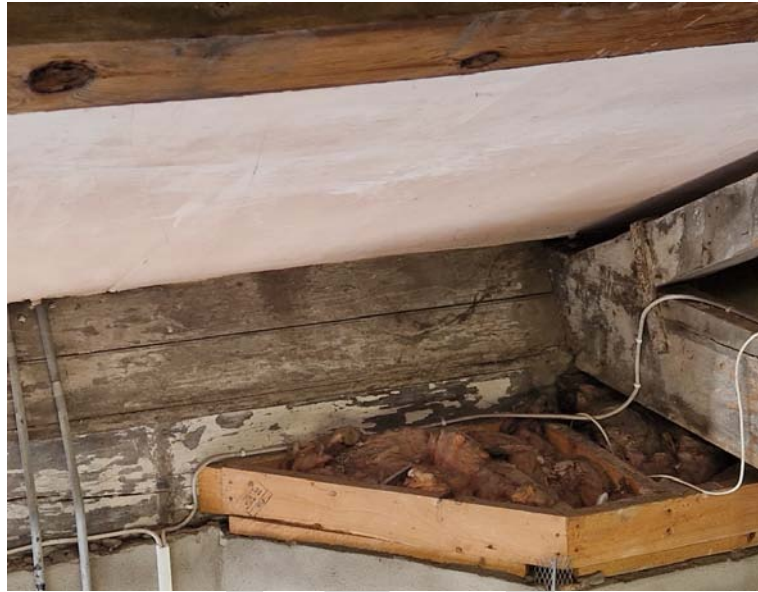
- The underside of the rafters has been plaster boarded for the majority of the building. At the locations where inspection could be undertaken the void between the plasterboard and the underside of the roof covering has been filled with insulation. This results in the timber being unable to breathe adequately and can result in deterioration of the roofing timbers. It is recommended that during any refurbishment works that the roofs be insulated allowing for a minimum 50mm of air gap between the insulation and the underside of the roofing.

Photograph 5 – Lack of air gap between insulation and underside of roof

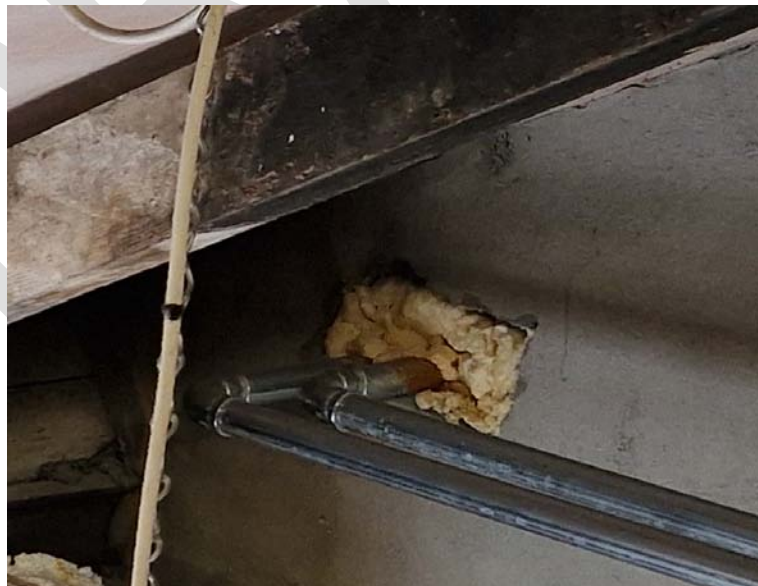
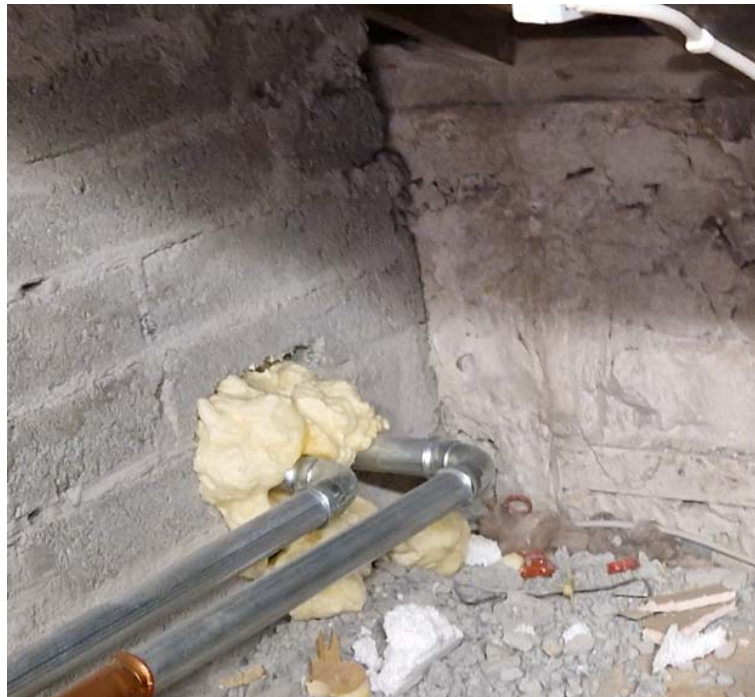
- Holes were noted from one compartment to another. Any penetrations in the roof zone should be fire stopped appropriate to the fire rating of the location.

Photograph 6 – Fire stopping required

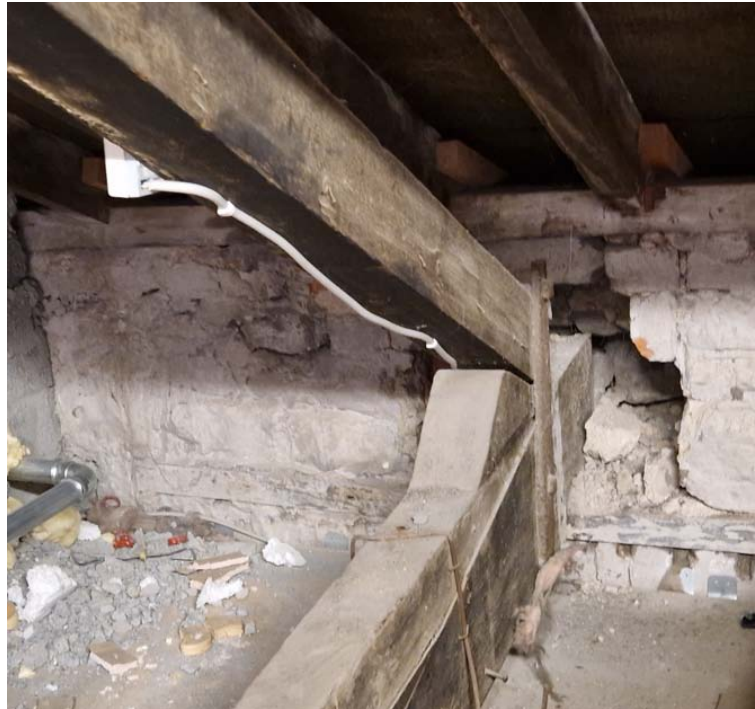
- Stones have been dislodged at the kingpost truss where it rests on the wall. This area should be rebuilt.

Photograph 8 – Section of wall to be rebuilt

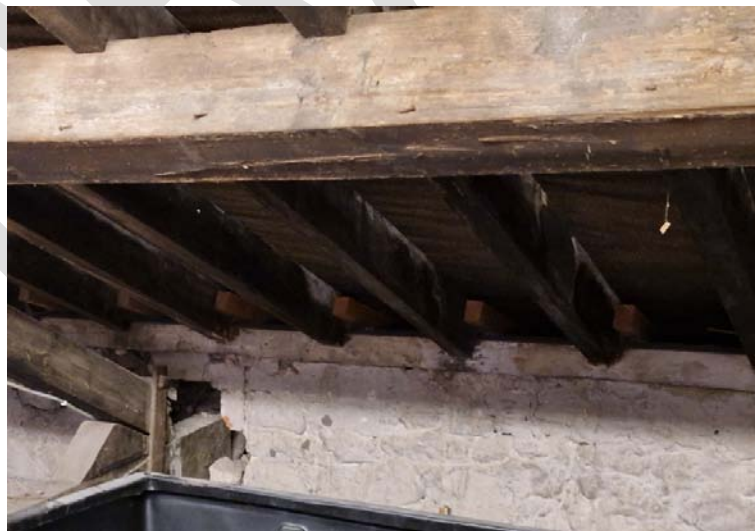
- Some evidence of moisture ingress was noted to rafters. Ends of rafters appear to have been adversely affected with wet rot at some stage in the past as new timbers adjacent to the existing have been fixed. Where significant refurbishment of the building is being undertaken it may be prudent to make an allowance for localised repair of the roof where leaks are apparent.

Photograph 9 – Repairs to existing rafters

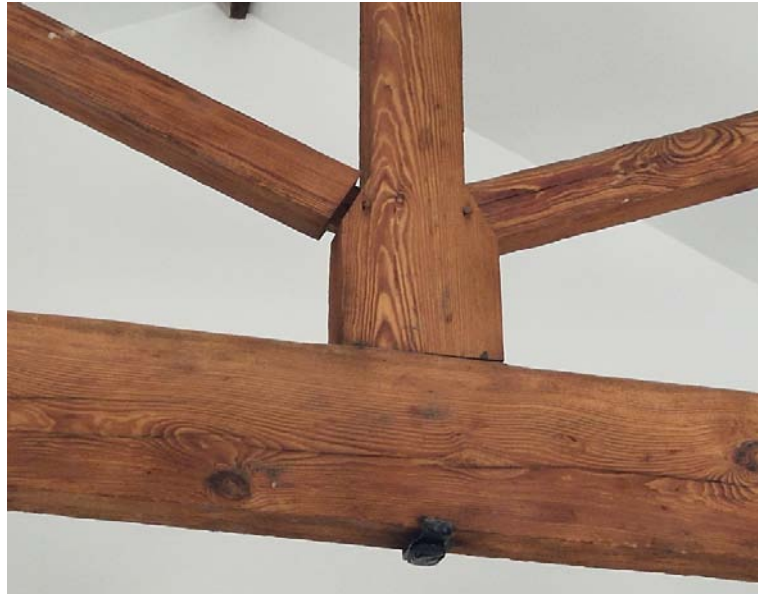
- A strut to the king post to the engineer's office area adjacent to the boiler room is not abutting the main king post. This is most likely historic and there does not appear to be any deflections noted. The gap between the post and the strut should be packed.

Photograph 10 – Kingpost strut

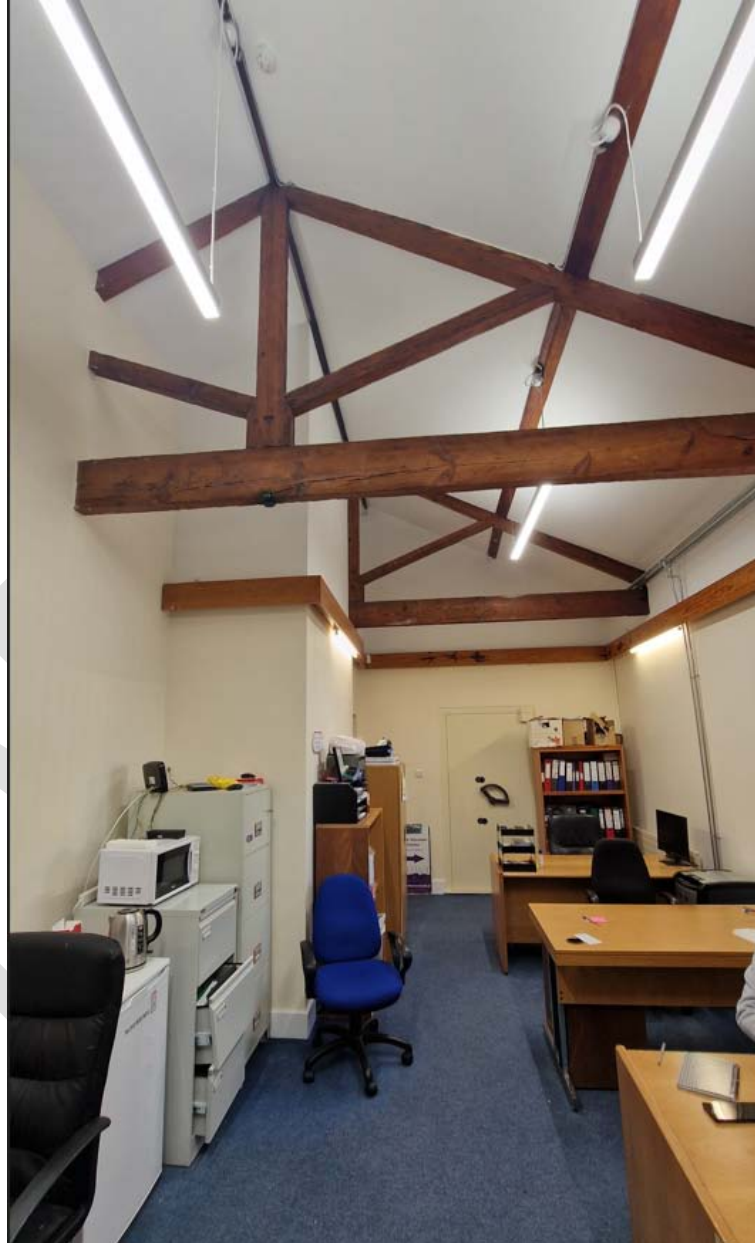
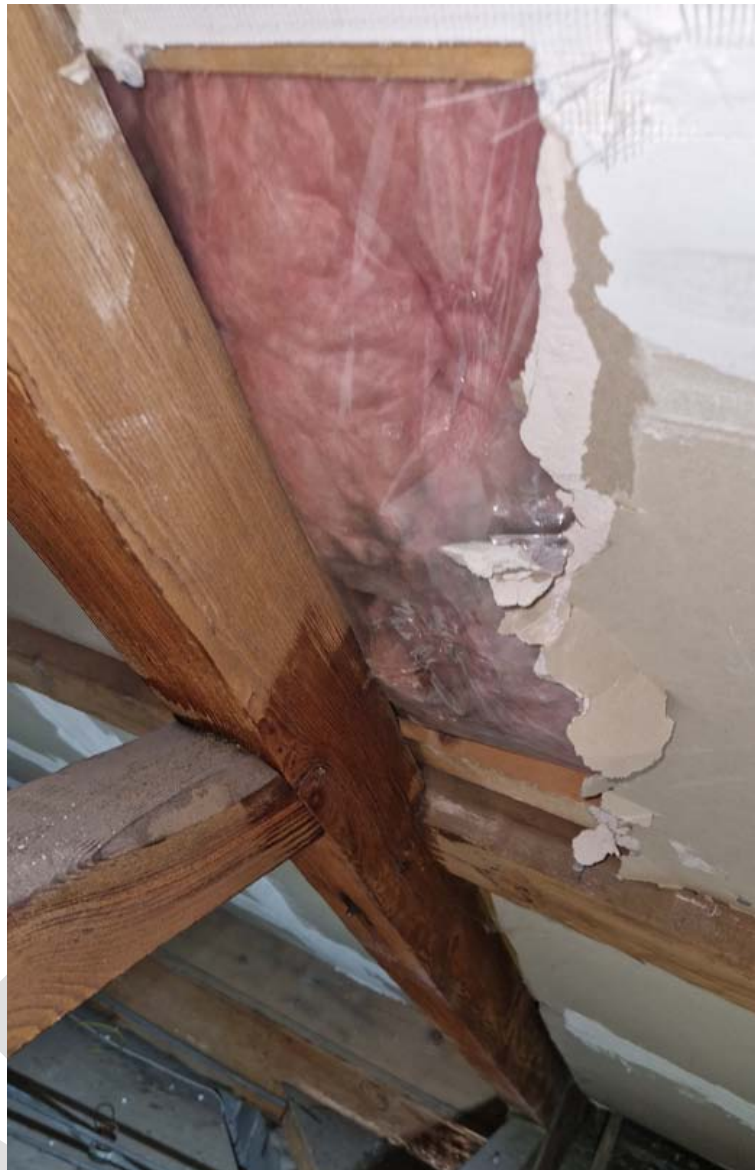
- The underside of the rafters to the office area adjacent to the engineer's office has been plaster boarded. At the locations where inspection could be undertaken the void between the plasterboard and the underside of the roof covering has been filled with insulation. Access was available to the tank room off this office area. This results in the timber being unable to breathe adequately and can result in deterioration of the roofing timbers. It is recommended that during any refurbishment works that the roofs be insulated allowing for a minimum 50mm of air gap between the insulation and the underside of the roofing. No access was available in this area to inspect the roof structure.

Photograph 12 – Insulation to underside of roof

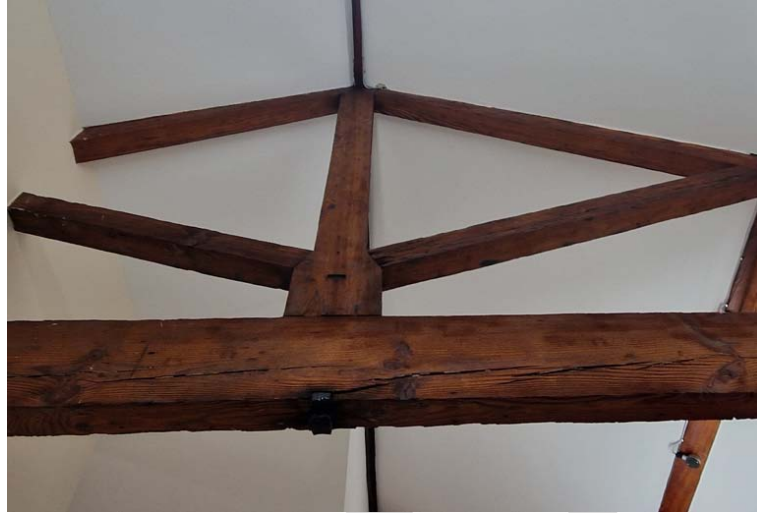
- Some cracking of the timber king post was noted this cracking of the bottom chord should be monitored for further signs of movement and strengthened where deemed necessary.

Photograph 13 – Kingpost strut

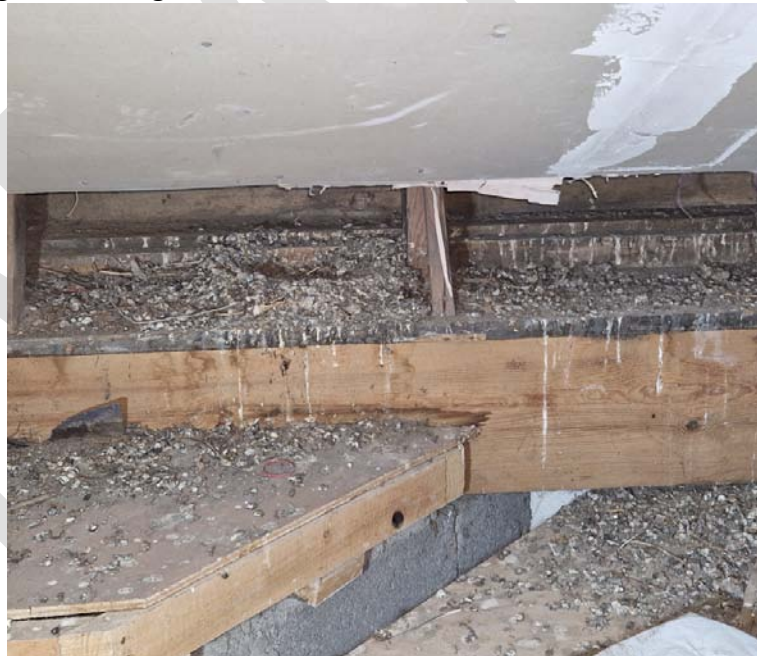
- Within the 'tank room' significant significant Pigeon guano was noted. This appeared to be historic. It is recommended that any guano be removed and the attics made secure to ensure pigeons can't gain access.

Photograph 14 – Pigeon Guano

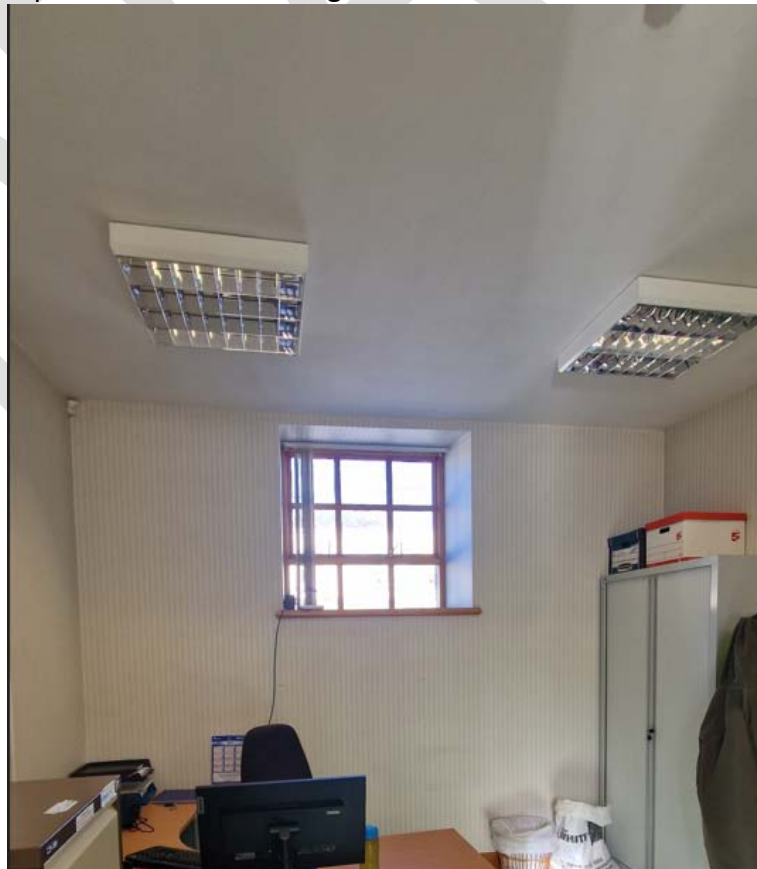
- Within the Senior Executive/architect housing office there was no access to the attic of the property a plasterboard flat ceiling existed.

Photograph 16 – Plasterboard ceiling

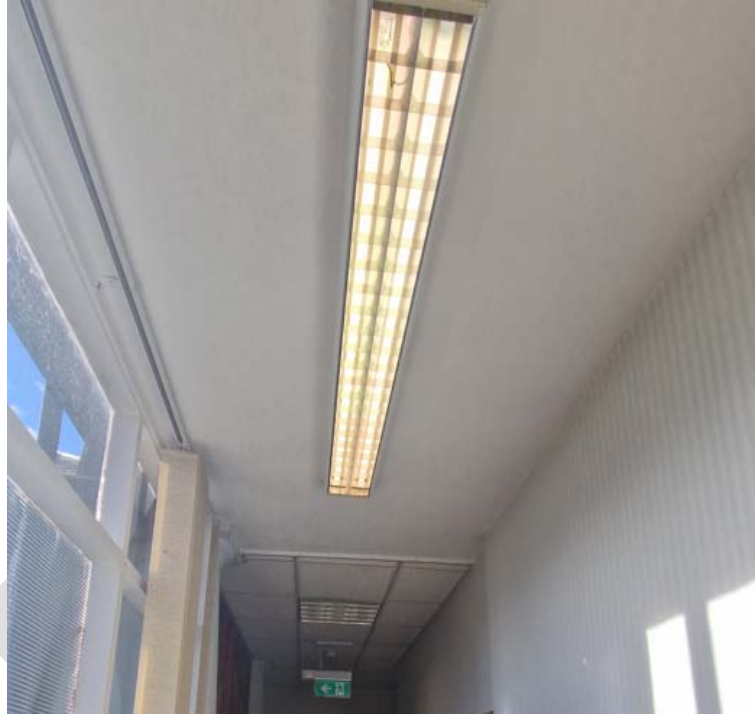
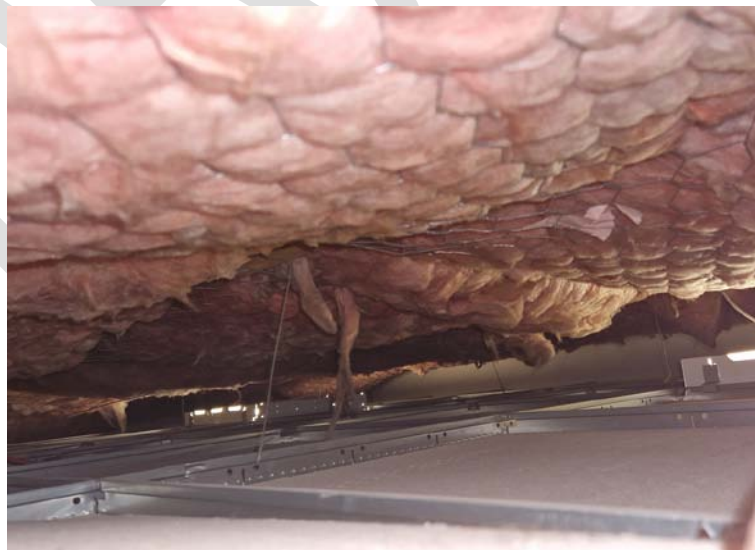
- The hall way adjacent to the above offices consisted of a plasterboard flat ceiling and a suspended tile ceiling. The Property Inspection unit office has also had a suspended flat ceiling. A ceiling tile was removed to gain access to the attic. Above the suspended ceiling was chicken wire supporting insulation, no access to the attic could be gained. The depth of insulation that was noted would not meet current standards. The entire roof area should be stripped of insulation and reinsulated in accordance with current standards incorporating appropriate air tightness and ventilation to attic spaces. Adequate access to all attics should be provided and these accesses should be readily identifiable.

Photograph 17 – Insulation and chicken wire

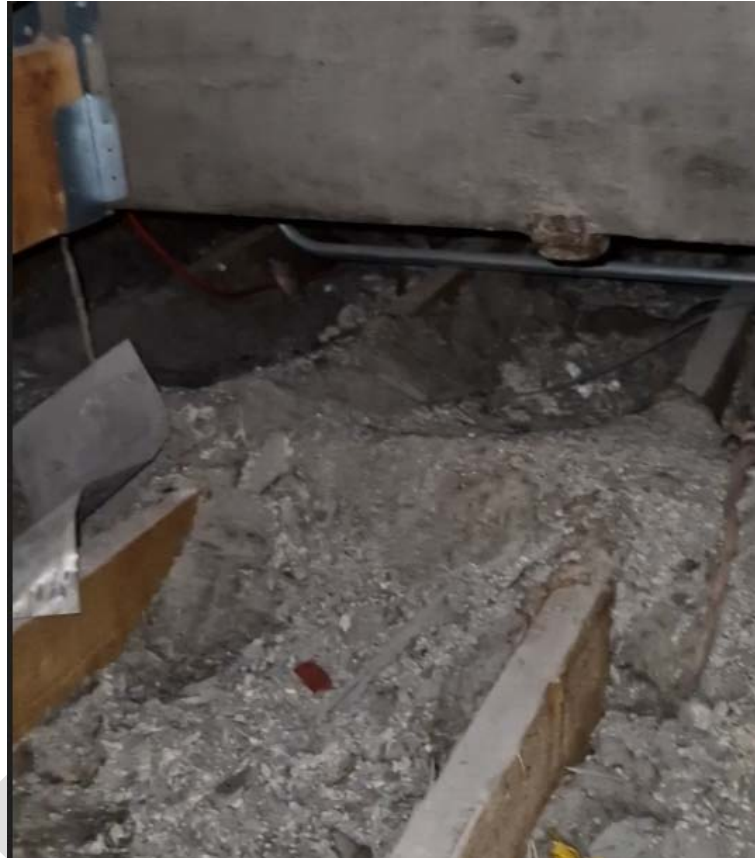
- Limited access was achieved over the plasterboard ceiling. This revealed insulation. The insulation had a significant amount of debris and this insulation should be removed and replaced in keeping with a strategy to improve the thermal performance of the property.

Photograph 18 – Debris on insulation

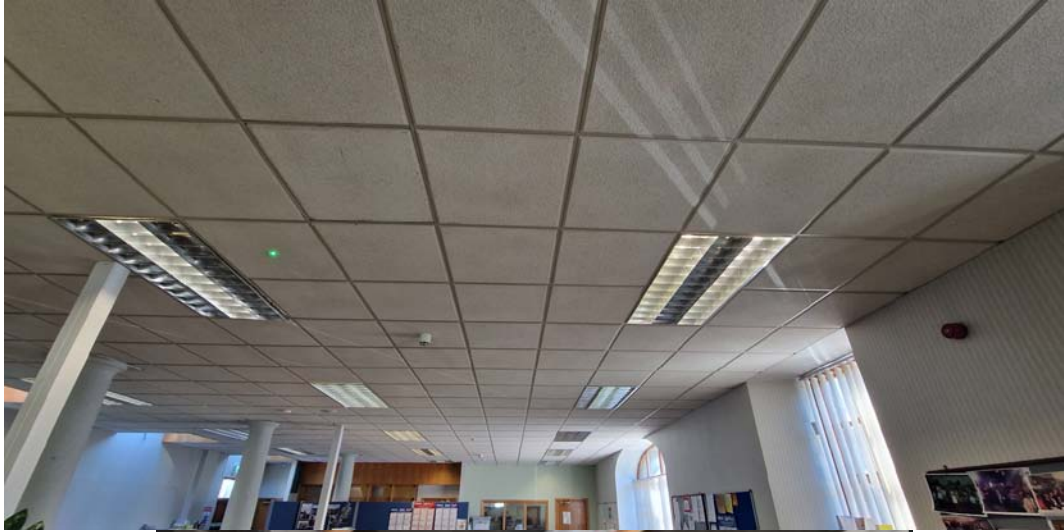
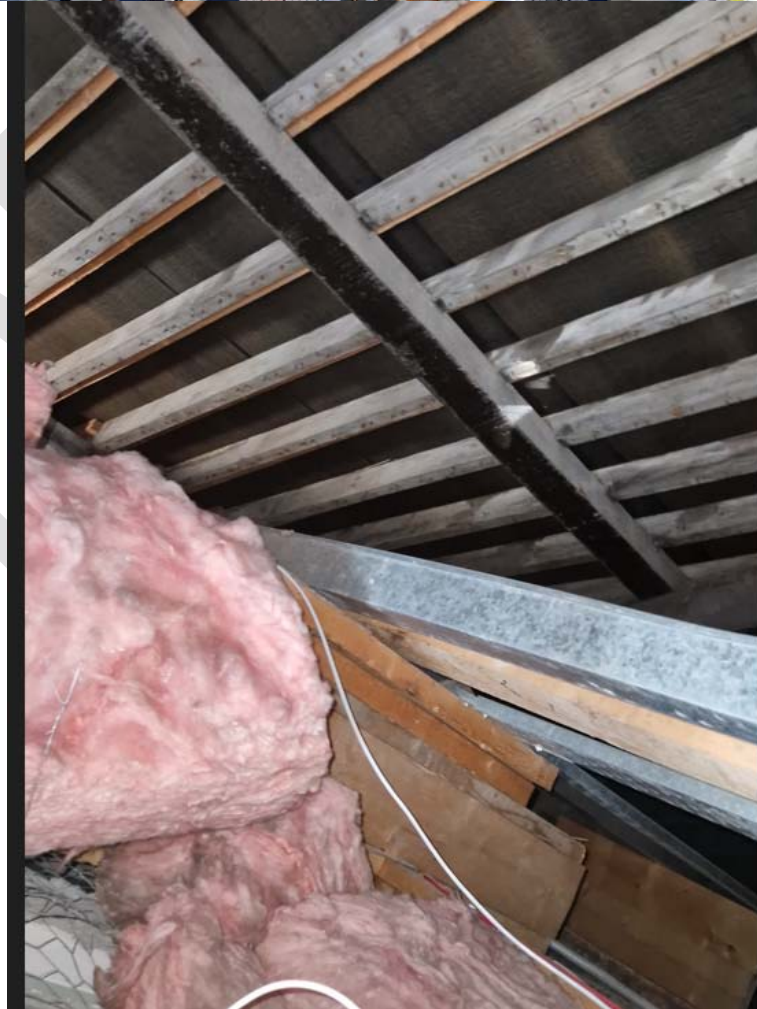
- Within the large open plan office area adjacent to Fairstreet consisted of a suspended tile ceiling. Ceiling tiles were removed to gain access to the attic. Above the suspended ceiling was chicken wire supporting insulation, no access to the attic could be gained. The depth of insulation that was noted would not meet current standards. The entire roof area should be stripped of insulation and reinsulated in accordance with current standards incorporating appropriate air tightness and ventilation to attic spaces. Adequate access to all attics should be provided and these accesses should be readily identifiable.

Photograph 19 – Insulation to attic

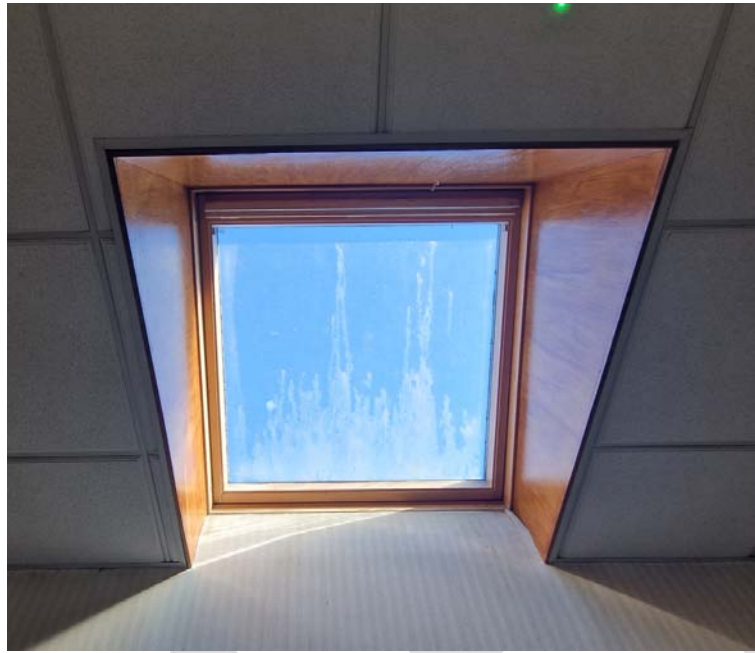
- Velux windows were noted to this area. These are inaccessible and should be replaced as part of any refurbishment incorporating new flashing with thought put into maintenance into the future.

Photograph 20 – Kingpost strut

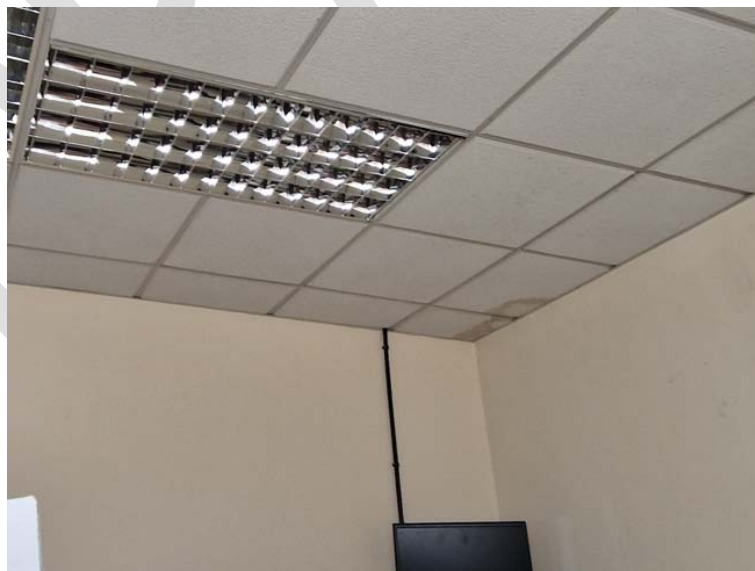
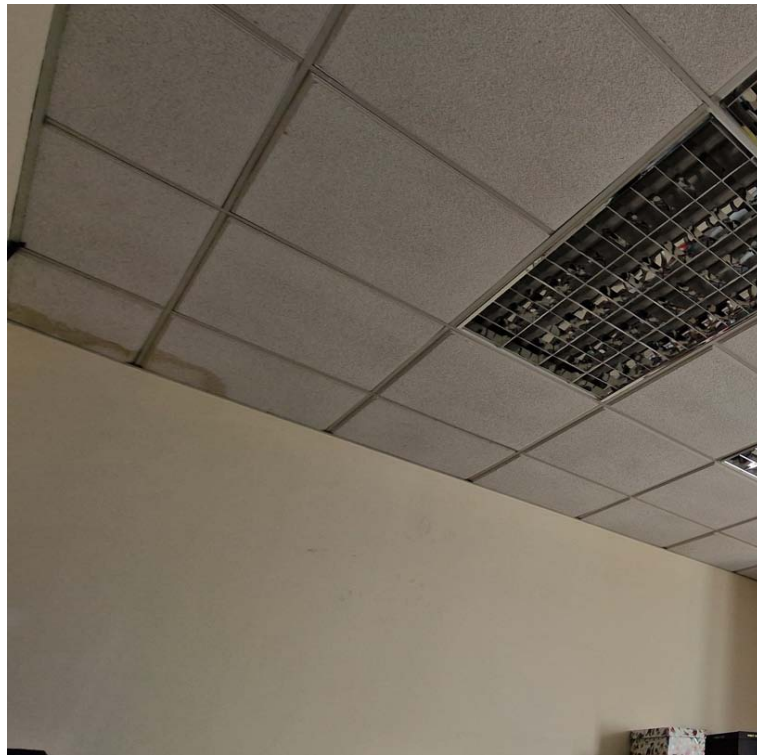
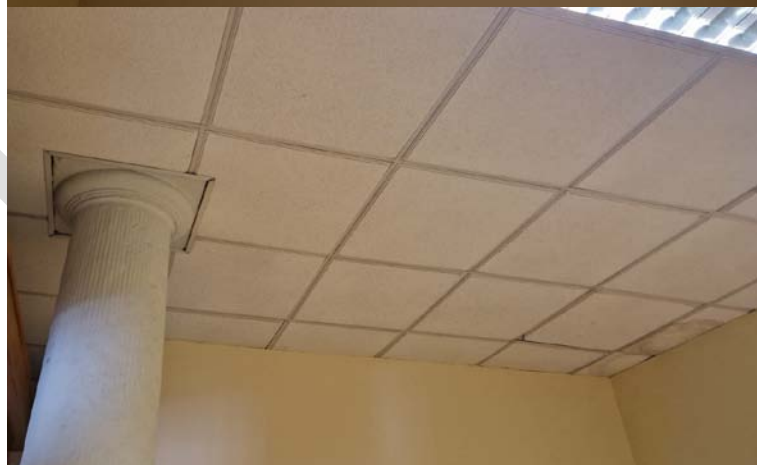
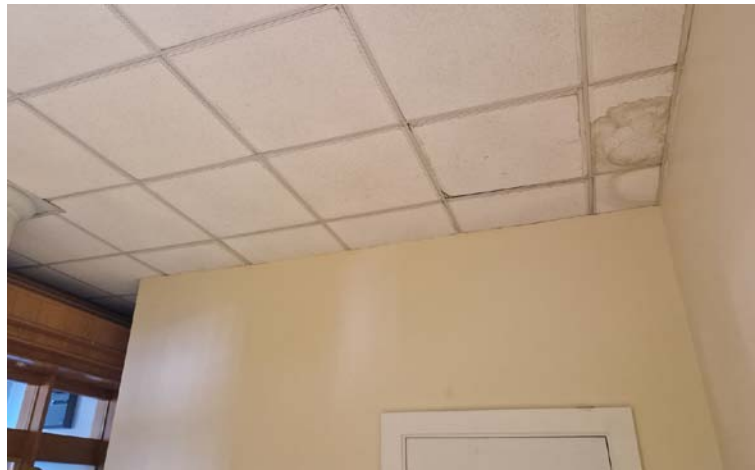
- Within the interview room and adjacent room staining was noted to the ceiling tiles. This indicates that there has or is a leak. No access was achievable due to the chicken wire and insulation. As part of the refurbishment works the leaks to the roof should be repaired.

Photograph 21 – Water staining on ceiling tiles

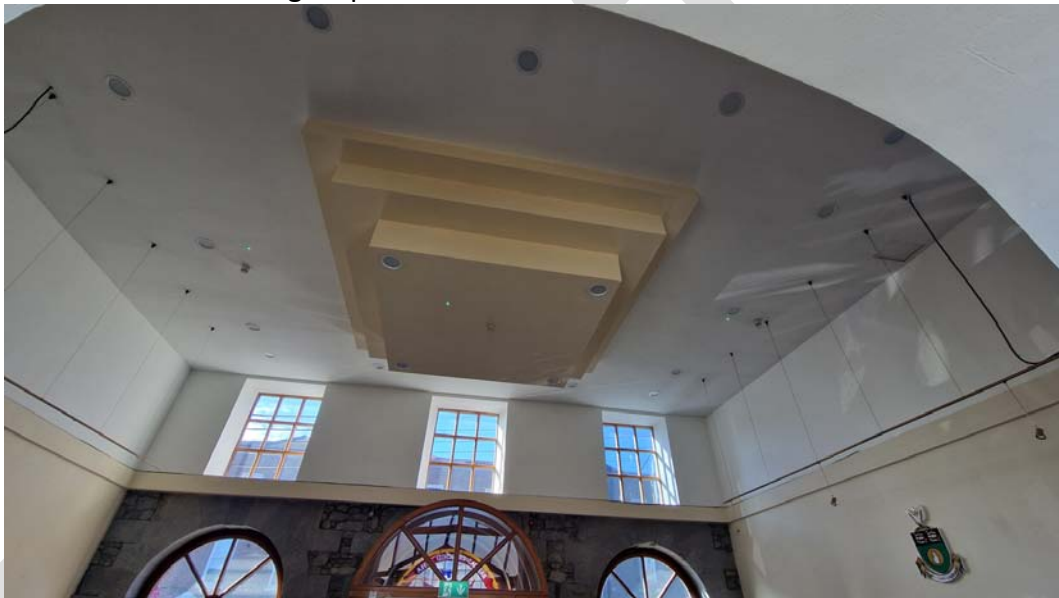
- Within the double height space no access was available to the attic.

Photograph 22 – No access to Attic

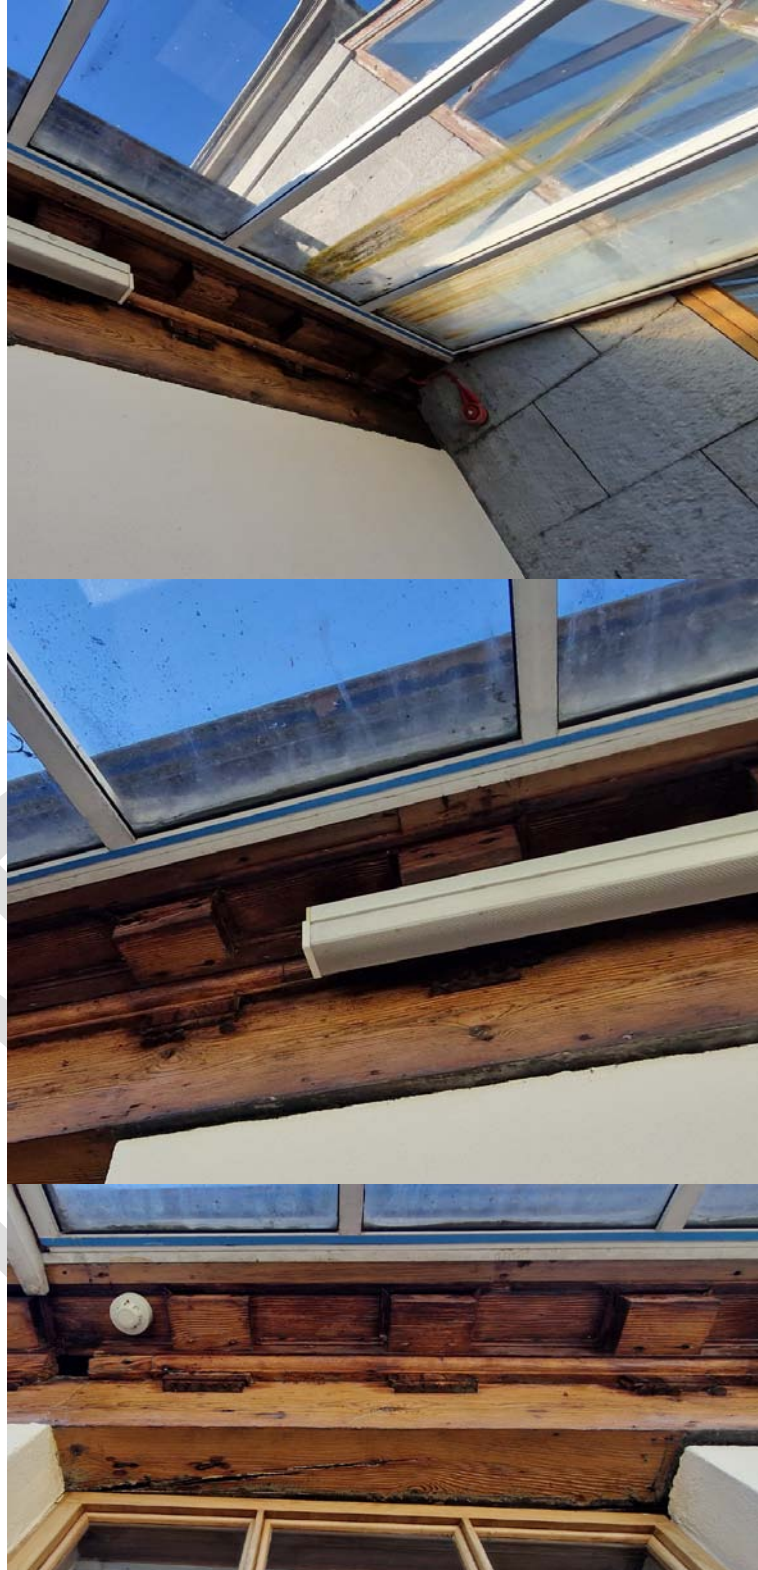
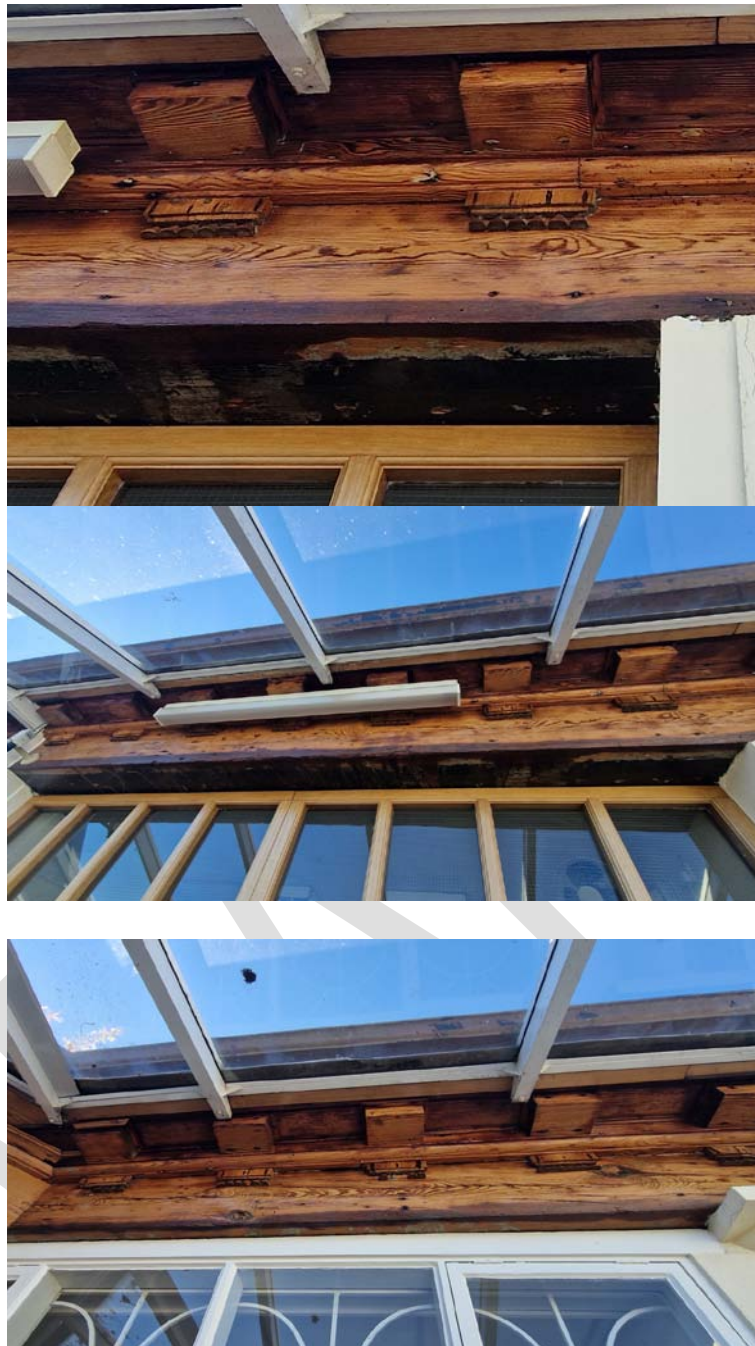
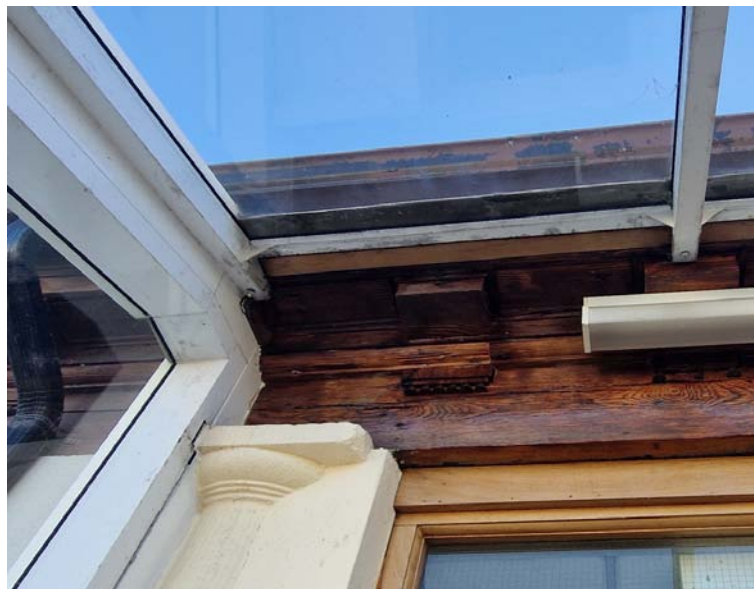
- The glazing lean-to appears to be letting in water; this is affecting the ornate timber beam and detail. It is recommended that the flashing on the exterior of the building is repaired as necessary to ensure that rain does not penetrate the building. Robust detailing of the gutter and associated flashing will be required.

Photograph 23 – Water penetration at lean-to

The glazing lean-to appears to be letting in water; it is recommended that the flashing at these locations have remedial works carried out to ensure rain does not penetrate the building. Robust architectural detailing at these locations will be required.

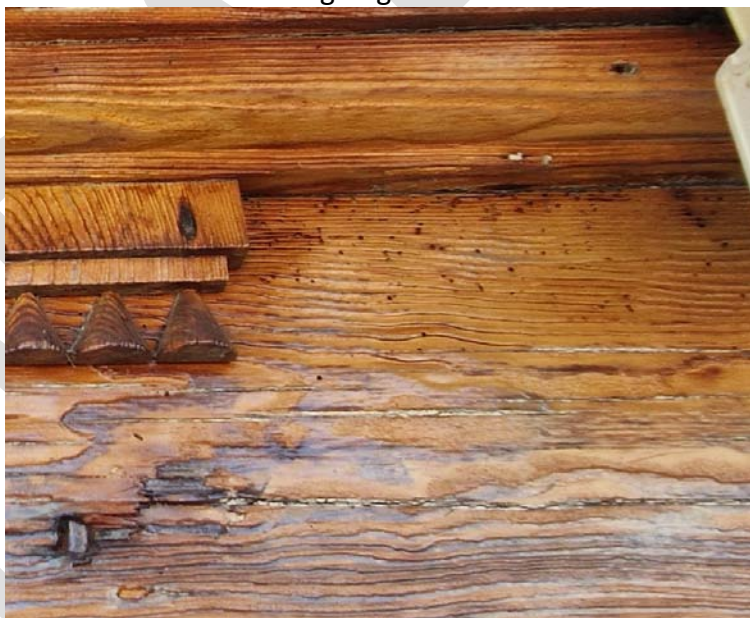
- Some evidence of insect attack to the timber beam was noted. This may be historic. It is recommended that a specialist inspect all timbers within the building and treat them as necessary when remedial works are ongoing.

Photograph 24 – Insect attack

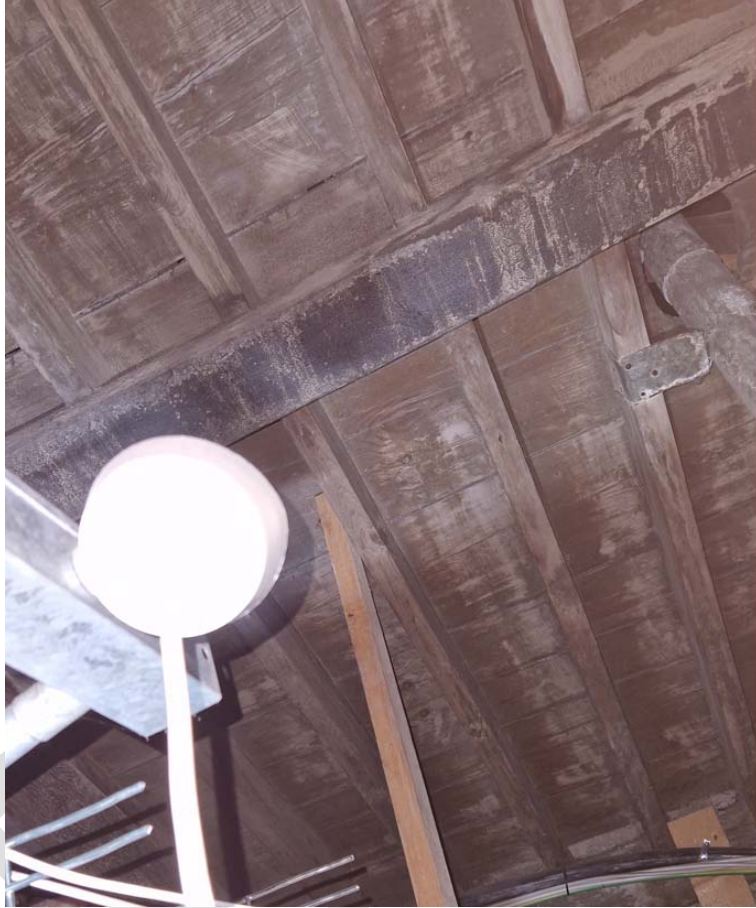
- From the limited access to the above attics it was observed from one location that the rafters are overlaid with timbers. Historically this was in lieu of felt. It is recommended that future opening up works be carried out to ascertain the extent of this timber board to establish if felt is in existence as felt underlay acts as a second line of defence to water ingress.

Photograph 27 – Timber sarking

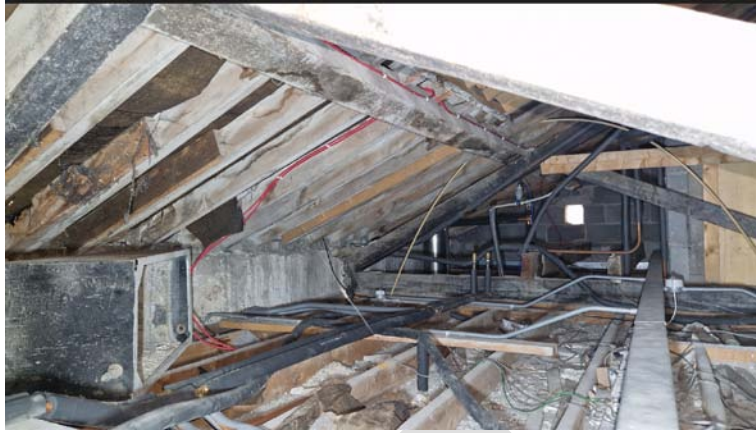
- The timbers in the locker area appeared to have damp staining. This would signify moisture ingress. It is recommended that any roof leaks be repaired as part of the future refurbishment works. The attic area should be cleared of all debris.

Photograph 29 – Kingpost strut

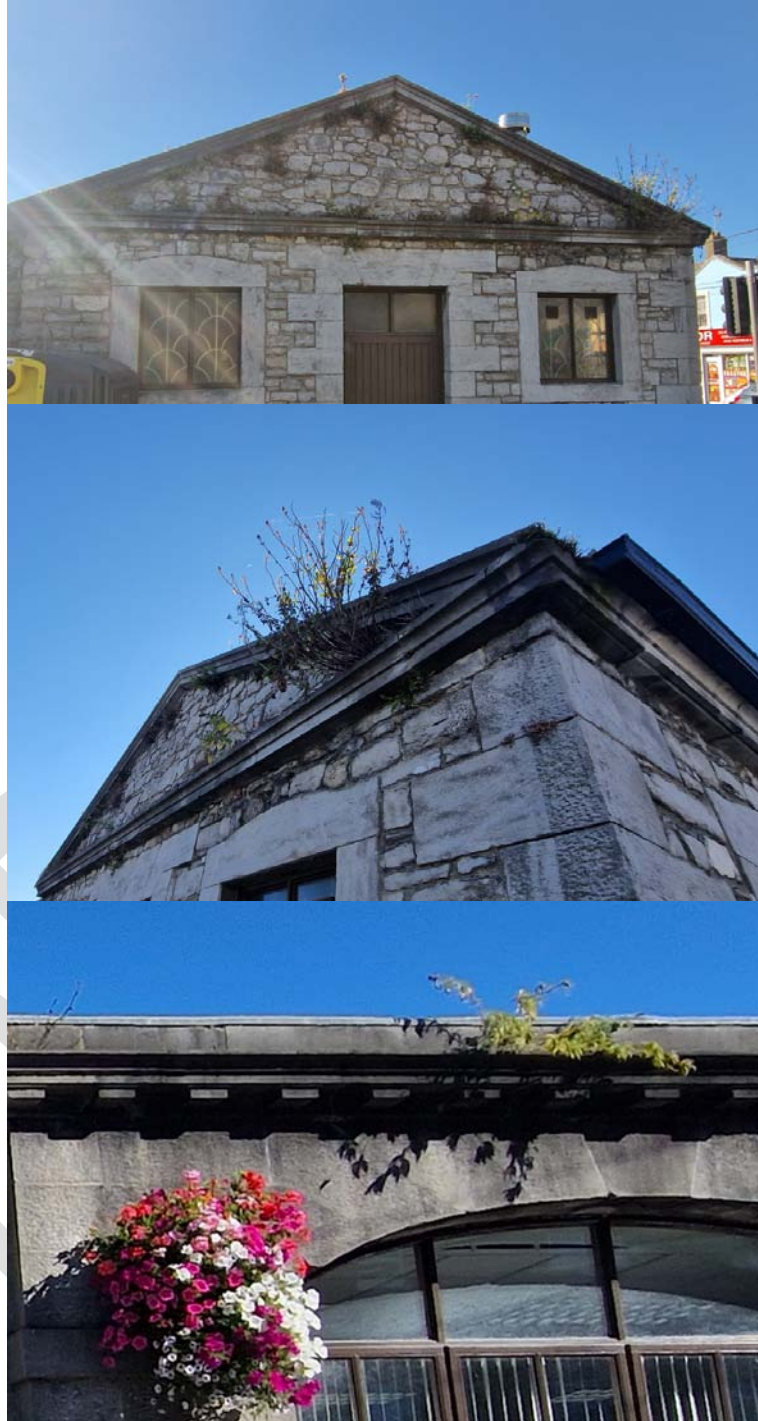
- Vegetation growth was noted to the roof structure and corbel, this vegetation should be removed and repointing carried out

Photograph 30 – Vegetation Growth

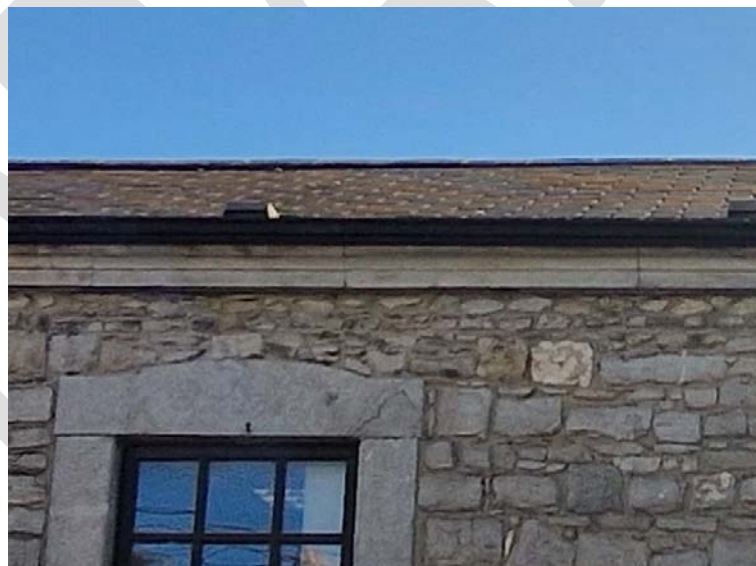
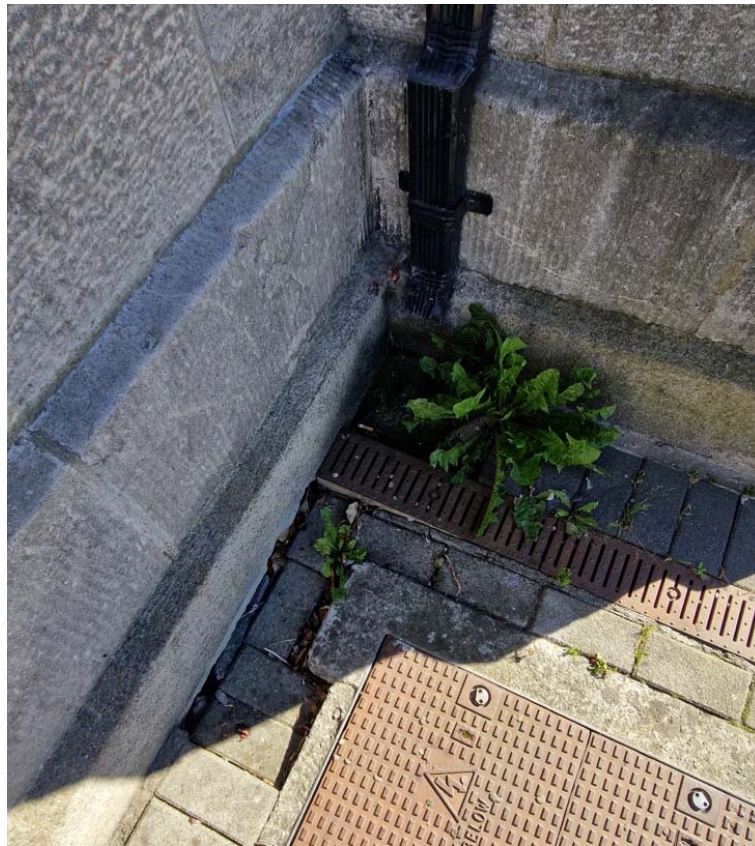
- The gutters to the roof sit on a corbel. This detail necessitates the gutters to be maintained to a high standard to ensure moisture does not enter the building. The gutters and downpipes are in need of repair and replacement in certain areas. Some downpipes are not directed to gullies and this has undermined the footpath at one location. The number of downpipes appeared sparse. It is recommended that well functioning and adequately sized gutters and downpipes are provided to the building directed to dedicated surface water gullies.

Photograph 32 – gutters and downpipes

The gutters and downpipes of the property should be repaired and replaced as necessary to ensure water is conveyed away from the building to dedicated surface water sewers.

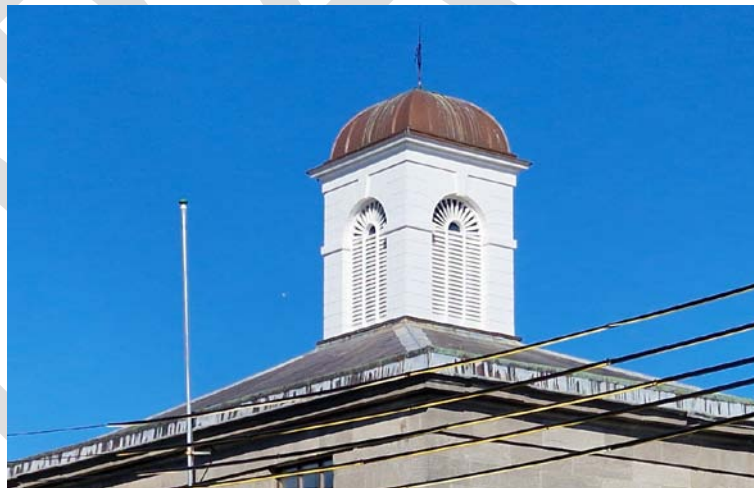
- The weather vane element of the roof was not inspected as there was no access available.

Photograph 33 – weather vane

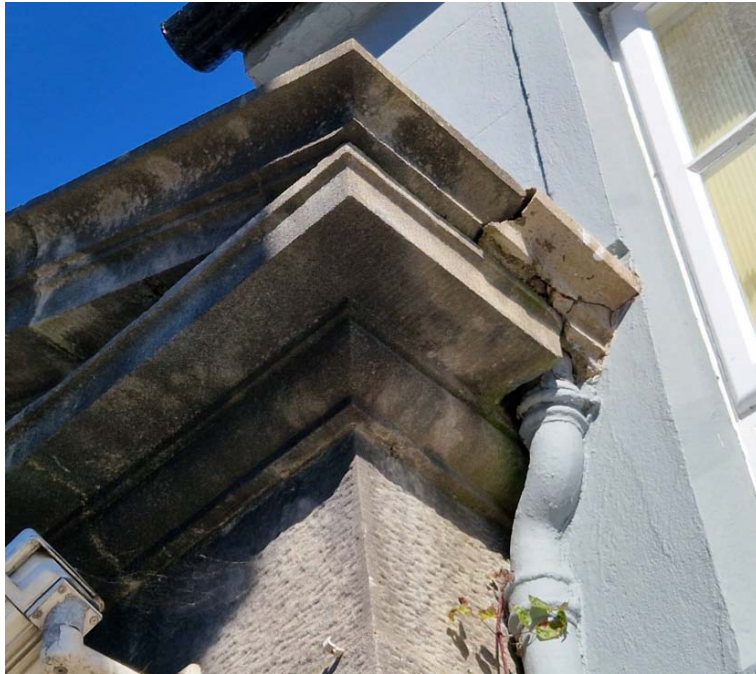
- The corbel has been badly repaired and requires remedial work.

Photograph 34 – Corbel

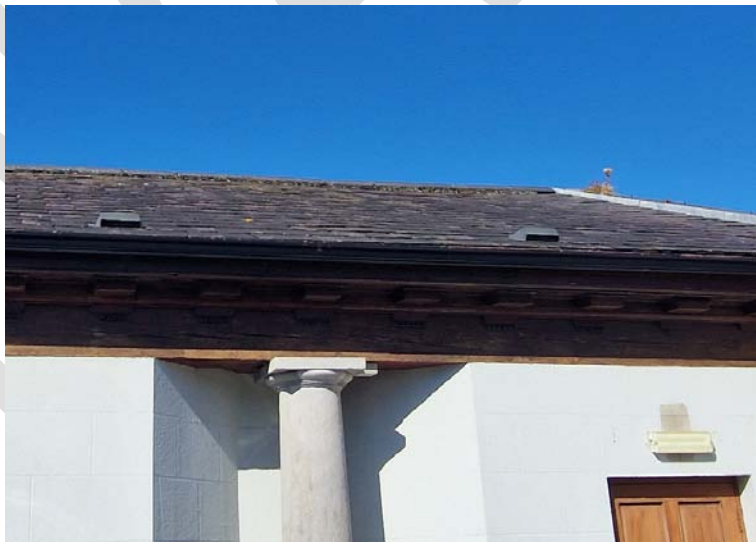
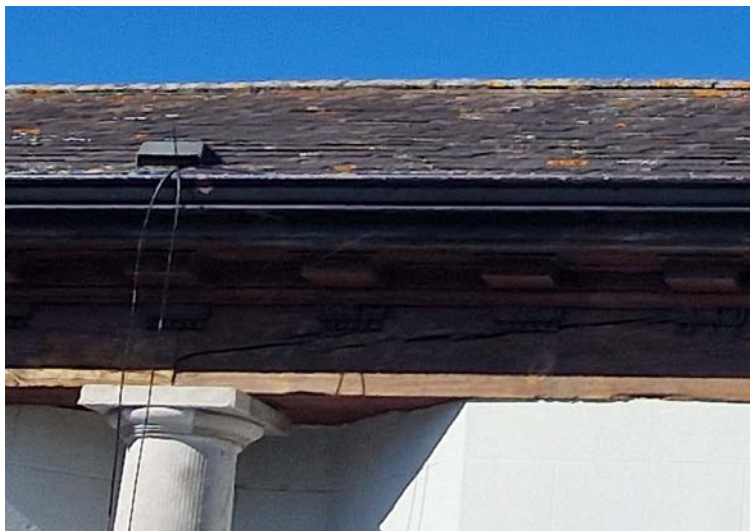
- The ornate timber beam to the court yard area has deteriorated due to the rigors of time and needs to be repaired and treated to ensure moisture does not have an adverse affect on the beam into the future, significant cracking was noted, early signs of wet rot was noted, further wet rot may exist which is not visible. The timbers need to be treated so moisture does not have an adverse affect on the timber.

Photograph 35 – Timber Beam

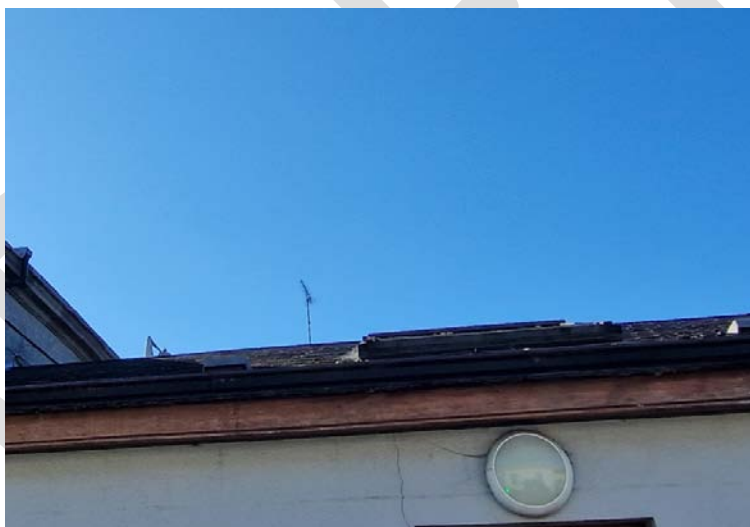
- Timber fascia exists within the courtyard, this timber requires painting/treatment/repair

Photograph 36 – Timber Fascia
