Declaration

Louth County Council:

Address:		Location:	
Name of Building:	Corn Exchange	National Grid co-ordinates:	E N
Address 1:	Fair Street	O.S. Map Type:	
Address 2:	Drogheda	Map Sheet:	
Address 3:	Co Louth	Site Number:	
Eircode:	A92 P440

The referrer has sought a Section 57 declaration as per the Planning and Development Act 2000 (as amended) in respect of works to a protected structure known as the Corn Market at Fair Street, Drogheda.

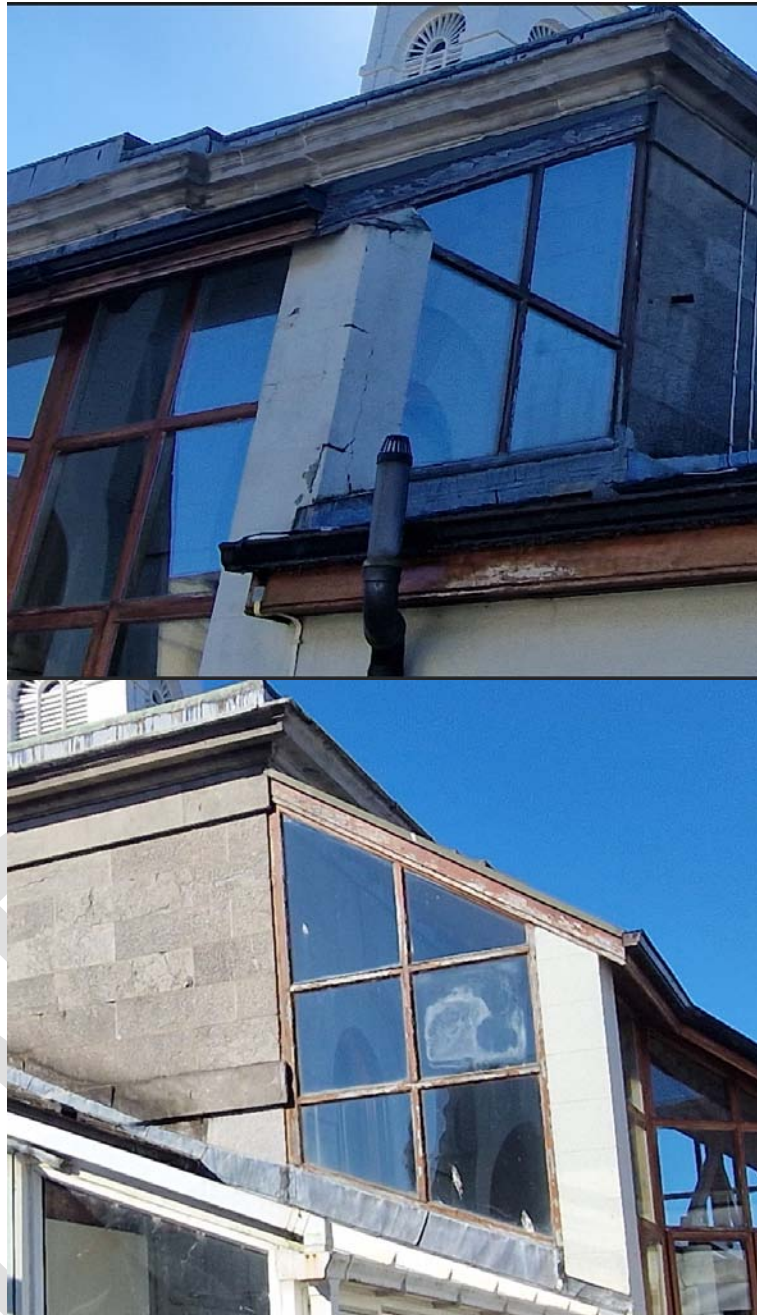
- The triangular glazing sections at the roof appear to be in poor condition these need to be inspected closely and repaired as necessary. Cracking of a column was noted (this is not part of the survey)

Photograph 37 – Glazing interaction with roof

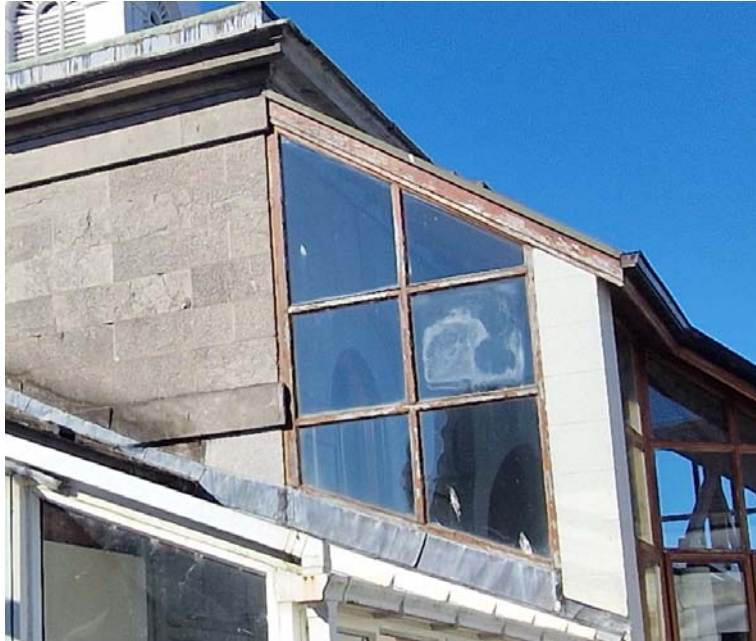
- All flashings to the building should be checked during any renovation works to ensure their integrity.

Photograph 38 – Roof Flashing

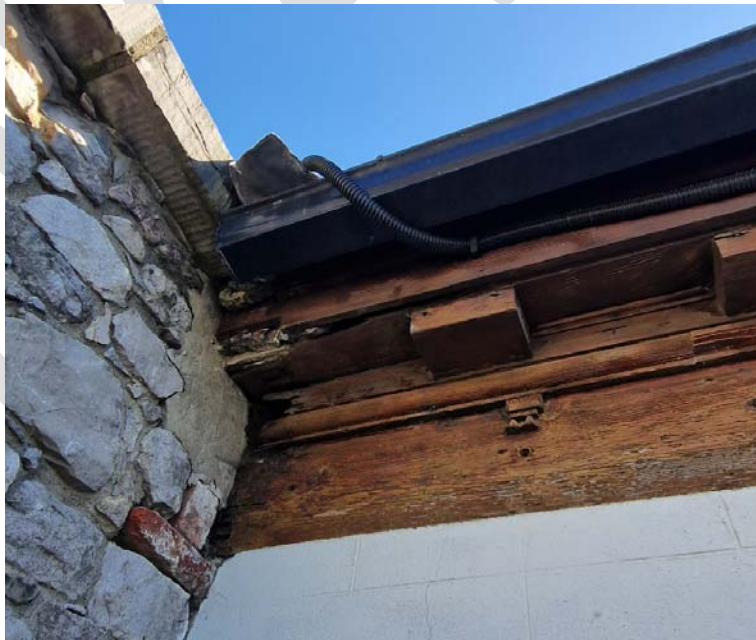
- Significant timber rot was noted where the timber beam abuts the boundary wall. This timber beam should be repaired by specialist to ensure further deterioration does not occur. The detailing should be reviewed at this location to ensure the timber beam is not within a moist wall.

Photograph 39 – Wet rot

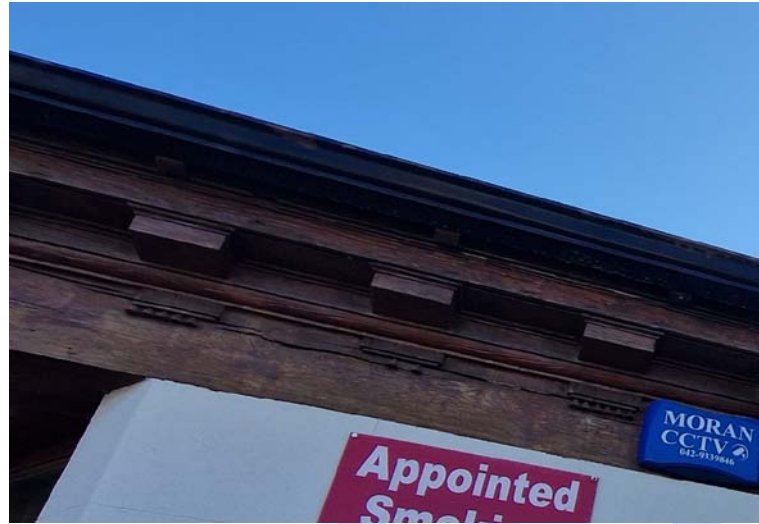
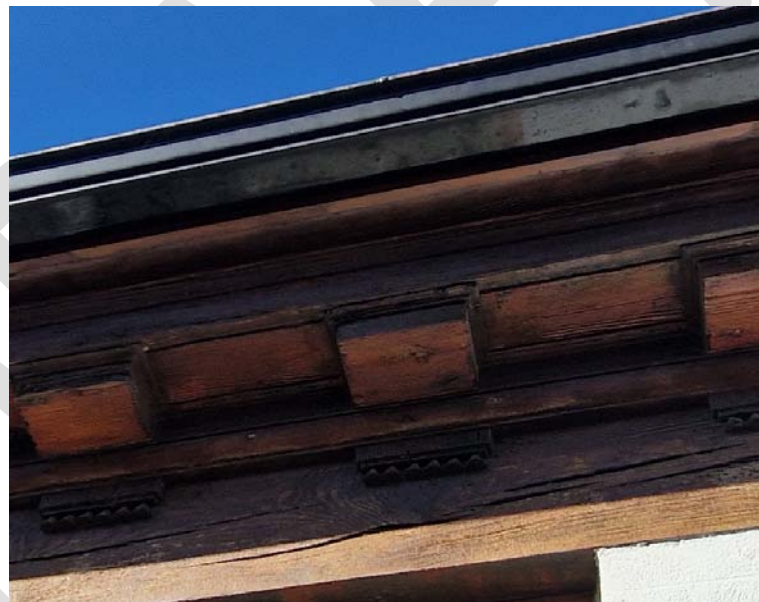
- Signs of wet rot were noted to the ornate timber beam. The gutters should be removed and repaired as necessary. The timber beam should be inspected thoroughly and treated for wet rot and repaired as necessary. The detail of how the gutter sits on the timber beam should be reviewed to ensure that the beam is not saturated if the gutters leak.

Photograph 40 – Wet rot

Some signs of wet rot was noted to timbers, particularly the ornate timber beam this should be treated and repaired as necessary.

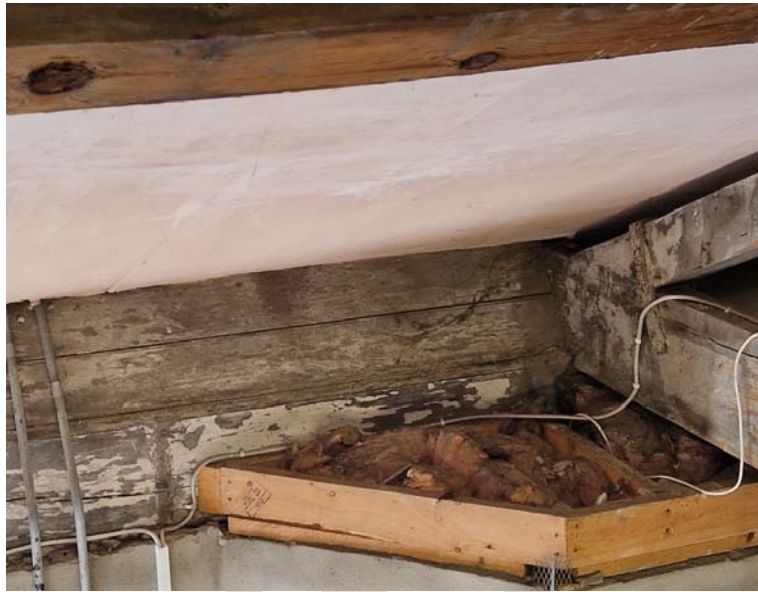
- The underside of the rafters has been plaster boarded for the majority of the building. At the locations where inspection could be undertaken the void between the plasterboard and the underside of the roof covering has been filled with insulation. This results in the timber being unable to breathe adequately and can result in deterioration of the roofing timbers. It is recommended that during any refurbishment works that the roofs be insulated allowing for a minimum 50mm of air gap between the insulation and the underside of the roofing.

Photograph 5 – Lack of air gap between insulation and underside of roof

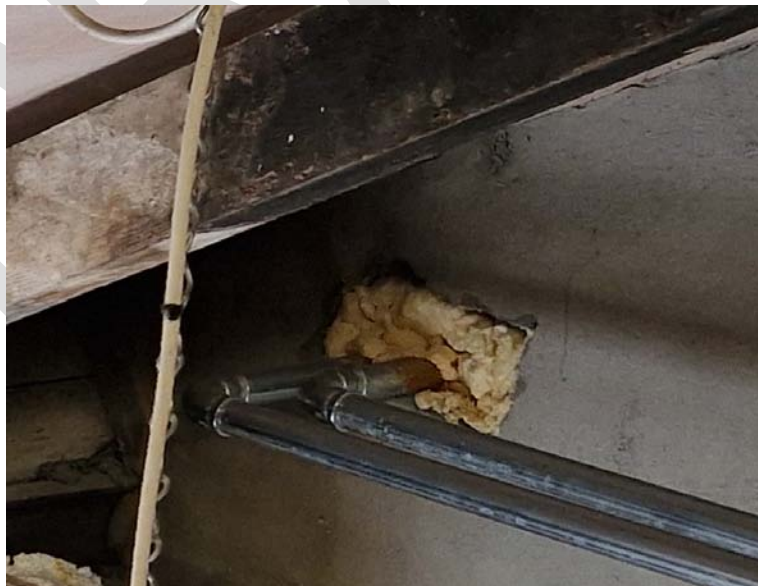
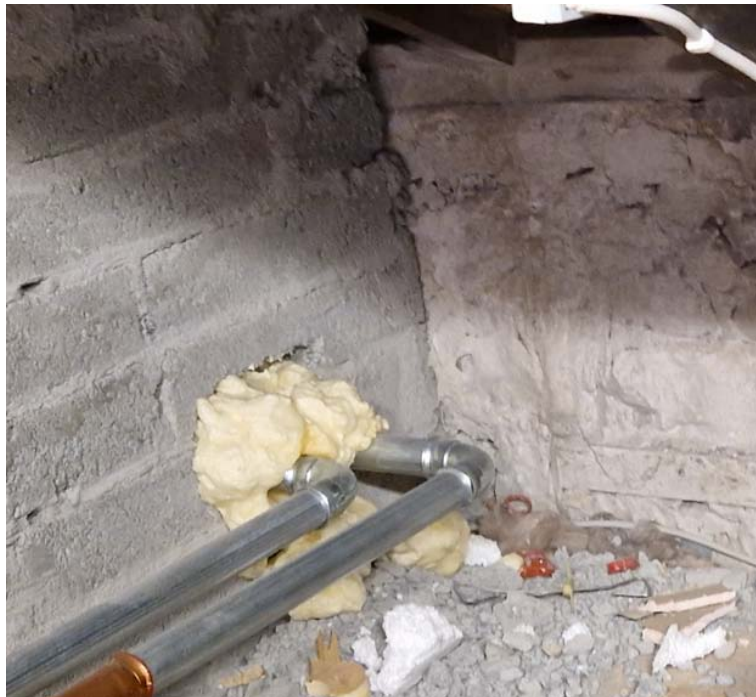
- Holes were noted from one compartment to another. Any penetrations in the roof zone should be fire stopped appropriate to the fire rating of the location.

Photograph 6 – Fire stopping required

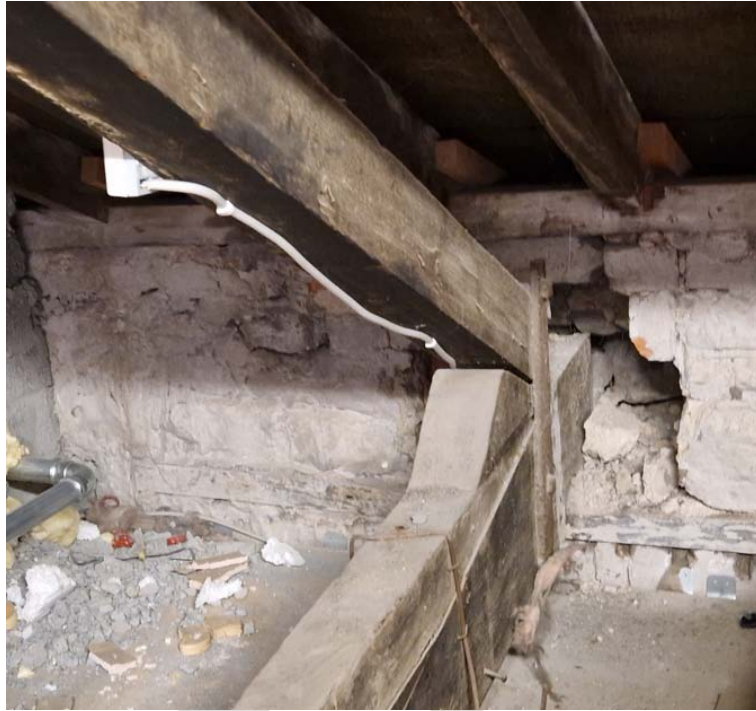
- Stones have been dislodged at the kingpost truss where it rests on the wall. This area should be rebuilt.

Photograph 8 – Section of wall to be rebuilt

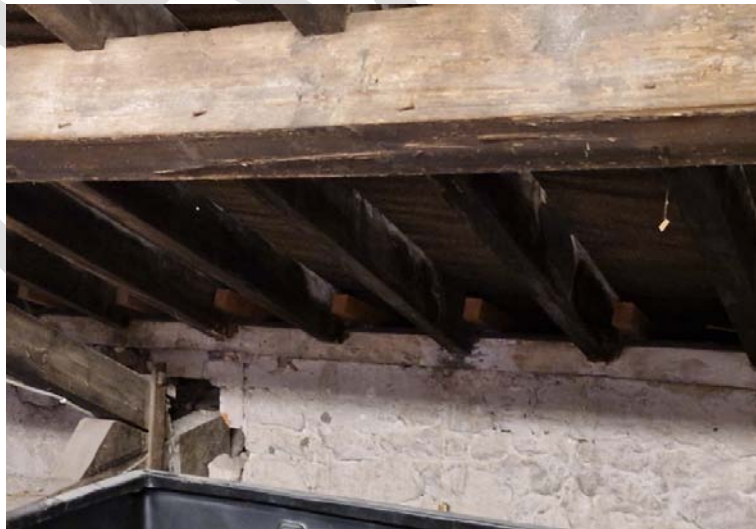
- Some evidence of moisture ingress was noted to rafters. Ends of rafters appear to have been adversely affected with wet rot at some stage in the past as new timbers adjacent to the existing have been fixed. Where significant refurbishment of the building is being undertaken it may be prudent to make an allowance for localised repair of the roof where leaks are apparent.

Photograph 9 – Repairs to existing rafters

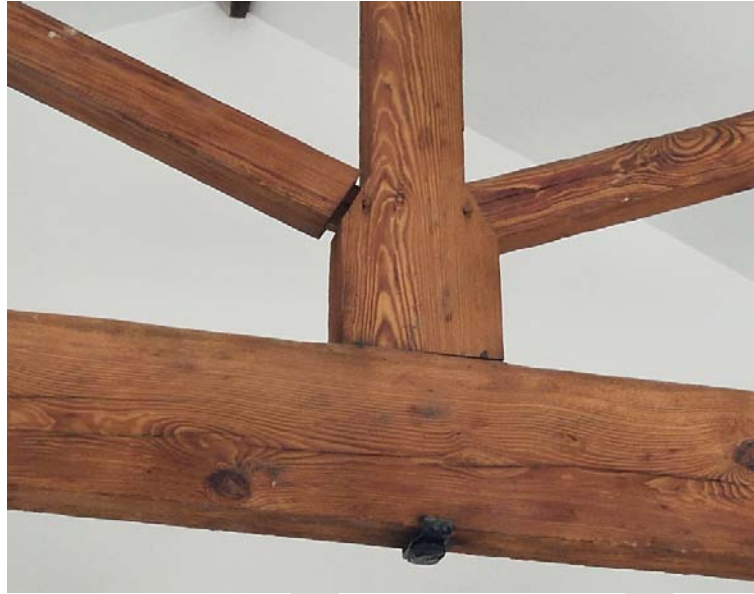
- A strut to the king post to the engineer's office area adjacent to the boiler room is not abutting the main king post. This is most likely historic and there does not appear to be any deflections noted. The gap between the post and the strut should be packed.

Photograph 10 – Kingpost strut

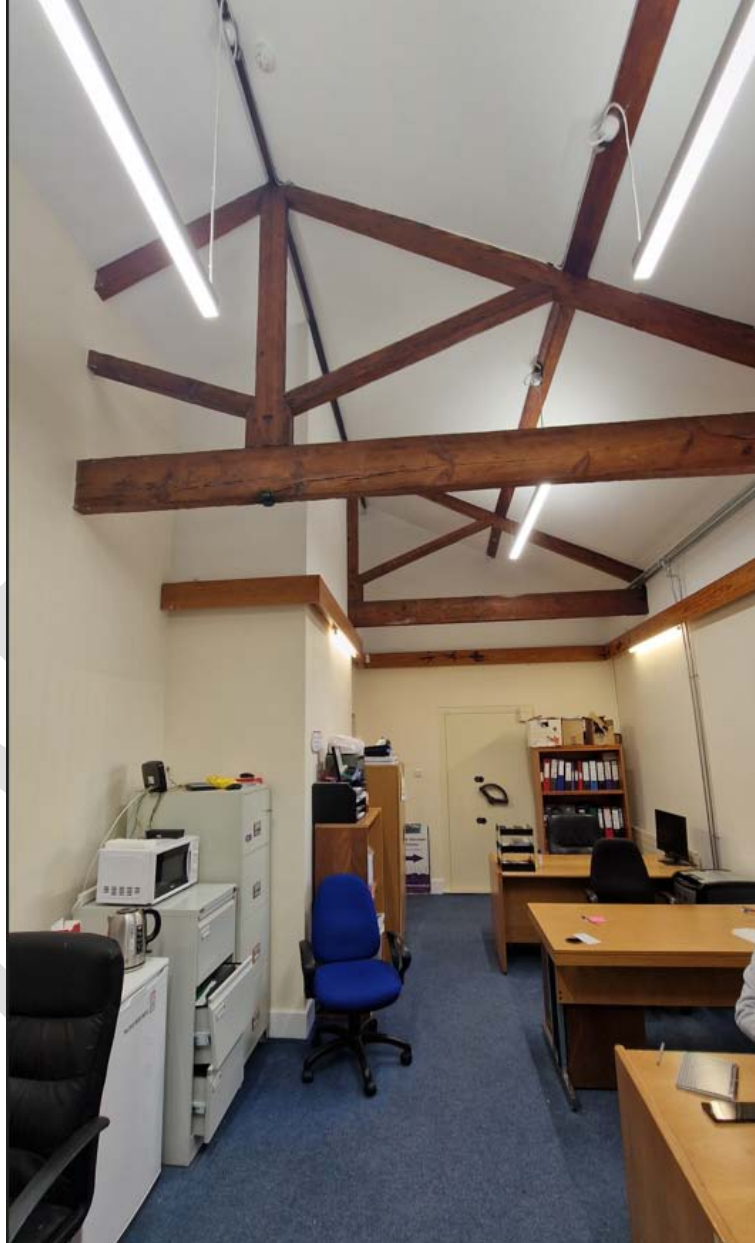
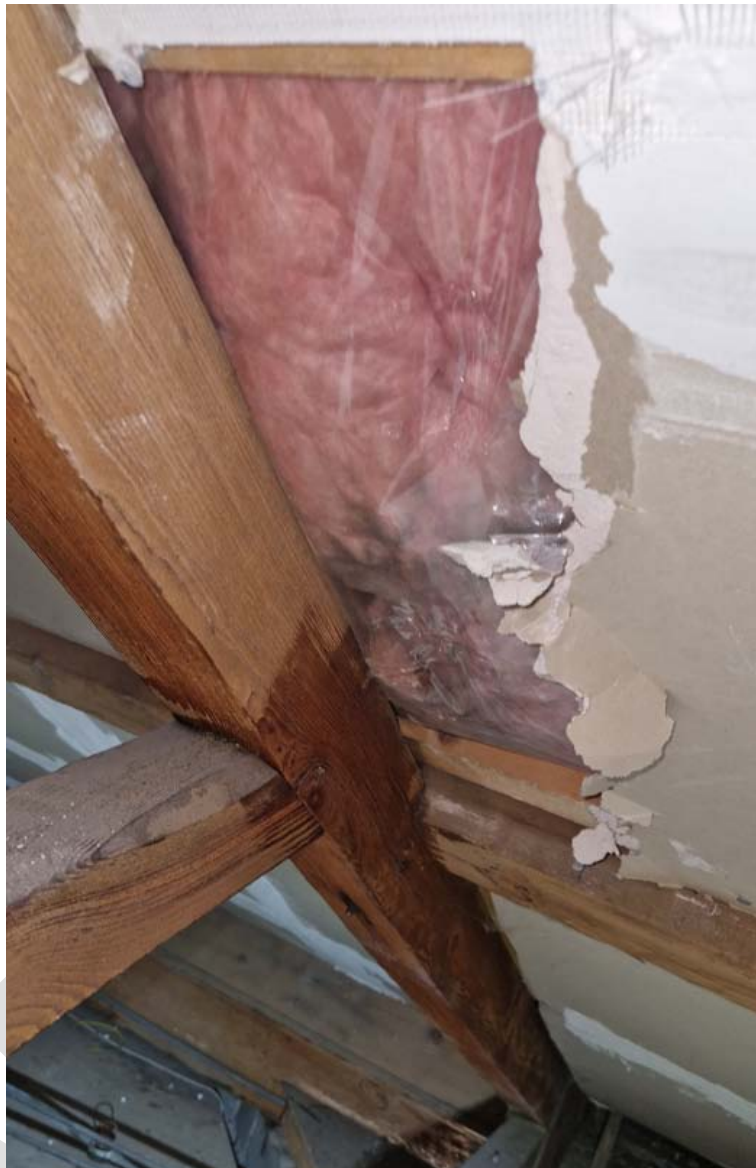
- The underside of the rafters to the office area adjacent to the engineer's office has been plaster boarded. At the locations where inspection could be undertaken the void between the plasterboard and the underside of the roof covering has been filled with insulation. Access was available to the tank room off this office area. This results in the timber being unable to breathe adequately and can result in deterioration of the roofing timbers. It is recommended that during any refurbishment works that the roofs be insulated allowing for a minimum 50mm of air gap between the insulation and the underside of the roofing. No access was available in this area to inspect the roof structure.

Photograph 12 – Insulation to underside of roof

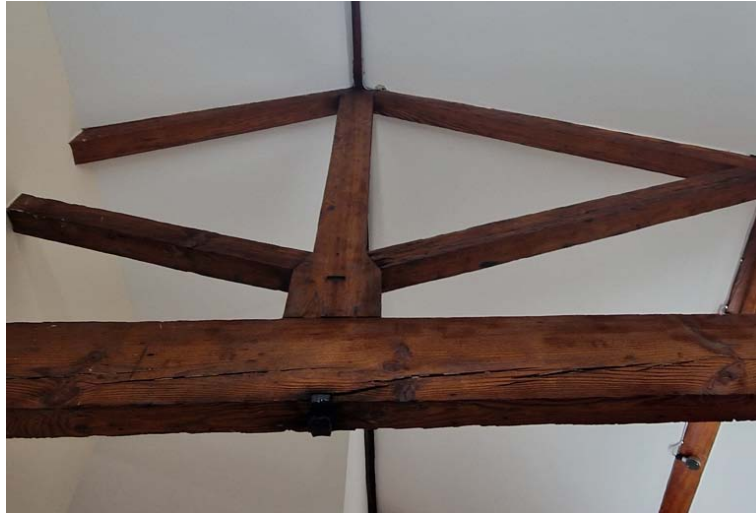
- Some cracking of the timber king post was noted this cracking of the bottom chord should be monitored for further signs of movement and strengthened where deemed necessary.

Photograph 13 – Kingpost strut

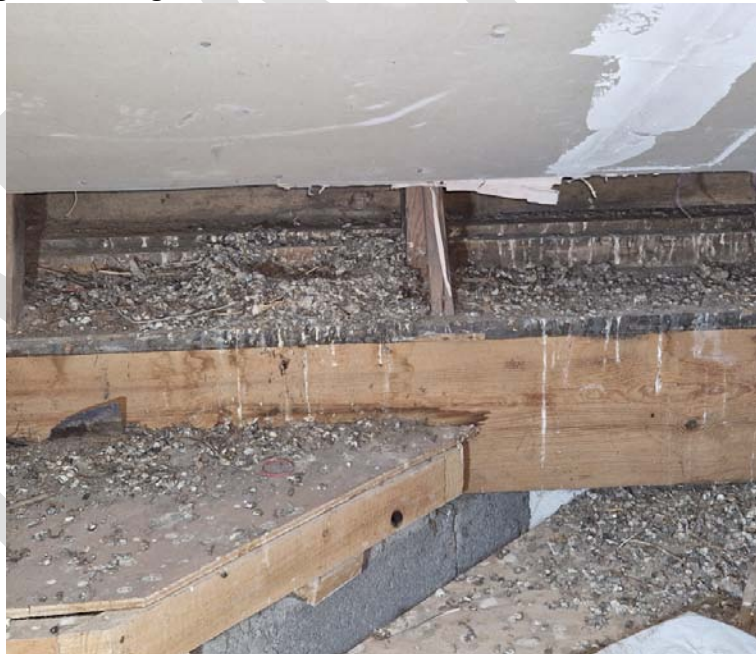
- Within the 'tank room' significant significant Pigeon guano was noted. This appeared to be historic. It is recommended that any guano be removed and the attics made secure to ensure pigeons can't gain access.

Photograph 14 – Pigeon Guano

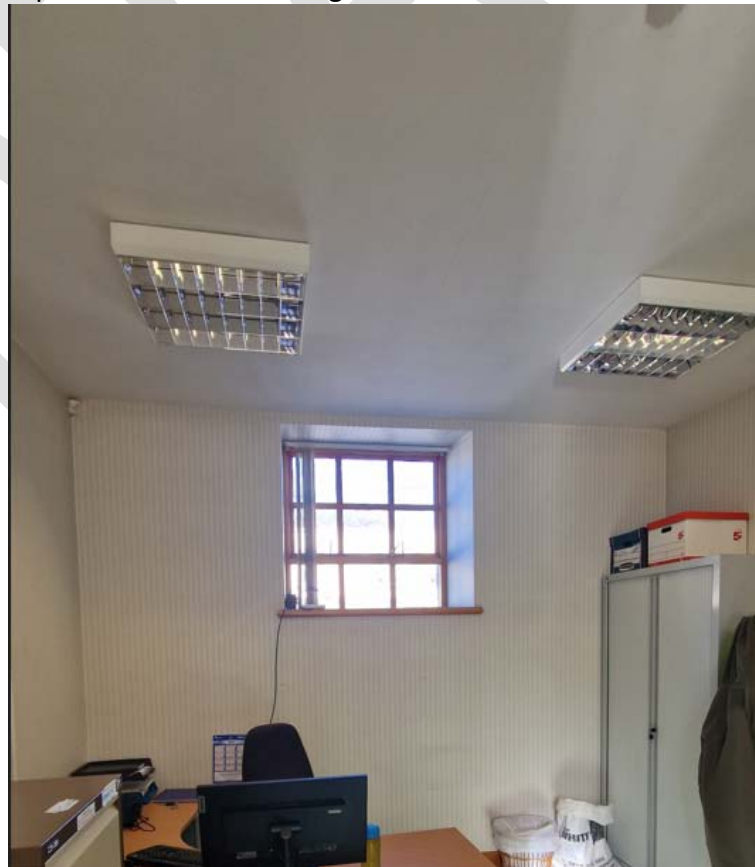
- Within the Senior Executive/architect housing office there was no access to the attic of the property a plasterboard flat ceiling existed.

Photograph 16 – Plasterboard ceiling

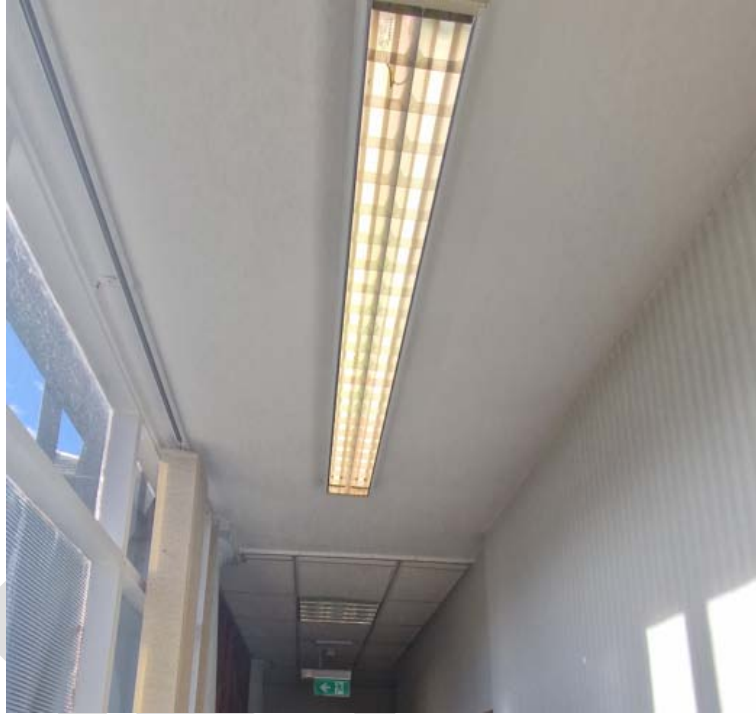
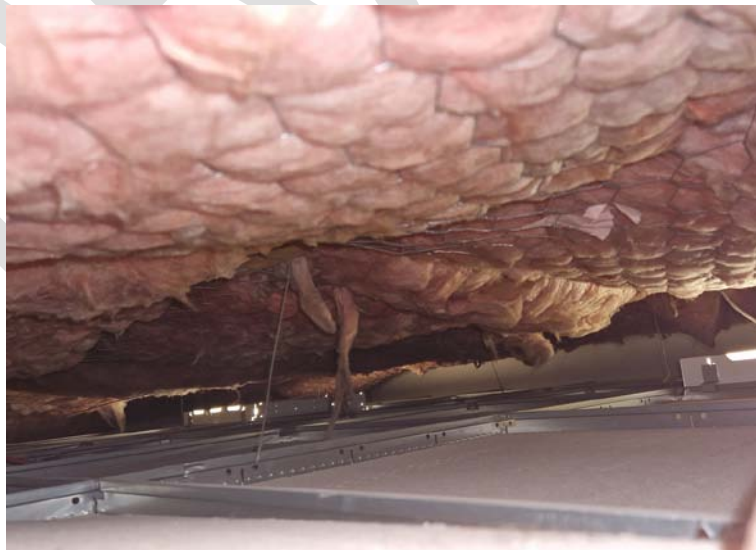
- The hall way adjacent to the above offices consisted of a plasterboard flat ceiling and a suspended tile ceiling. The Property Inspection unit office has also had a suspended flat ceiling. A ceiling tile was removed to gain access to the attic. Above the suspended ceiling was chicken wire supporting insulation, no access to the attic could be gained. The depth of insulation that was noted would not meet current standards. The entire roof area should be stripped of insulation and reinsulated in accordance with current standards incorporating appropriate air tightness and ventilation to attic spaces. Adequate access to all attics should be provided and these accesses should be readily identifiable.

Photograph 17 – Insulation and chicken wire

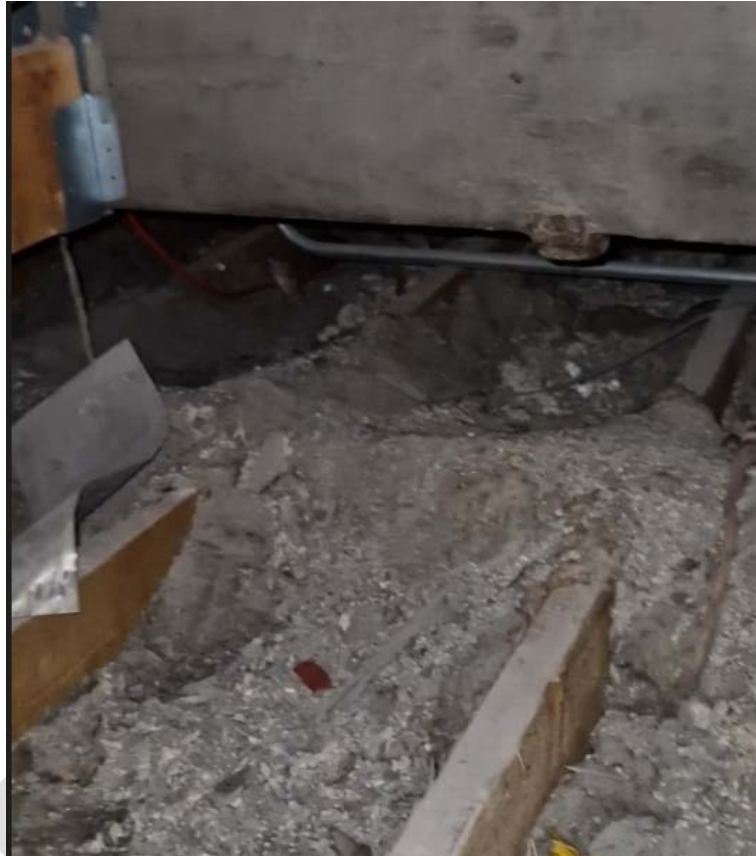
- Limited access was achieved over the plasterboard ceiling. This revealed insulation. The insulation had a significant amount of debris and this insulation should be removed and replaced in keeping with a strategy to improve the thermal performance of the property.

Photograph 18 – Debris on insulation

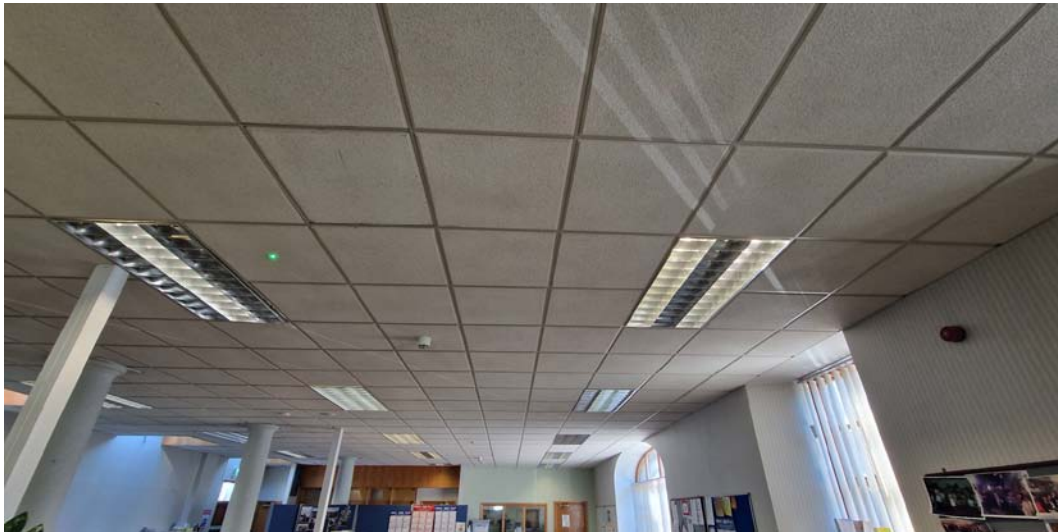
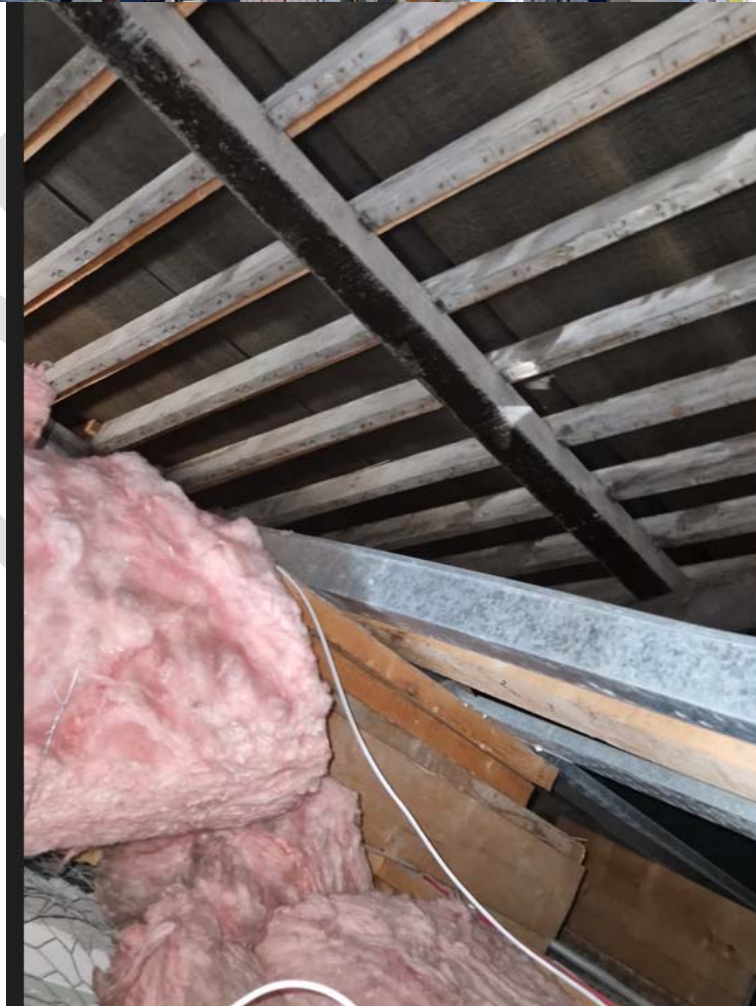
- Within the large open plan office area adjacent to Fairstreet consisted of a suspended tile ceiling. Ceiling tiles were removed to gain access to the attic. Above the suspended ceiling was chicken wire supporting insulation, no access to the attic could be gained. The depth of insulation that was noted would not meet current standards. The entire roof area should be stripped of insulation and reinsulated in accordance with current standards incorporating appropriate air tightness and ventilation to attic spaces. Adequate access to all attics should be provided and these accesses should be readily identifiable.

Photograph 19 – Insulation to attic

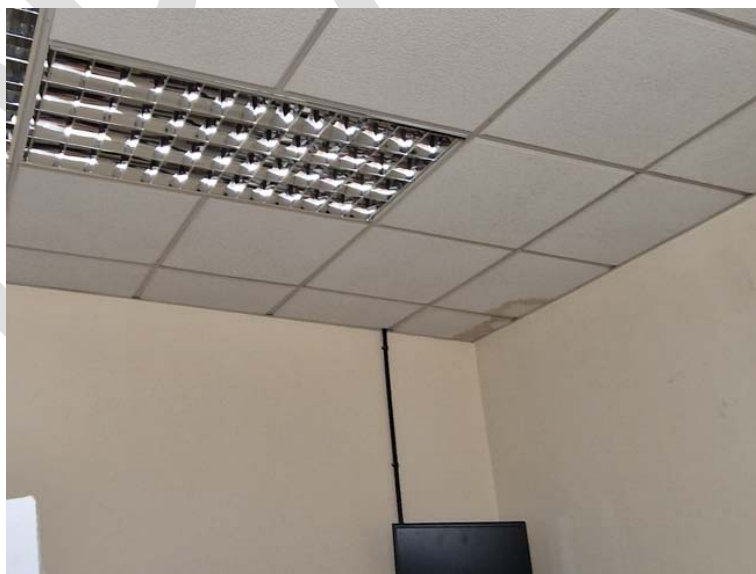
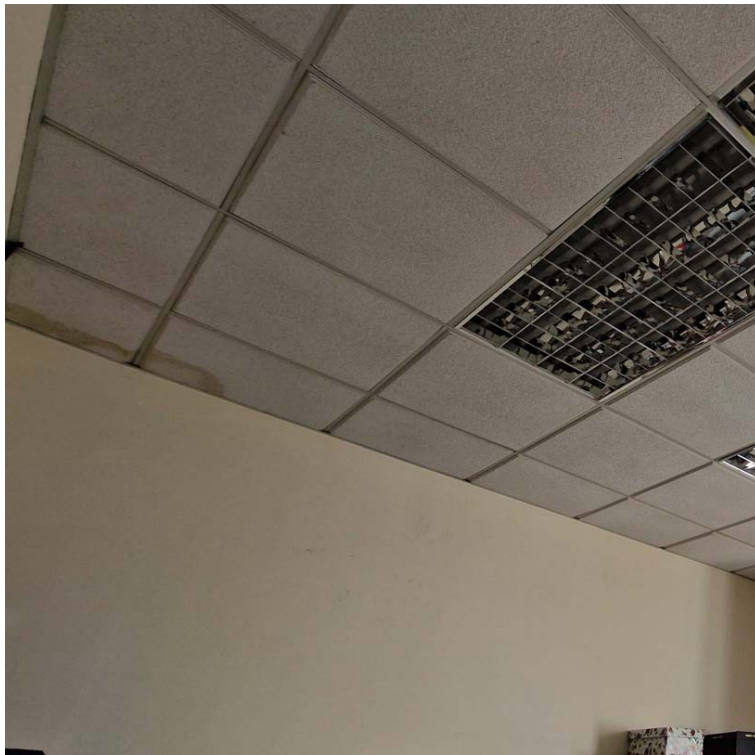
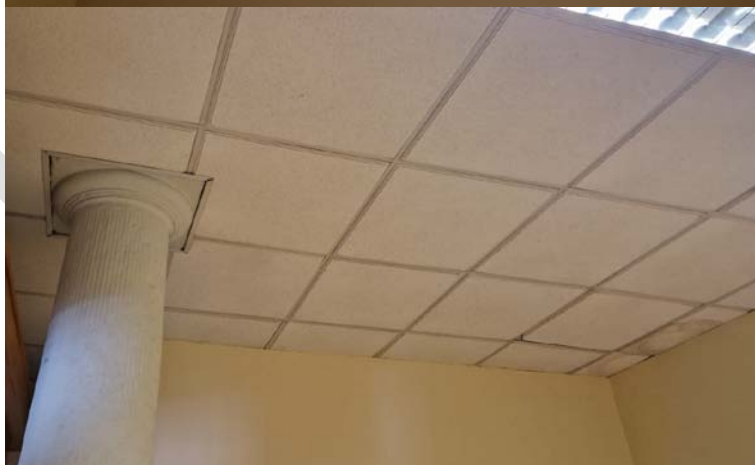
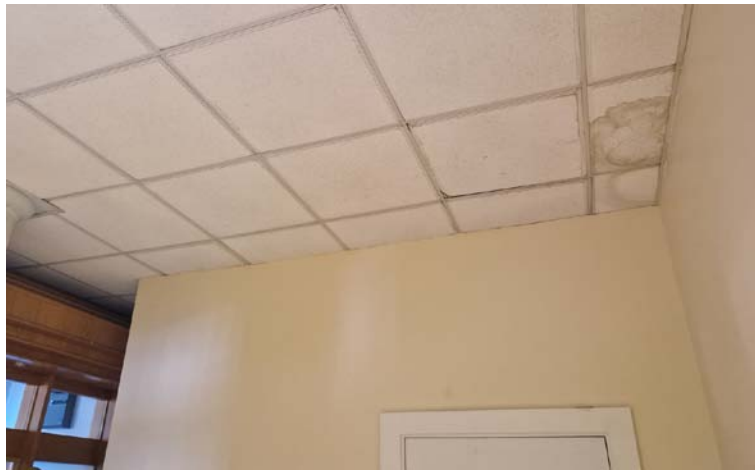
- Within the interview room and adjacent room staining was noted to the ceiling tiles. This indicates that there has or is a leak. No access was achievable due to the chicken wire and insulation. As part of the refurbishment works the leaks to the roof should be repaired.

Photograph 21 – Water staining on ceiling tiles

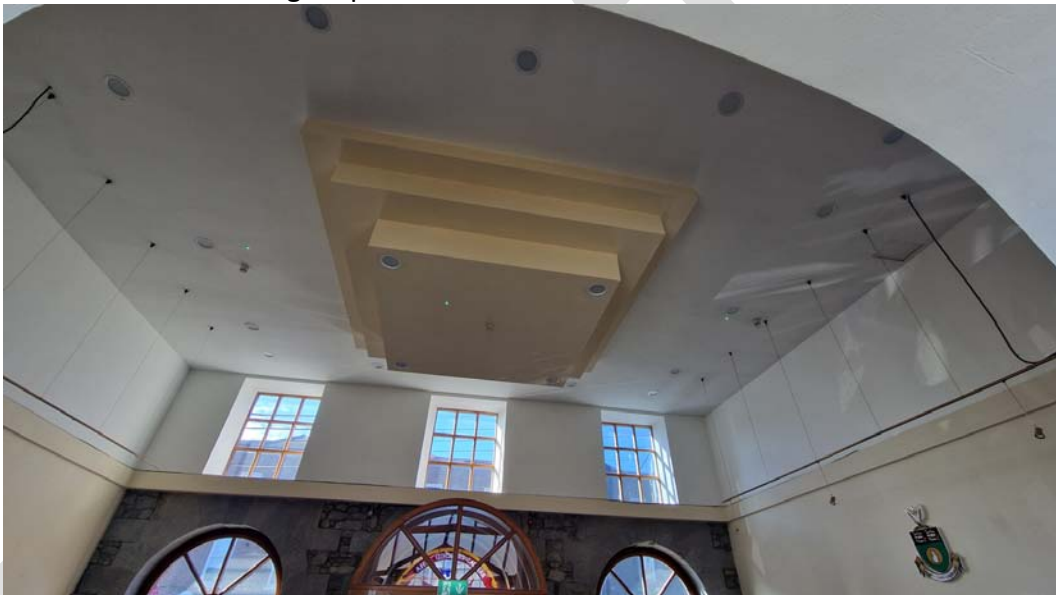
- Within the double height space no access was available to the attic.

Photograph 22 – No access to Attic

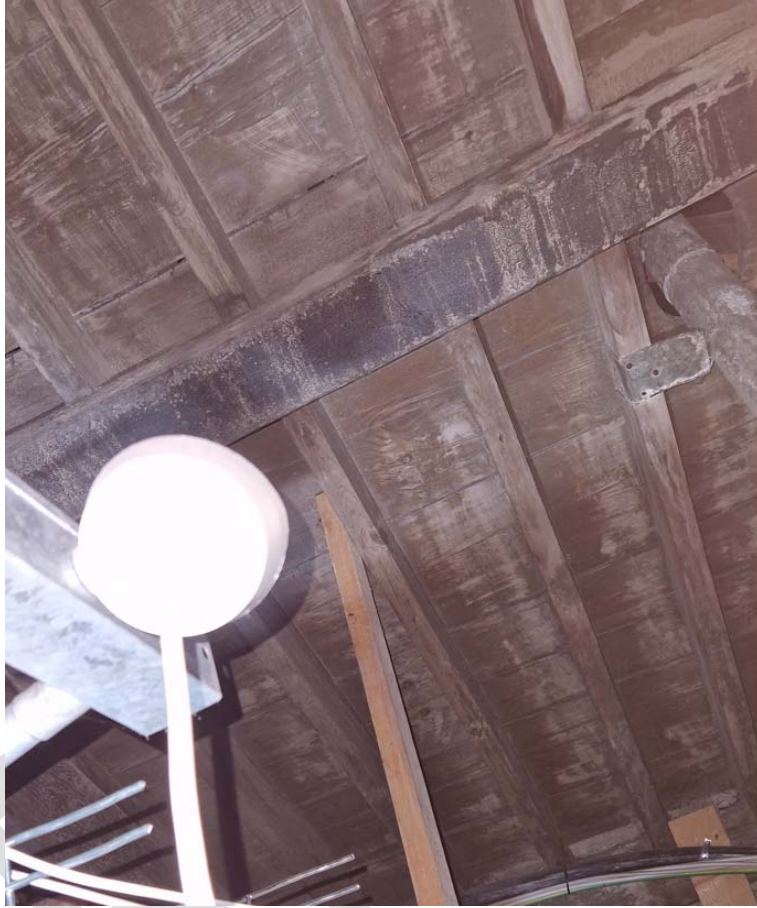
Photograph 27 – Timber sarking
