## FAUGHART GRAVEYARD CONSERVATION AND MANAGEMENT REPORT

For Louth County Council

## Executive Summary

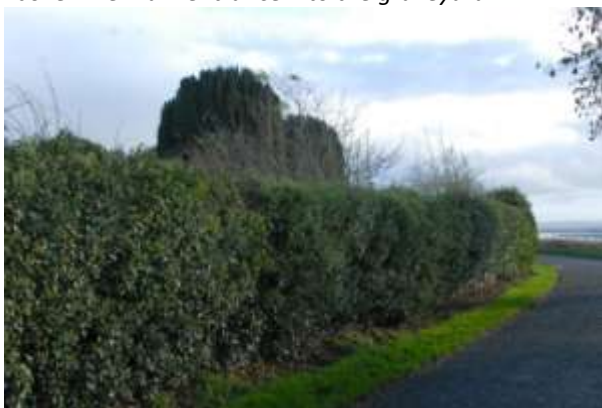
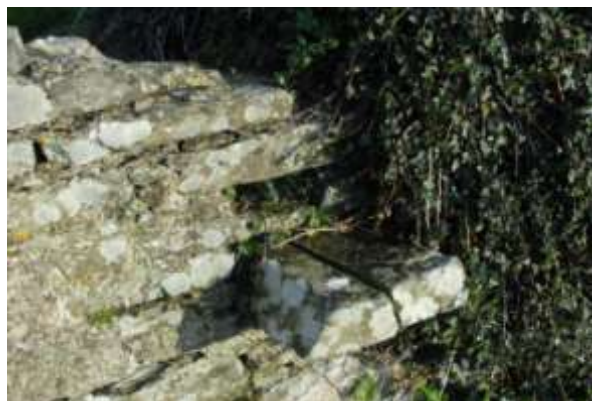
*Above: The graveyard enclosure wall is largely concealed by well-developed vegetation, and entered via one main entrance with an adjacent broken stile, and an impromptu entrance through a breach in the graveyard wall providing access from the car park.*

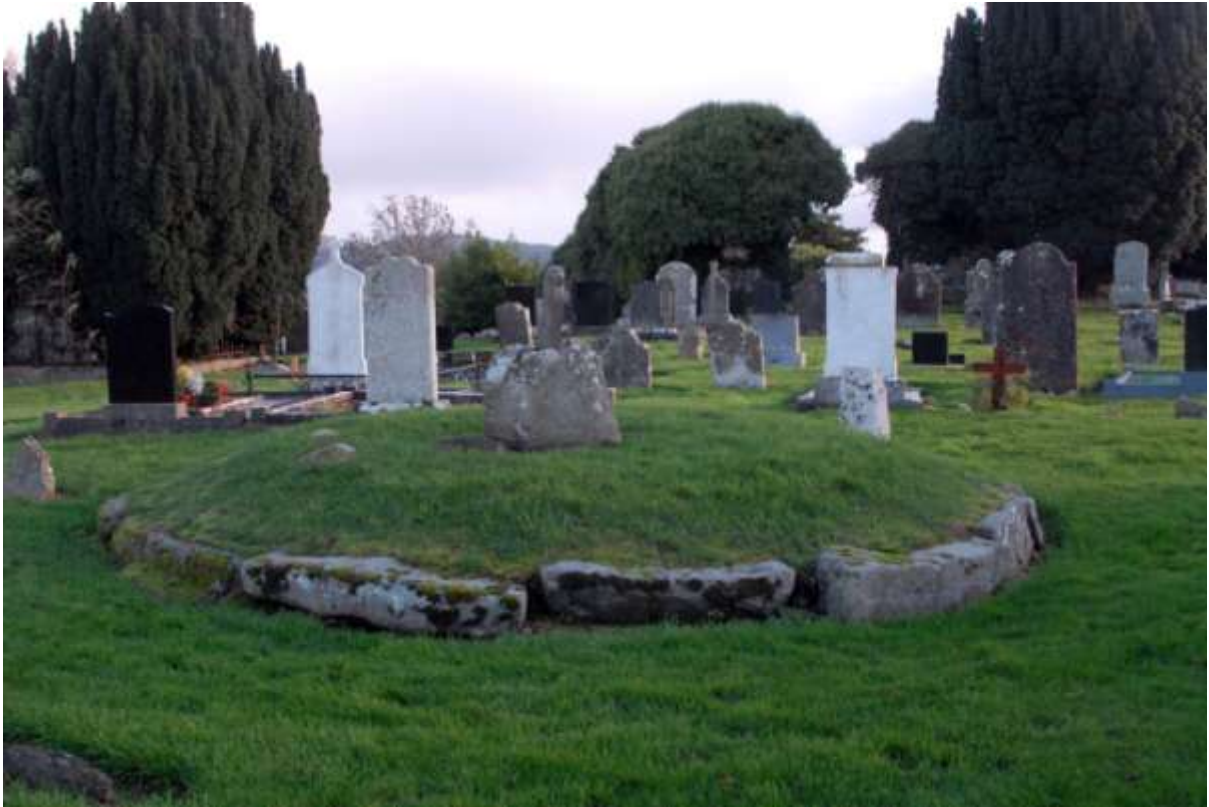
*Above: General view of the base of a possible round tower, with a plain high cross base mounted in the centre of the mound.*

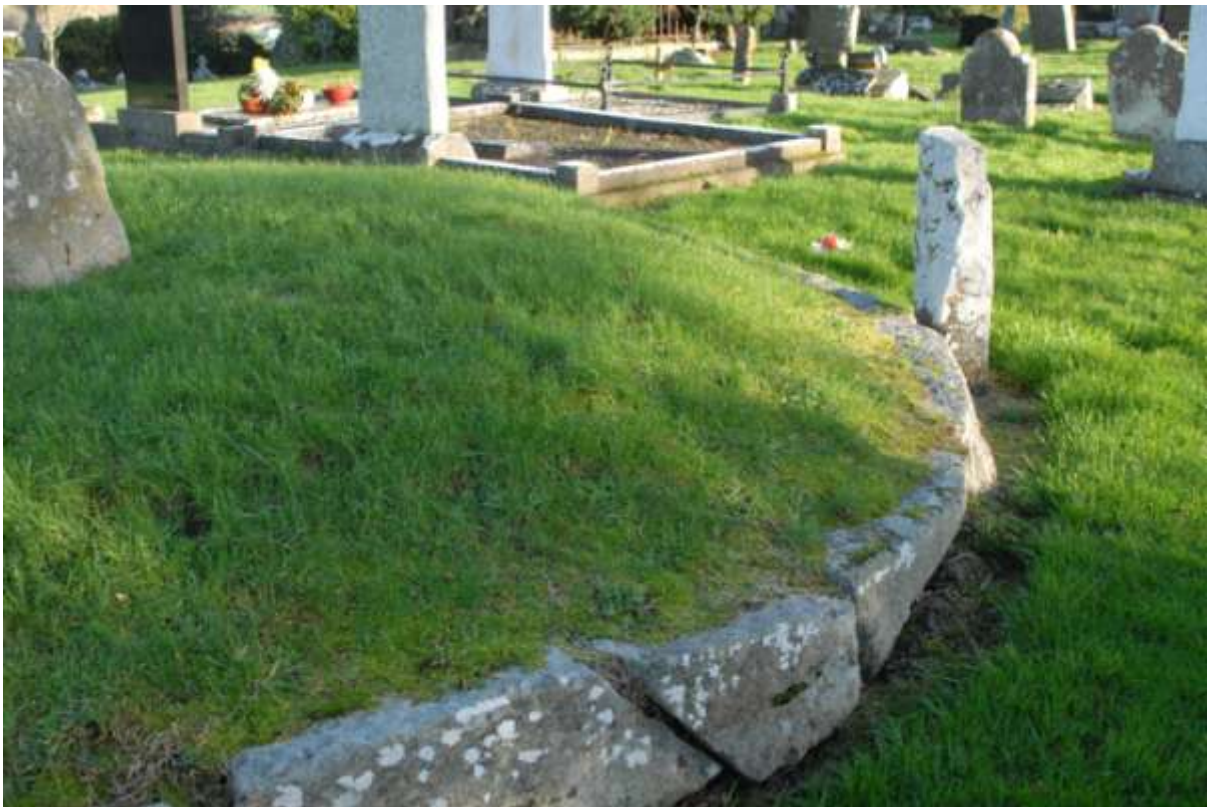
*Above: The stones are cut to a curve, lending some weight to the argument that they represent the base of a round tower.*

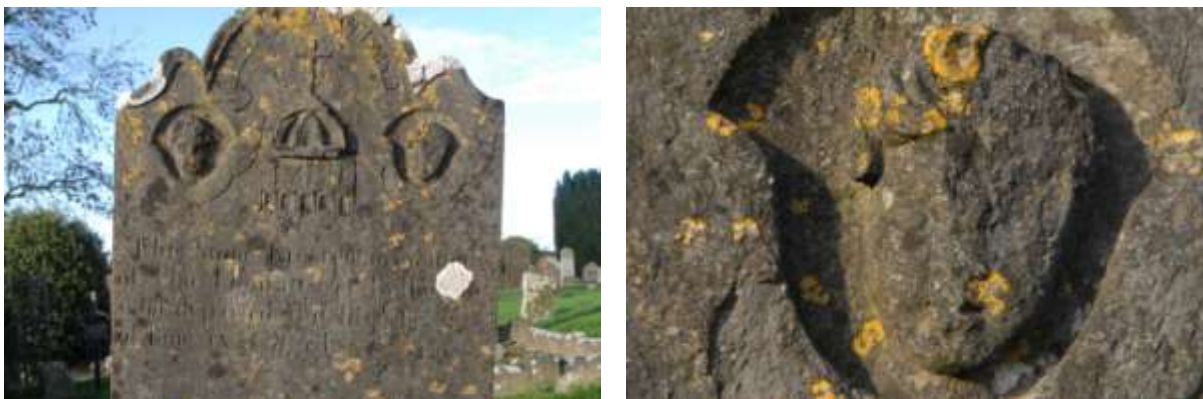
Above: The memorials are generally in good condition, but many show stone weathering.

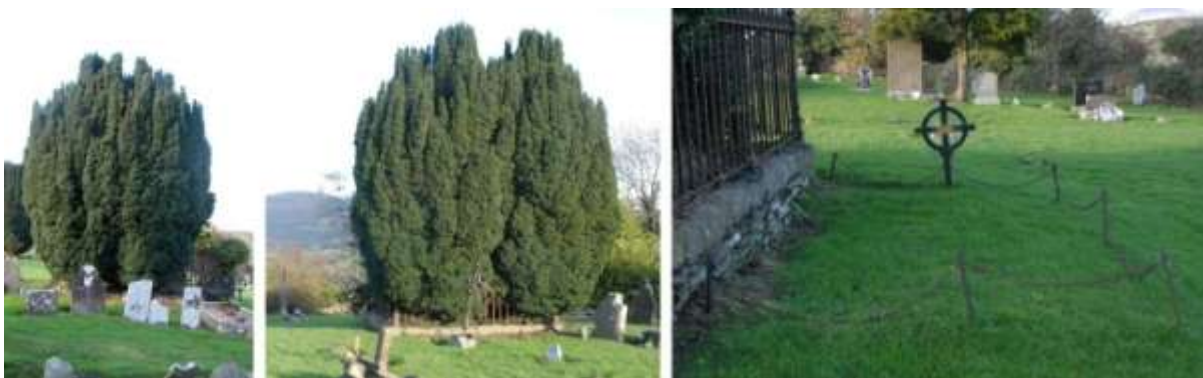
Above: Iron railed enclosure almost entirely enveloped by mature vegetation, with a simple chain delineating the extent of the adjacent burial plot.

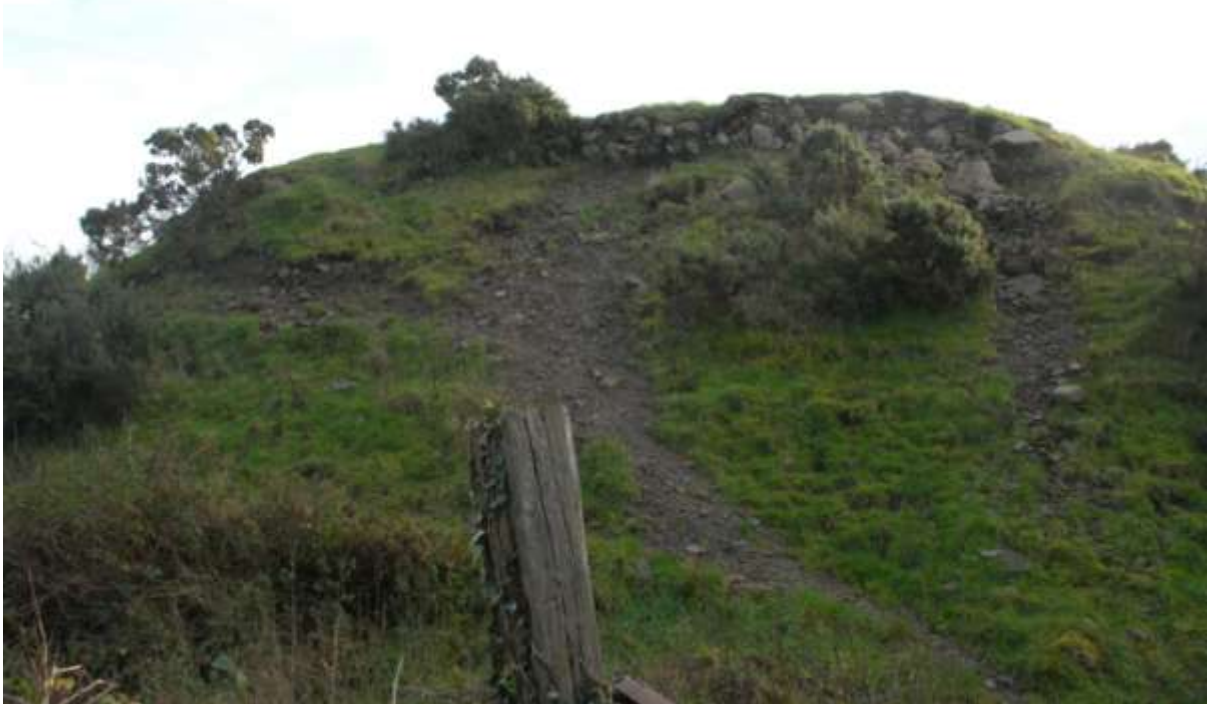
*Above: View of the motte showing a fragment of the masonry wall which encircled the top of the earthen mound.*

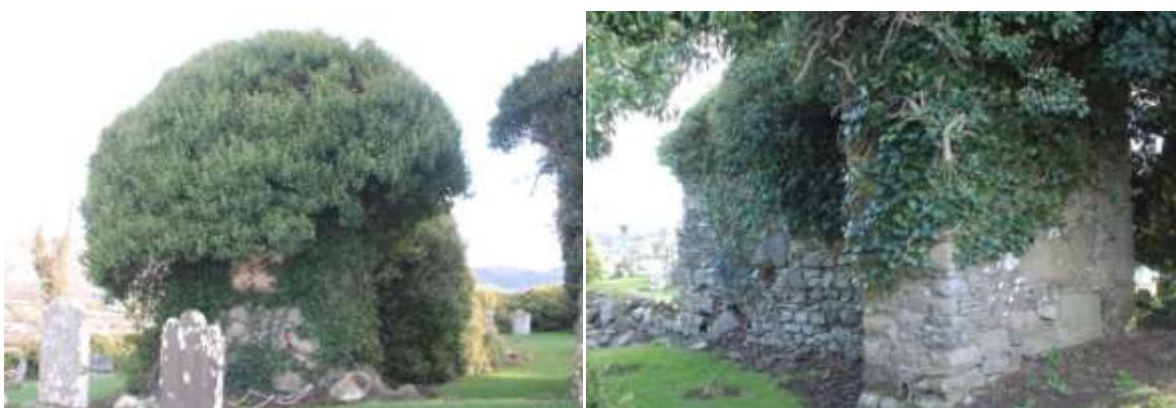
The church is in very poor condition, and the intense vegetation both conceal the extent of damage, and also exacerbate the process of deterioration. The present remains consist of two walls standing to/close to full height (though largely obscured by vegetation) with lower walls surviving in the later chancel, with the cross-wall surviving at little more than foundation level. It should be noted that trenches were previously opened within the building in 1966 as part of archaeological excavations.

*Above: The north face of the north wall is obscured by well-developed vegetation which almost entirely envelopes this part of the structure (left). The west wall has been opened by a breach which has been historically repaired. The southern wall (right) has vegetation confined mainly to the upper half.*

**All vegetation should be carefully removed from the church to allow for repointing and consolidation of the masonry.** This work should be done by the mason(s) who are to undertake the repairs as it will be necessary to repoint and consolidate the masonry with lime-based mortars immediately on removal of the vegetation. It should be noted that well-developed vegetation can be very difficult to thoroughly remove without dismantling masonry, and it is preferable to kill the larger parts of plants and allow dead root systems to remain within the masonry rather than cause damage to the archaeological significance and character of the building by dismantling and re-building. No part of the church should be dismantled, and all repairs should be undertaken on the basis of consolidating 'as found'.

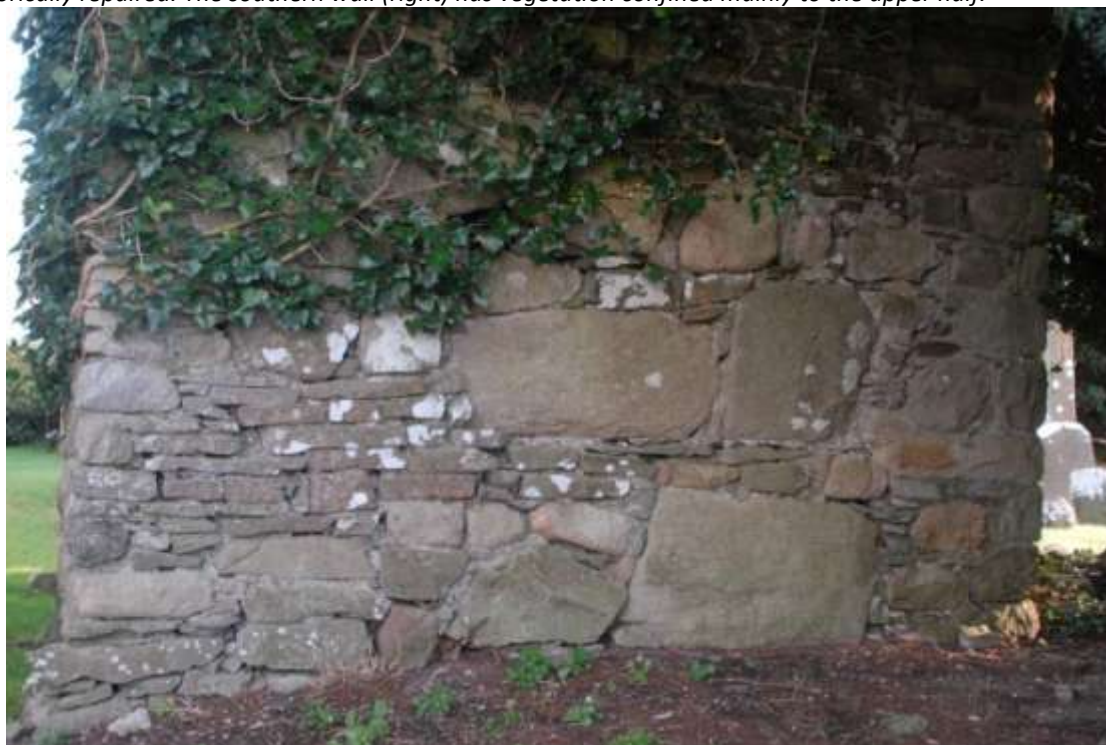
*Above: Surviving fragment of the west wall showing a mixture of massive (possibly face-bedded slabs) and smaller flaggy masonry with a number of generations of mortars indicating ongoing 'patch' repair work.*

**All repairs should be carried out using a lime-based mortar** compatible with the weathered and fire-damaged granitic and greywacke masonry. Areas of sound pointing and especially areas of render should be retained. Any Portland Cement-based mortars should be removed from the wall. All existing stone should be consolidated in place. Where stones have fallen from the outermost leaf of the masonry wall on the north elevation of the south wall of the nave, they should be replaced face-bedded and no attempt should be made to re-align or otherwise 'improve' the masonry.

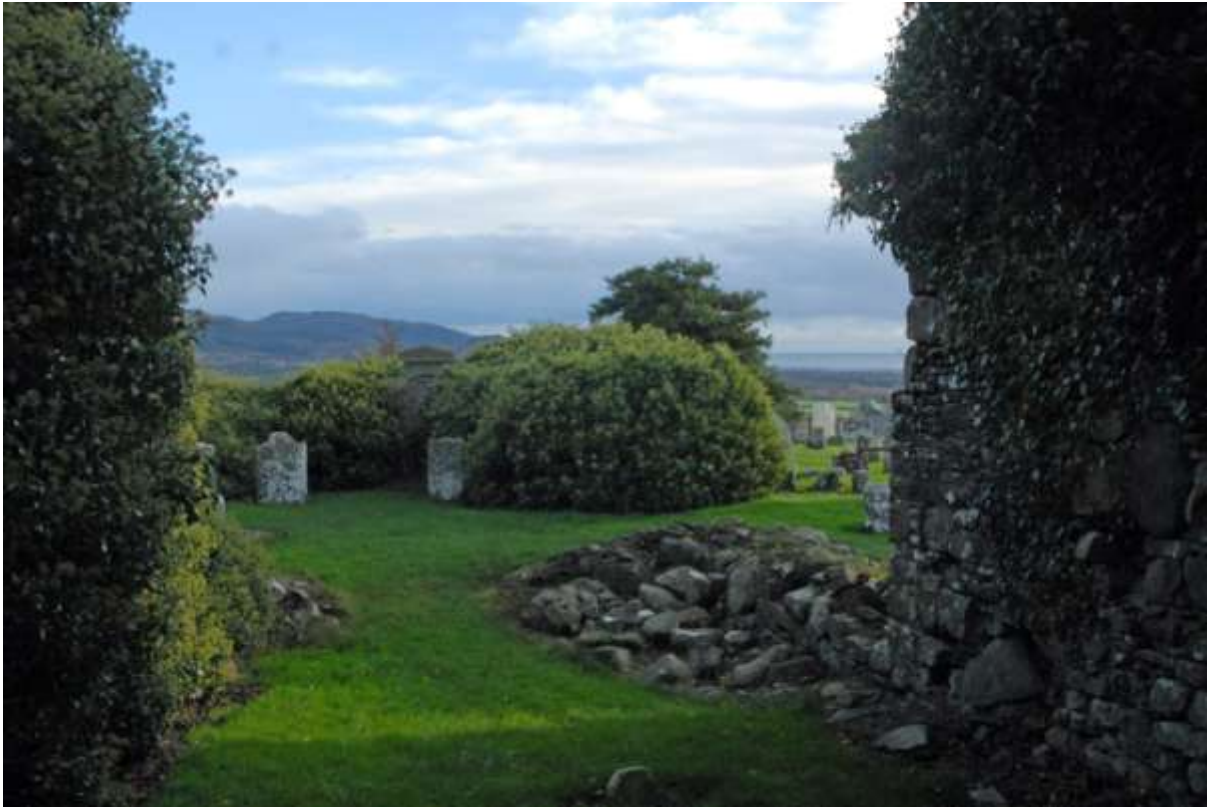
*Above: The interior of the church (seen from the west) is grassed over, with the cross-wall surviving at foundation level only, the centre part of the south wall collapsed and appearing as a pile of debris (centre) with the later chancel obscured by vegetation (background).*

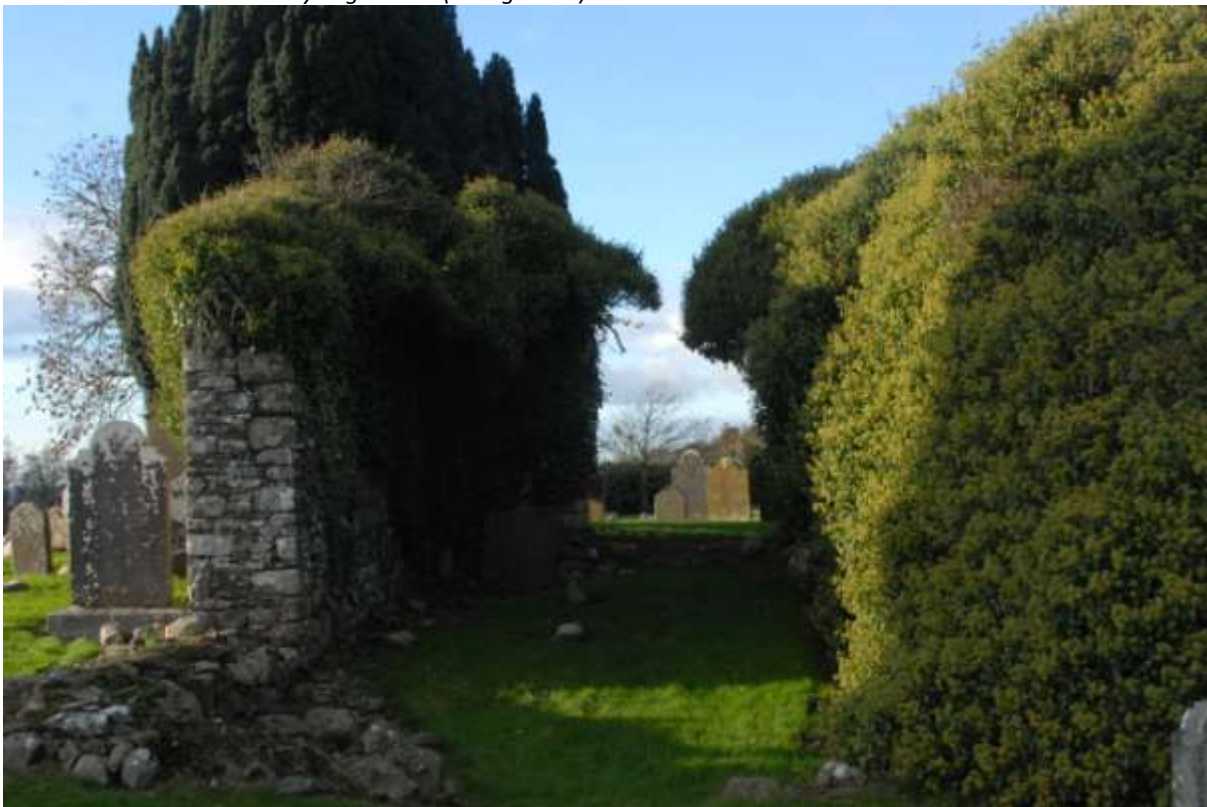
*Above: View of the chancel from the east showing the overgrown north wall (right) and collapse of part of the south wall (left).*

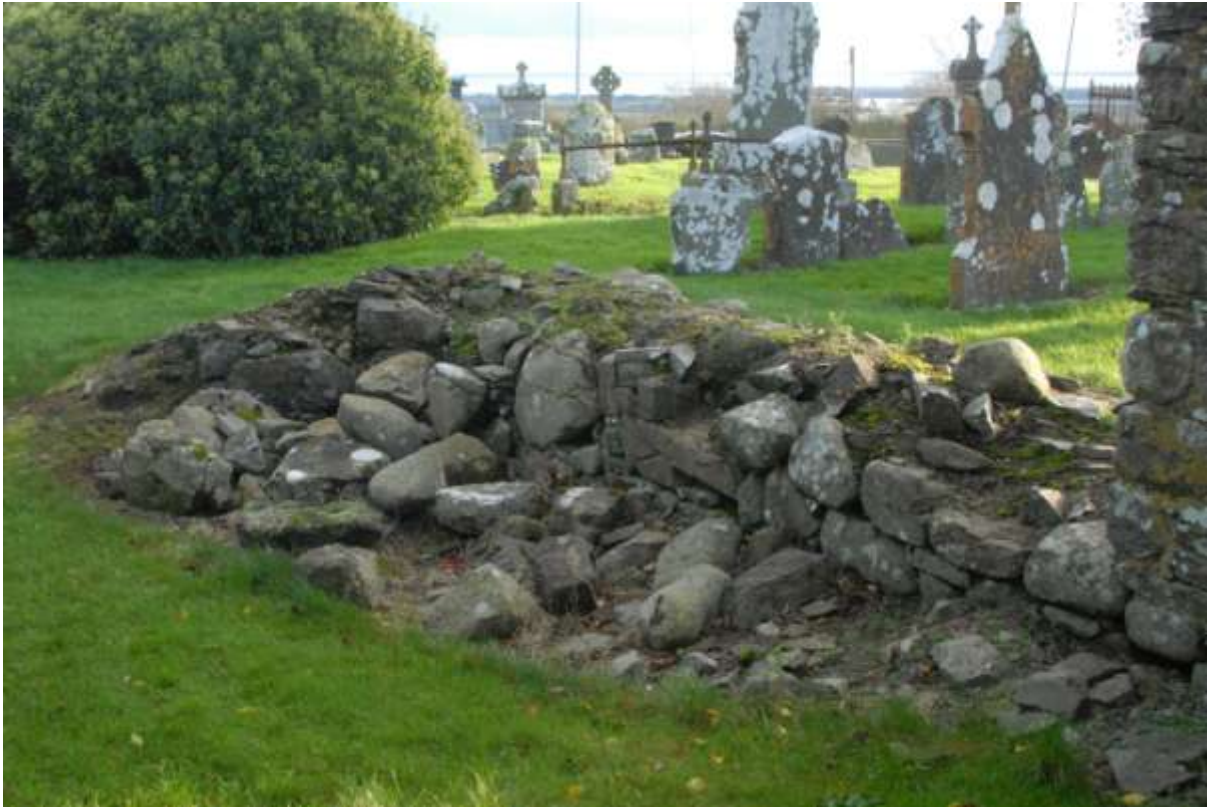
*Above: Collapsed section of the south wall of the nave and the cross-wall.*

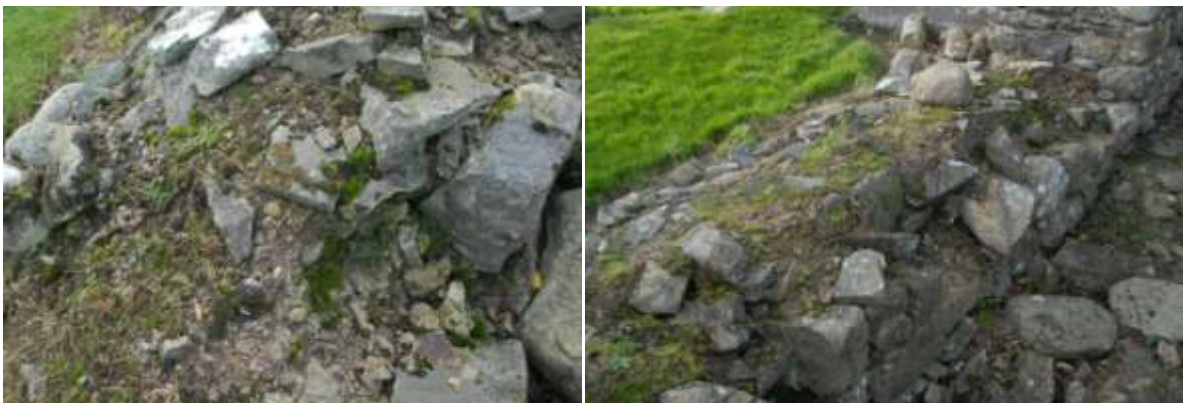
*Above: Exposed weathered wall-core of the south wall of the nave.*

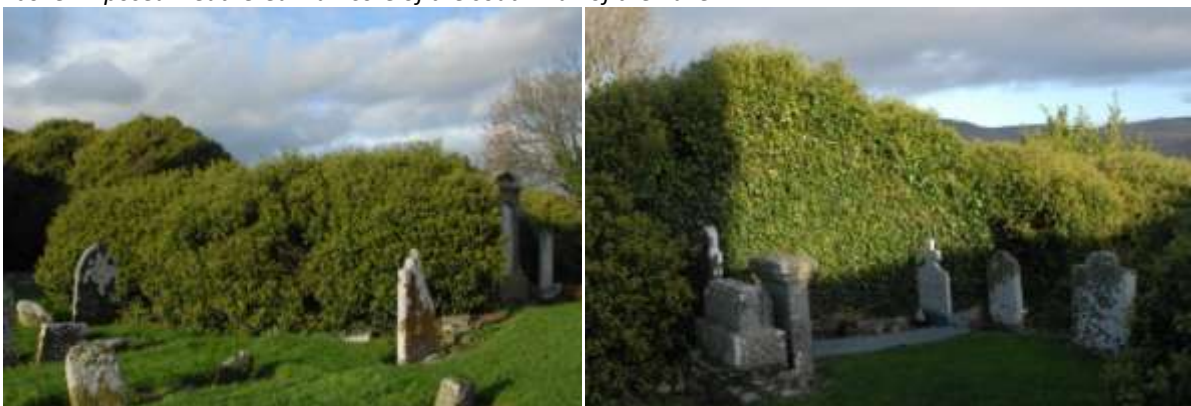
*Above: North face of the church (left) and view of the inner (south elevation) of the north wall of the chancel (right).*

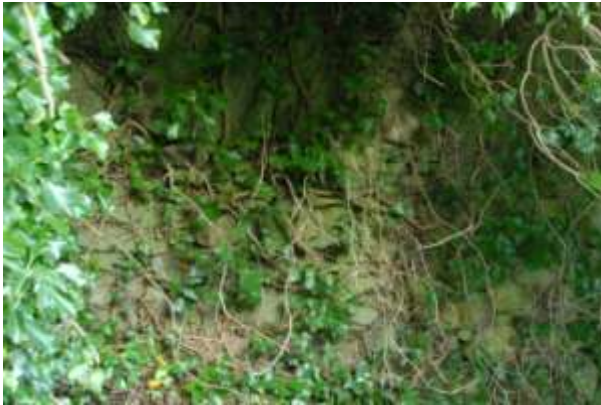
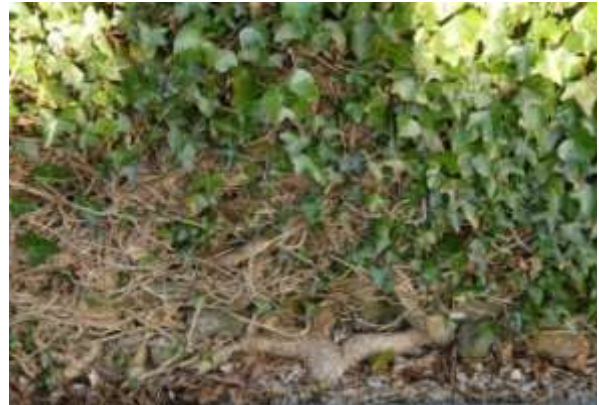
*Above: Only a small fragment of the masonry of the north wall of the church is exposed (left) which shows dry joints and root penetration (right).*

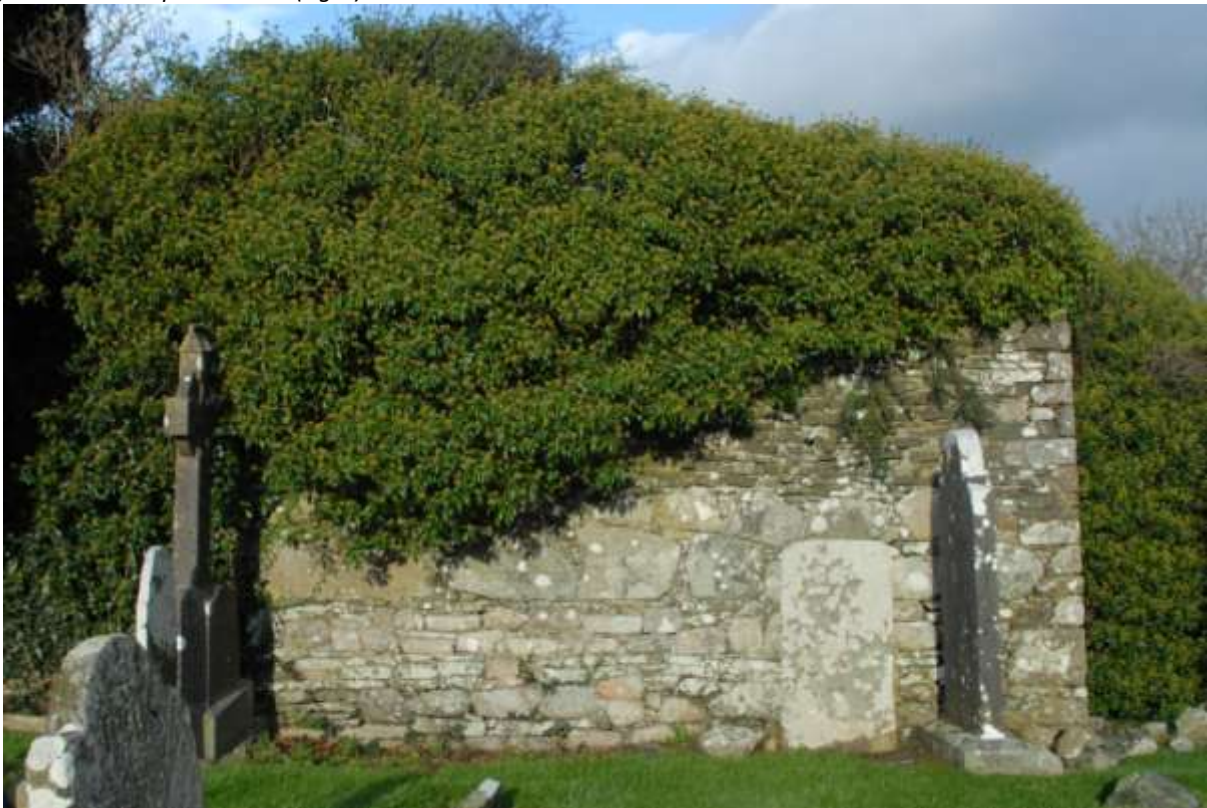
*Above: The exposed masonry of the south elevation of the south wall is in reasonable condition.*

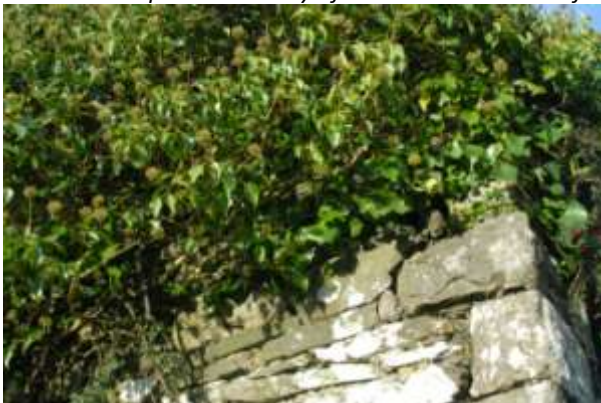
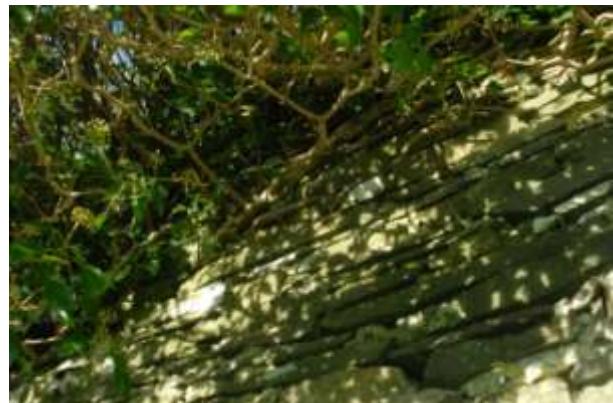
*Above: However, the upper half of the wall, largely concealed by vegetation, shows extensive dry jointing and displacement of masonry through the penetration of roots into the fabric of the wall.*

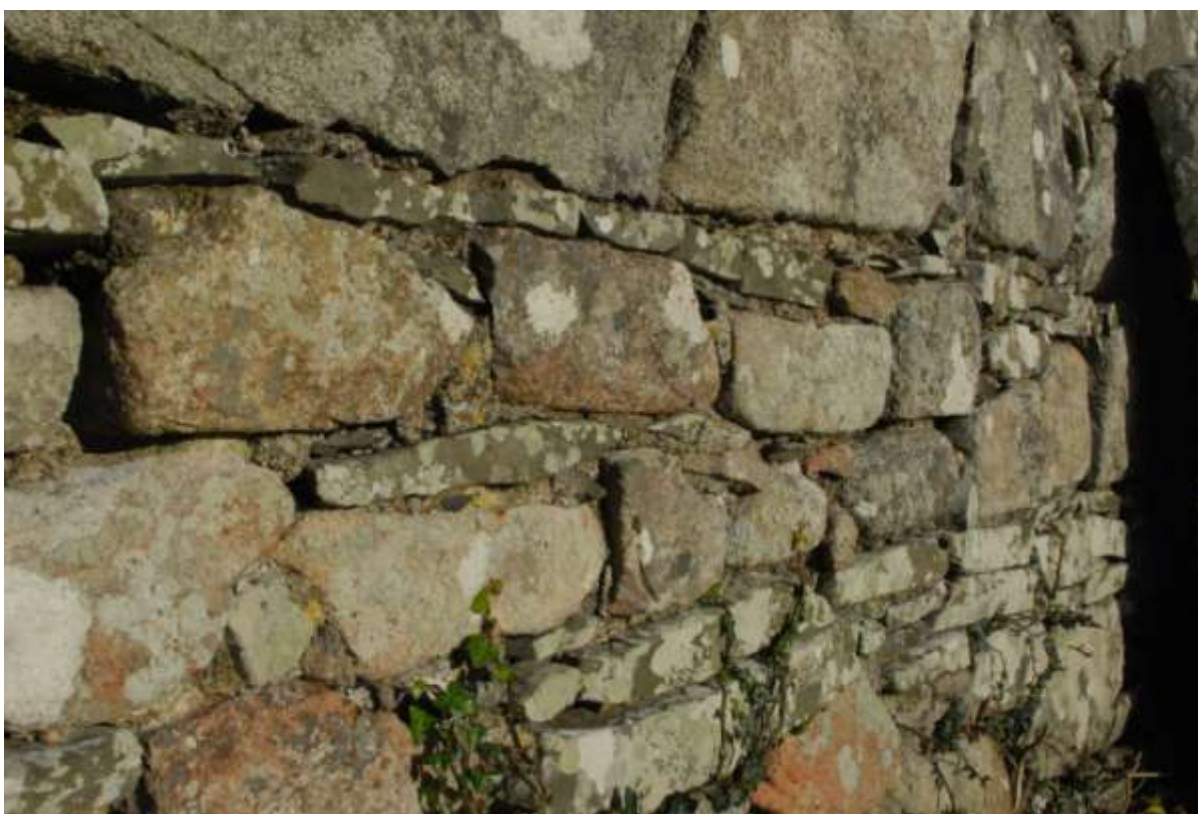
*Above: The bedding mortars of the of the south elevation of the south wall of the nave show some recession but can be retained with delicate pointing-up repairs focused on the dry joints only.*

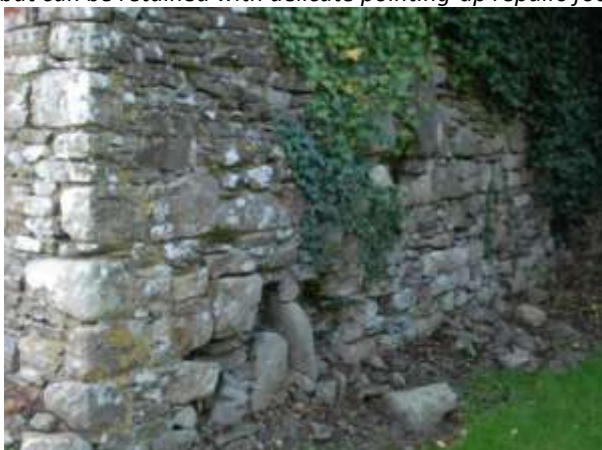
*Right: The north face of the south wall of the nave is in poor condition, with large stone detaching from the face of the wall and ivy penetration into the upper half of the wall.*

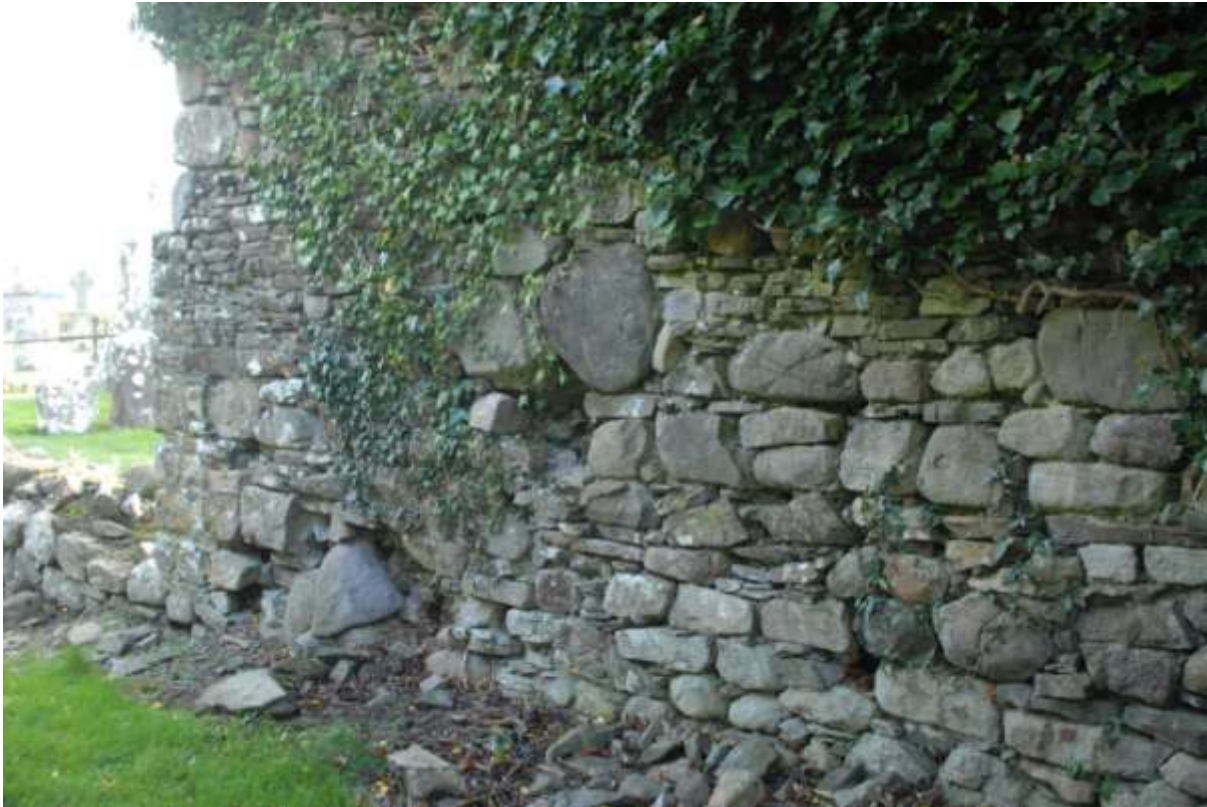
*Above: The north face of the south wall of the nave shows extensive dry joints, loose unstable masonry and ivy penetration to the upper half of the wall. It should be noted that the large stones shown in the photograph above appear to be face-bedded and are so at particular risk of collapse.*

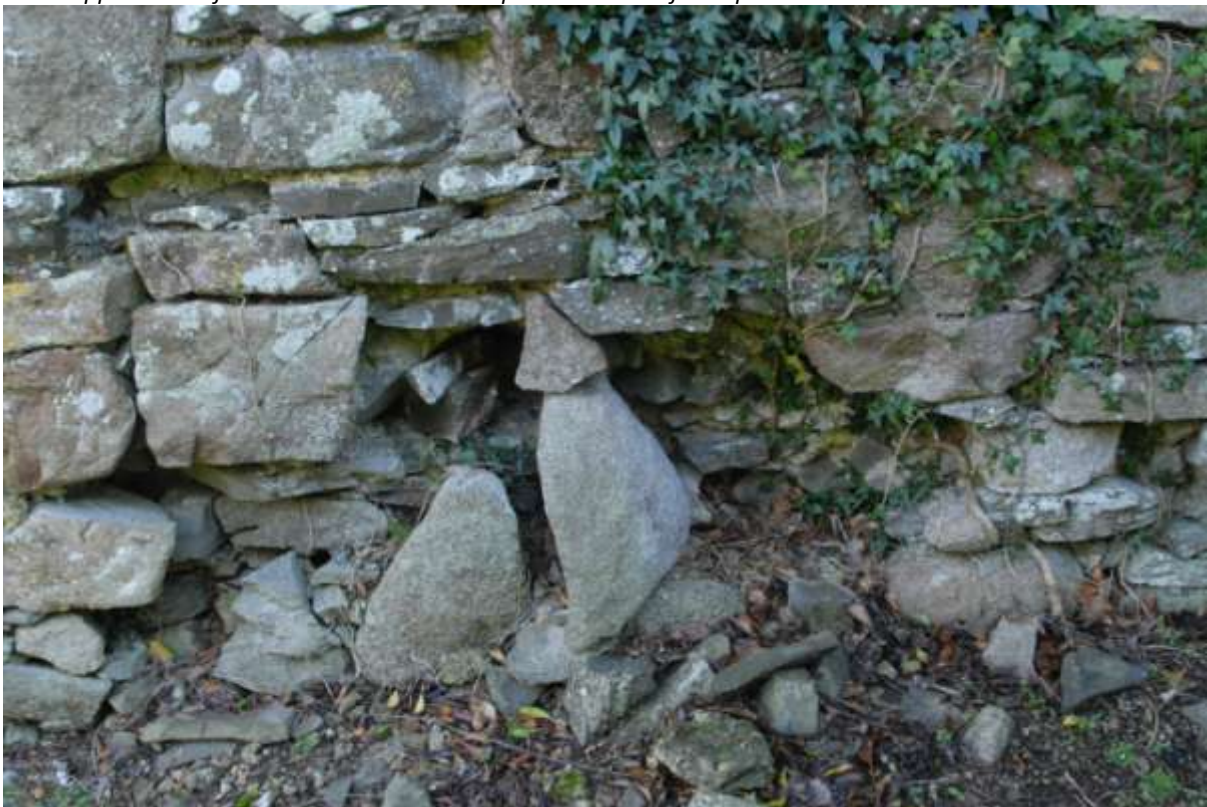
*Above: Collapse of the outer leaf of masonry at the base of the north face of the south wall of the nave*

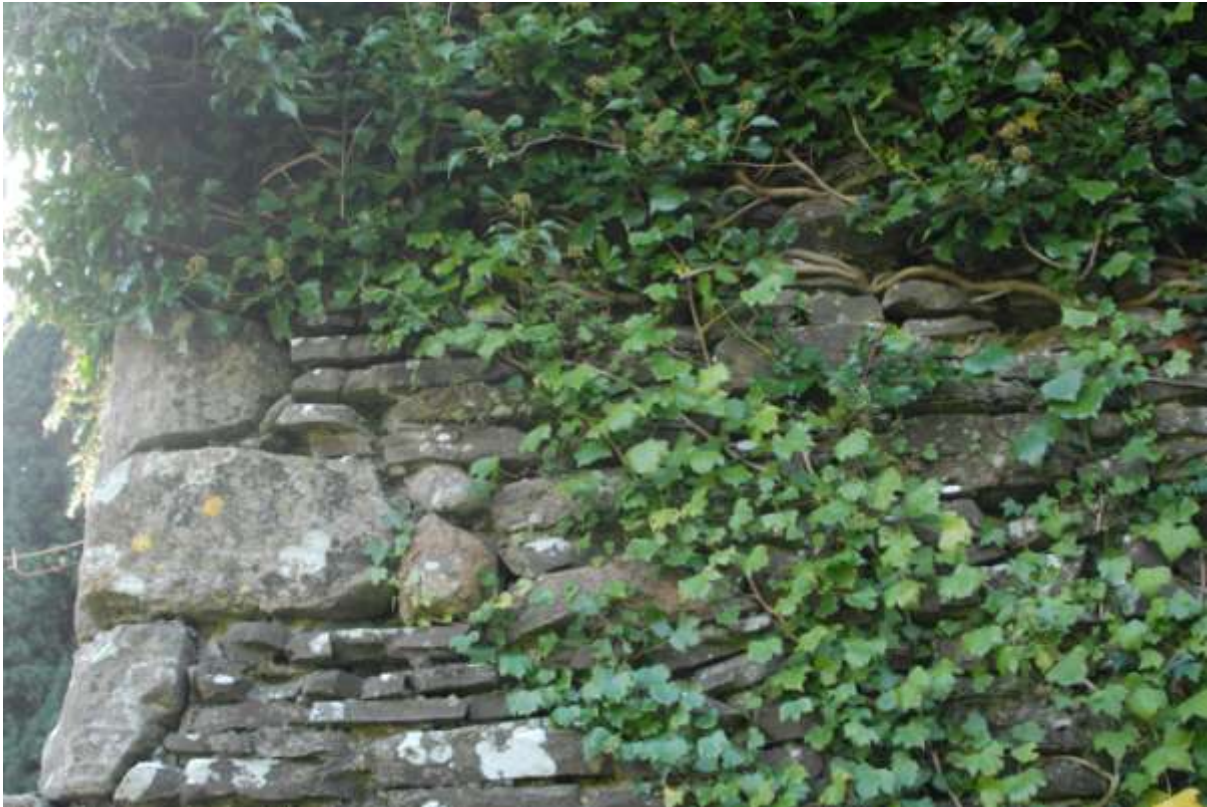
*Above: The upper half of the north face of the south wall of the nave shows extensive open dry joints and invasive vegetation threatening to de-stabilise the masonry.*

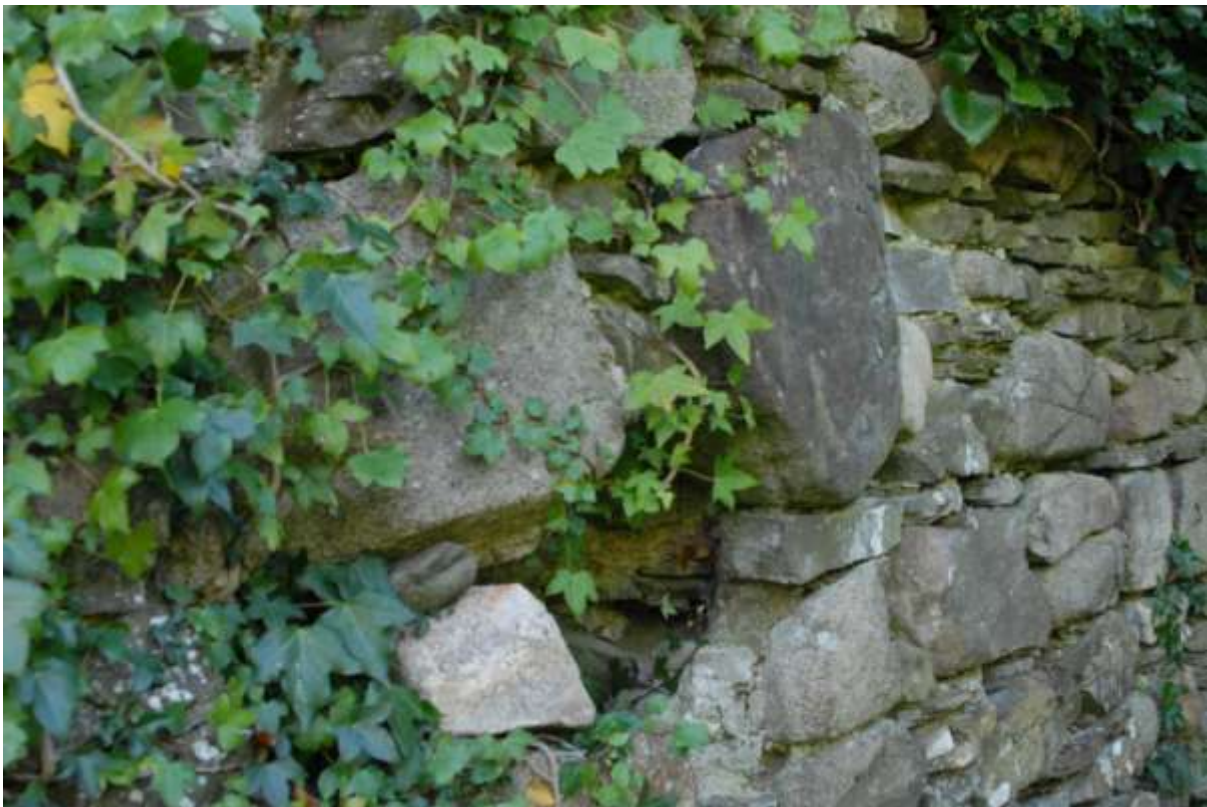
*Above: The larger stones exposed in the wall (originally concealed by an internal lime plaster or other finish) appear to be face-bedded, and are precariously positioned on loss of the bedding mortar.*

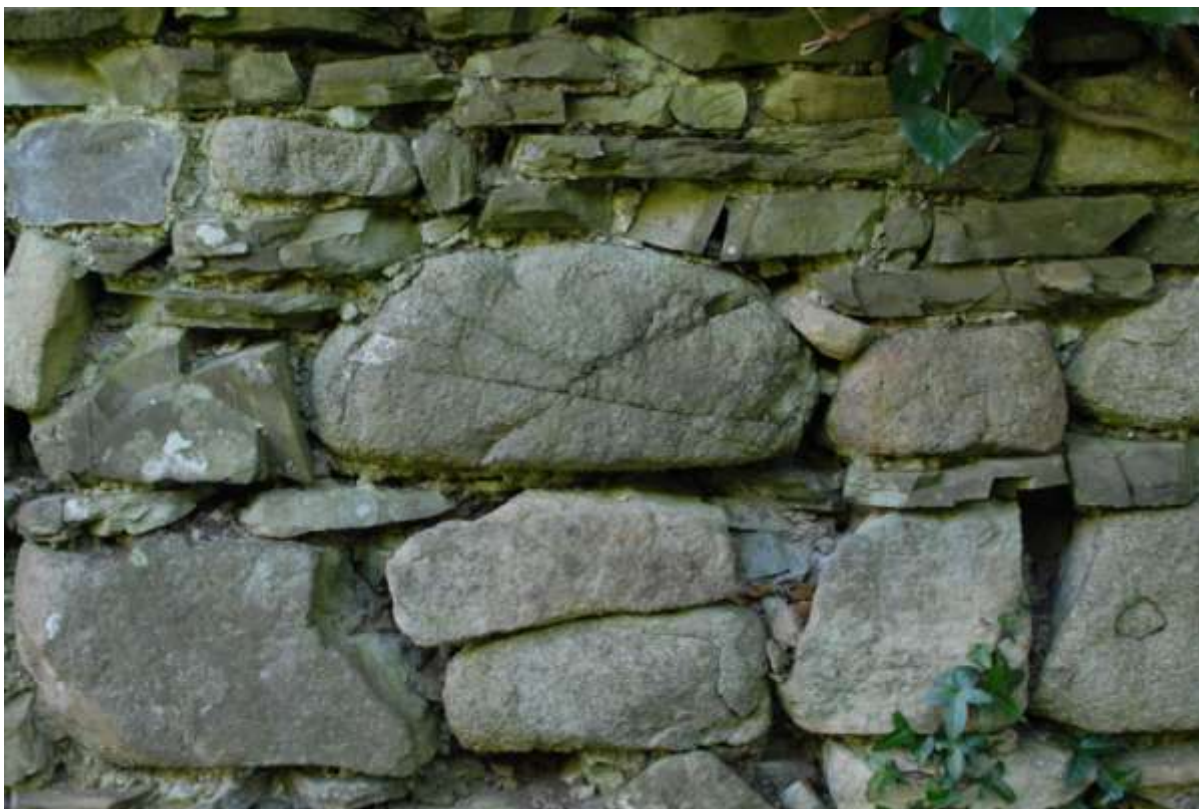
*Above: Dry jointing is common, but the masonry also appears to have suffered other types of damage.*

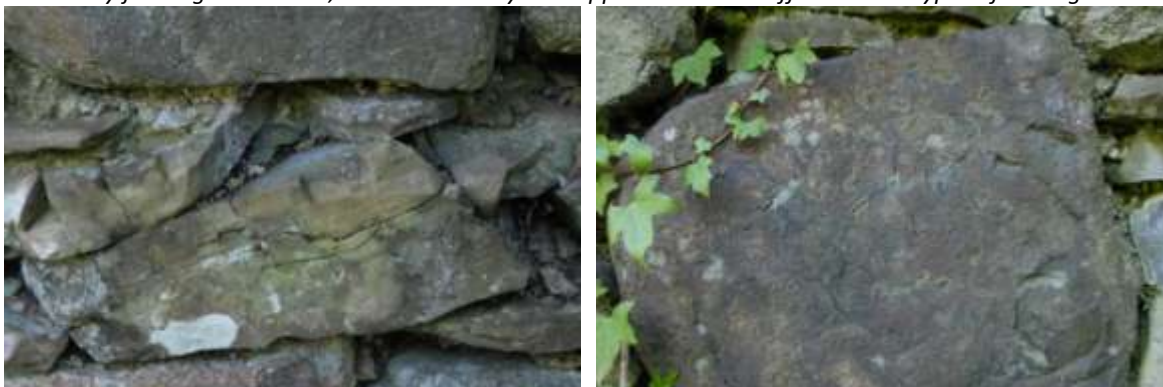
*Above: Fire-damaged stones are commonly found among the masonry (left) and face-bedded laminated stones showing delamination can also be seen (right).*

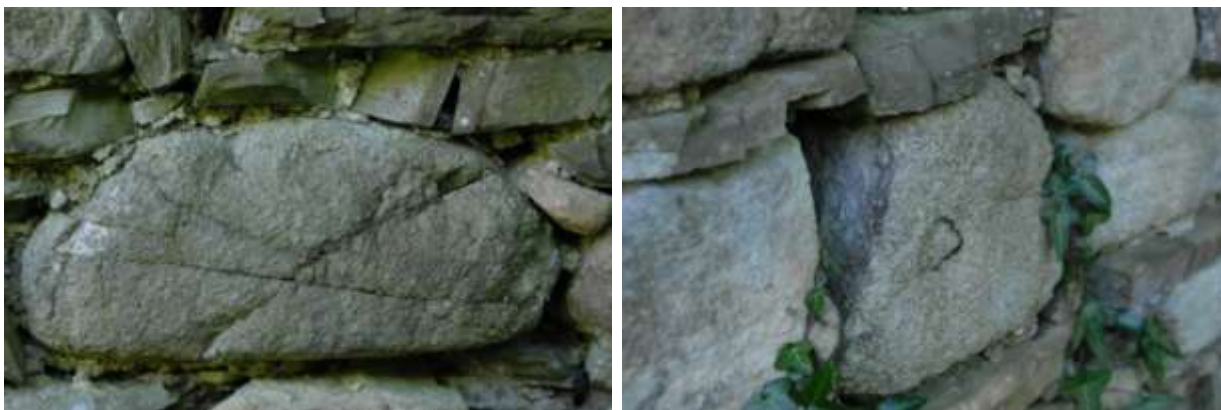
*Above: Some of the granitic stones show well-developed decay forms - this could be the result of using pre-weathered stones (if the stone was a glacial erratic quarried as a fieldstone), but can also arise as a result of thermal stress arising from fire damage.*

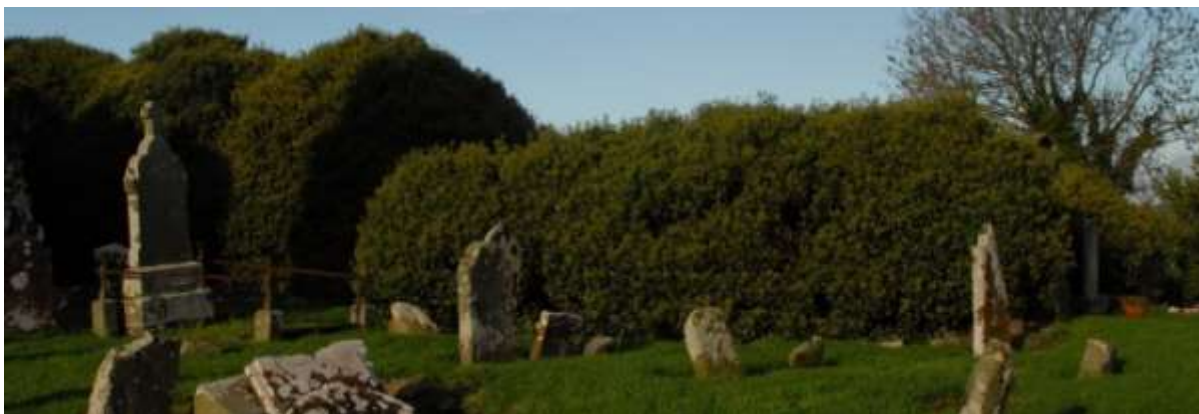
*Above: The chancel is enveloped by vegetation and close inspection of the masonry was not possible. However, given the repairs required to the north and south walls of the nave, it is very likely that similar levels of dry jointing and root penetration into the masonry fabric can be expected in this part of the church.*

It will be necessary to entirely remove the vegetation from the wall-tops of the church to accurately determine their condition and repair needs. However, it is to be expected that in addition to consolidation, a limited amount of lime-based grout may be required, and it should be expected that a lime-based haunching should be applied to protect the top of the wall.

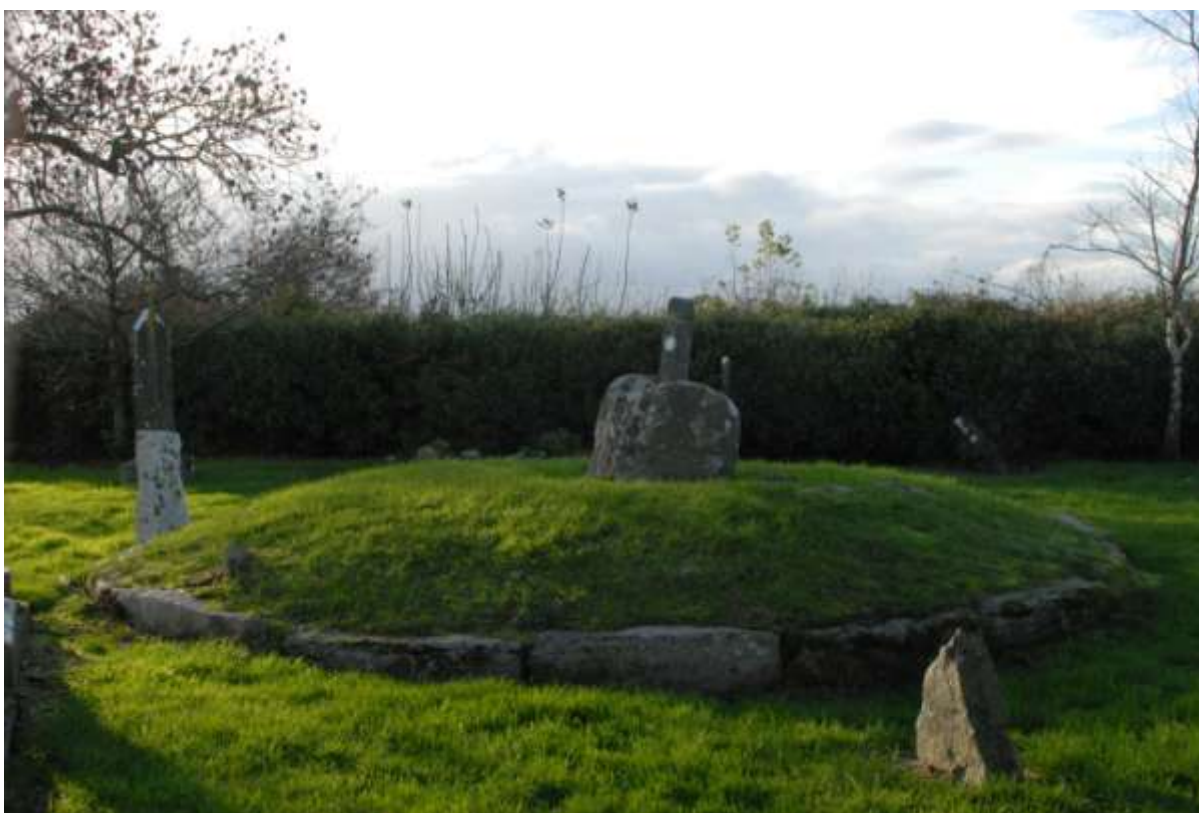
The base of the round tower is in good condition and requires no urgent or immediate works. The ground are well-maintained and care should be taken during grass-cutting that the blades of strimmers or other tools do not abrade the surface of the stones. Care should also be taken not to dislodge the stones which are not secured by mortar and are earth-fast drystone. The stones show a biofilm of moss and lichen. However, the stone surfaces do not appear to retain any dressing or other features, and it is not necessary to remove or otherwise treat the surface of the stones.

*Above: The grass on the earthen mound is well-maintained. The structure requires no immediate repair.*

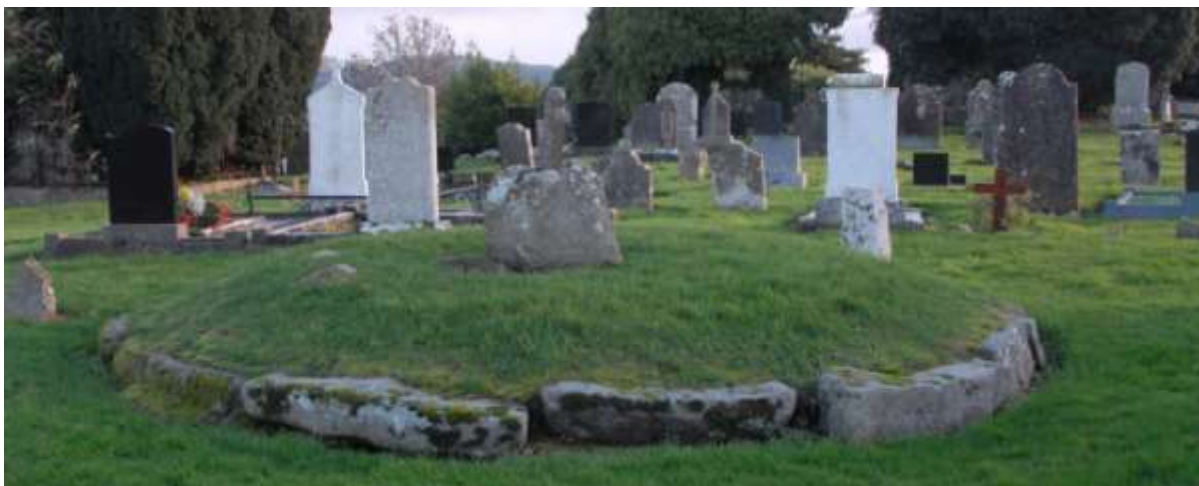
*Above: The stones are not perfectly aligned and show a greenish biofilm, but do not currently require any urgent or immediate intervention.*
