## FAUGHART GRAVEYARD CONSERVATION AND MANAGEMENT REPORT

For Louth County Council

## Executive Summary

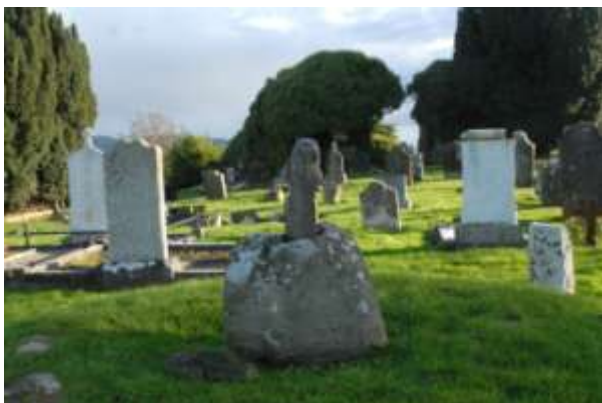
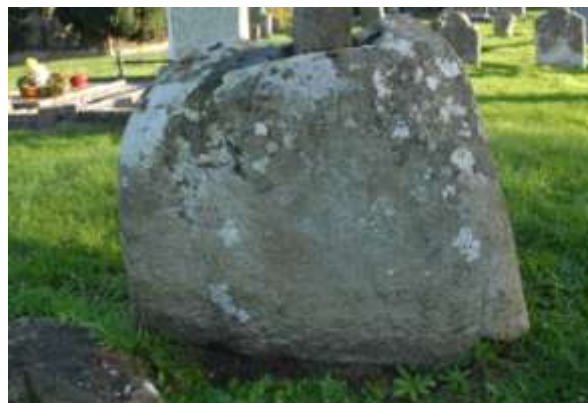
The base of the high cross appears to be in reasonable condition and requires no urgent or immediate works. The stone shows a number of weathering forms and a well-established lichen biofilm and has experienced surface loss over the centuries. However, the surface appeared reasonably sound at the time of inspection, with no significant surface loss and no urgent repair requirements.

*Above: The high cross base is positioned in the centre of the possible round tower (see Section 3.3) and is without surface decoration.*

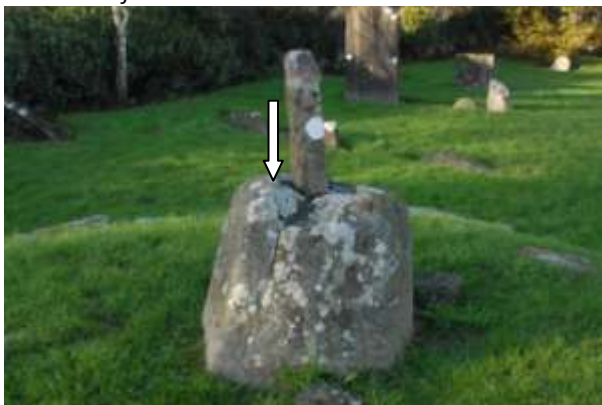
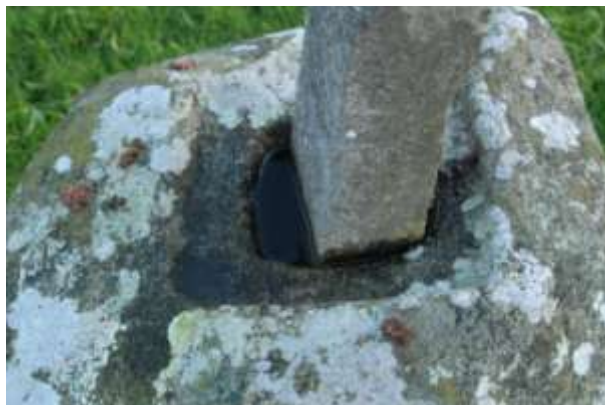
*Above: The side of the base stone shows an incipient vertical fracture which appears to be an inherent fault of the stone (left, arrowed). The socket on the top of the stone is filled with moisture but is not associated with any severe stone decay, and the upper surface shows well-established biofilm.*

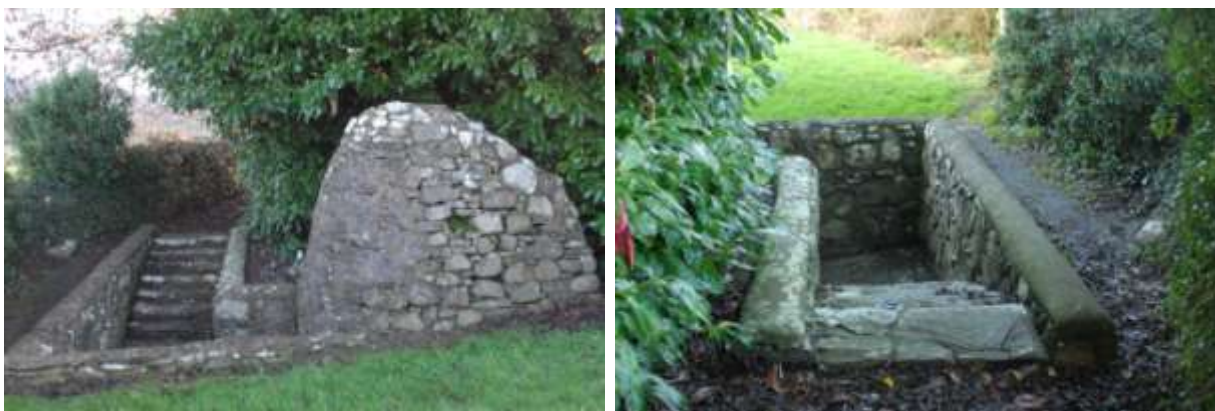
The Holy Well appears to be in reasonable condition and requires no urgent or immediate works.

*Above: General views of Saint Brigid's Well.*

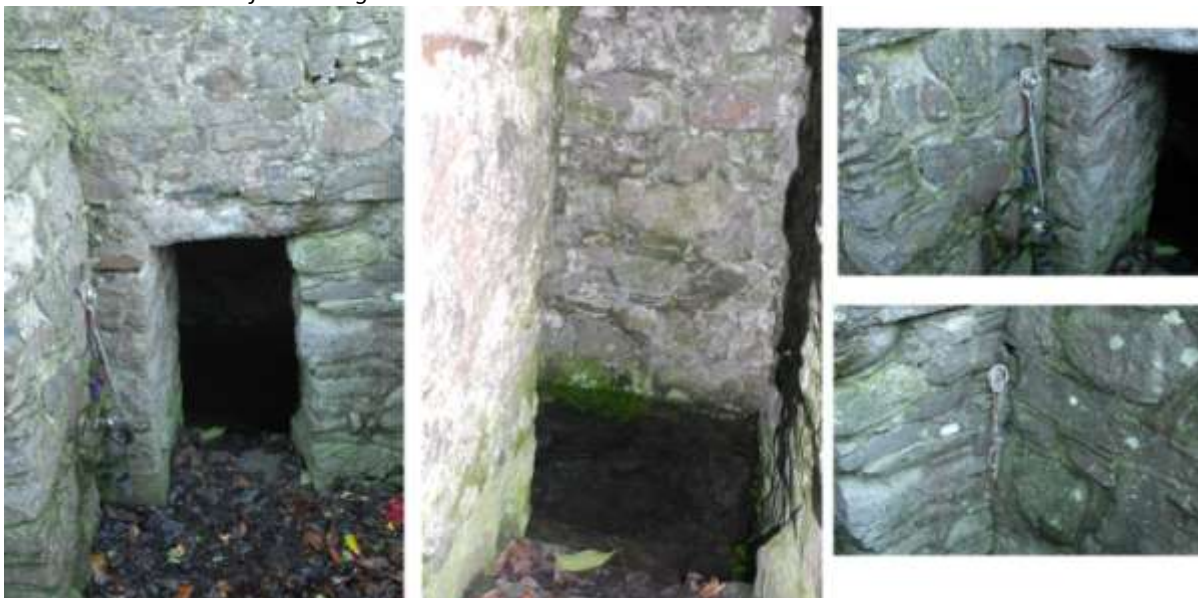
*Above: The entrance to the well (left) leading to a shallow well (centre) with the masonry showing Portland Cement based pointing mortars (right).*

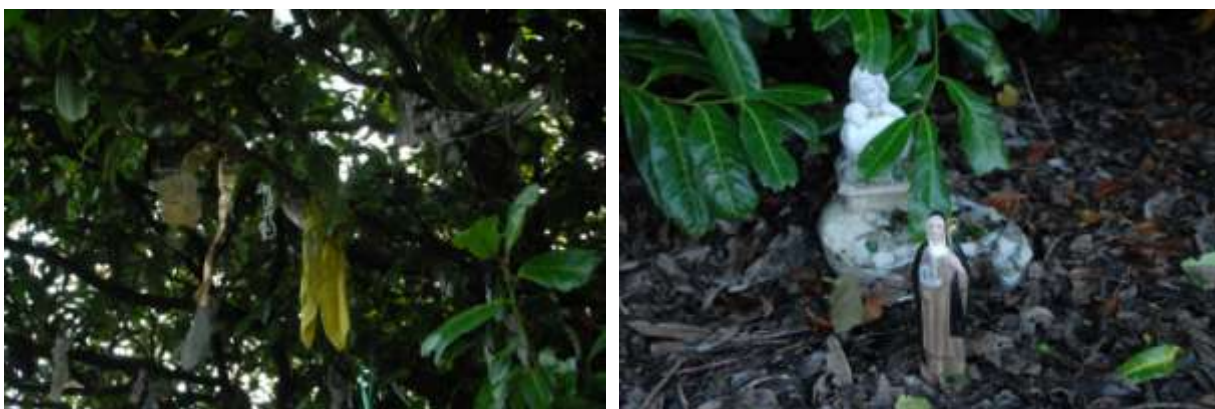
*Above: The adjacent tree is also incorporated into modern veneration practices at the well. However, the vegetation is not having any impact on the well structure and no intervention is currently required.*

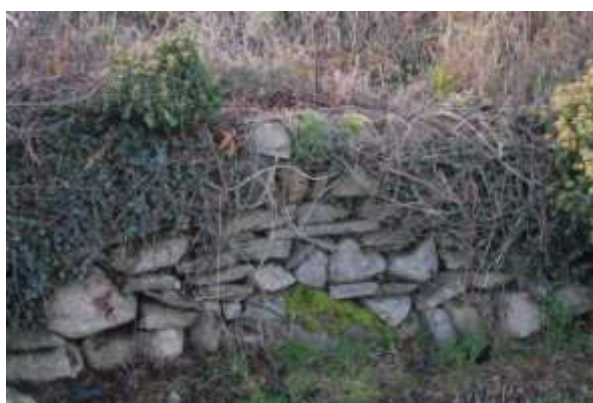
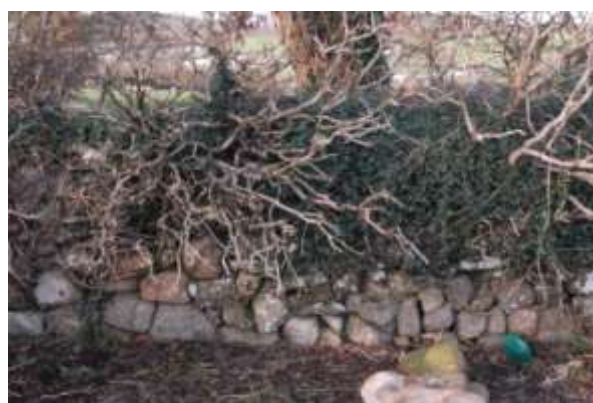
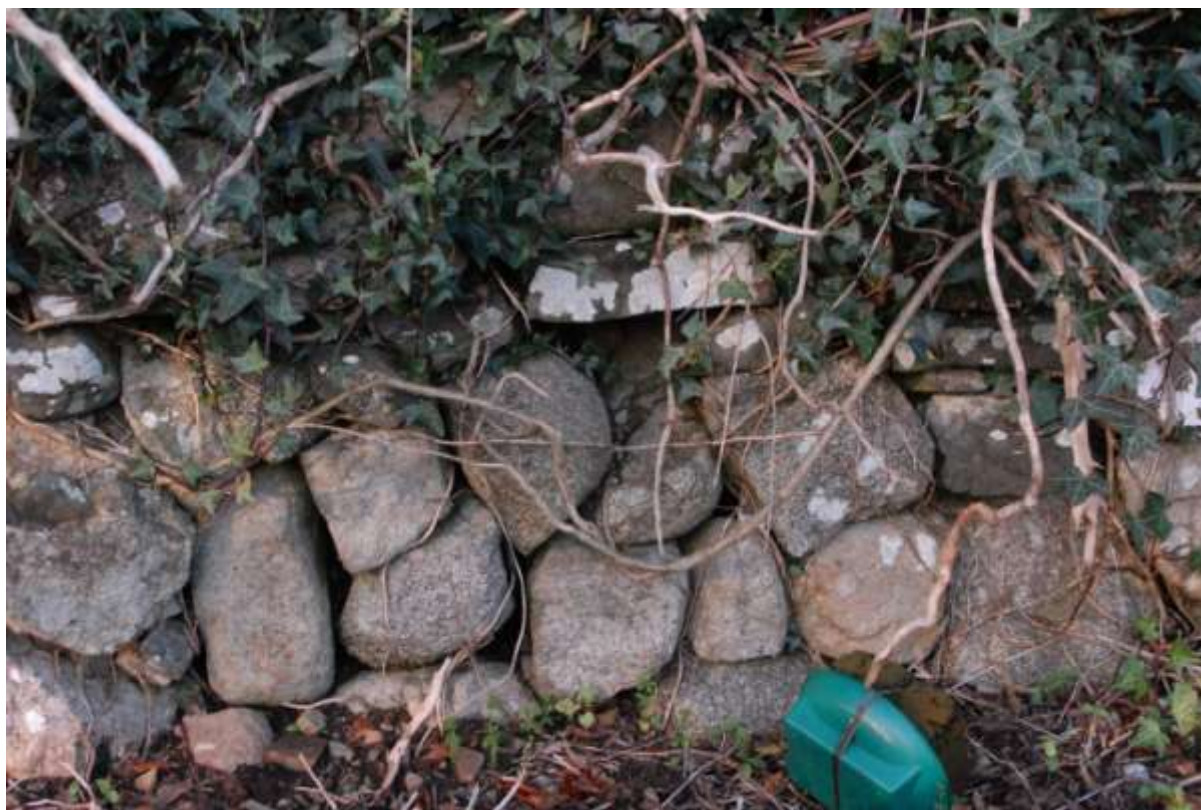
*Above: The adjacent tree is also incorporated into modern veneration practices at the well. However, the vegetation is not having any impact on the well structure and no intervention is currently required.*

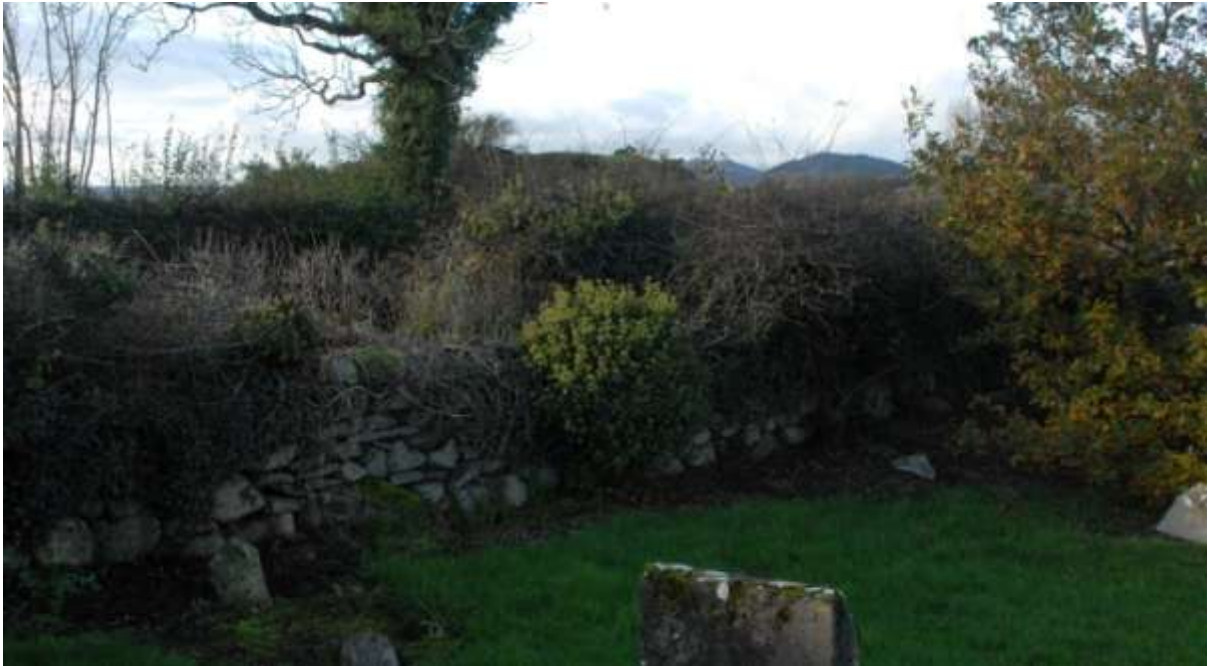
*Above: General view of the north wall of the graveyard with Faughart Motte in the background.*

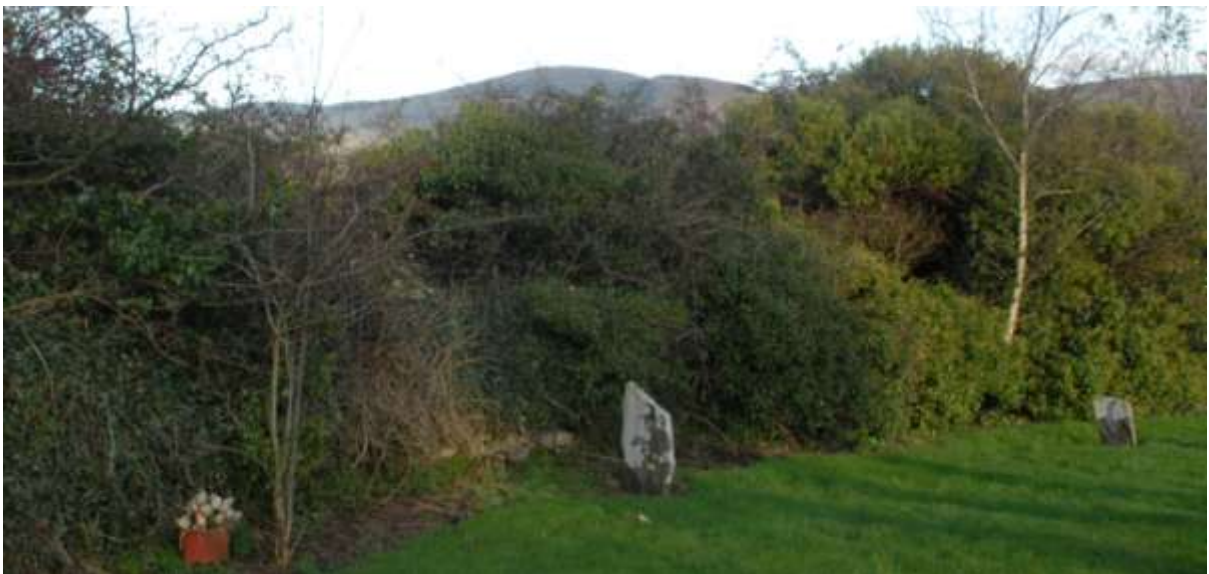
*Above: General view of the inner face of the east side of the enclosure wall obscured by vegetation.*

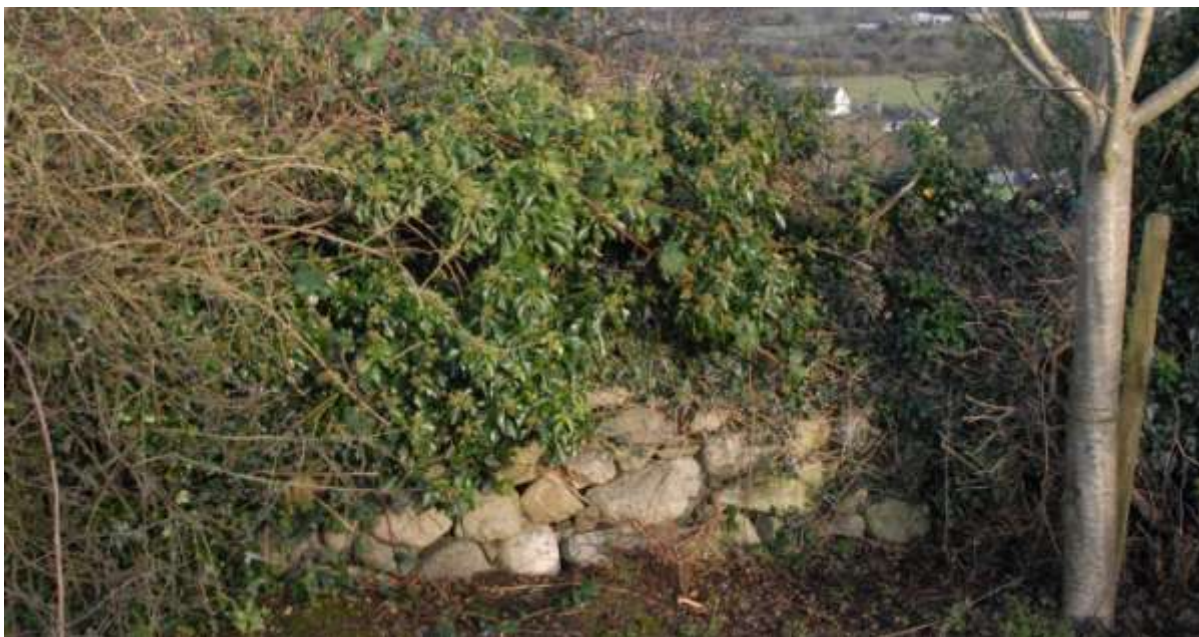
*Above: The east side is also largely composed of drystone granitic erratic boulders.*

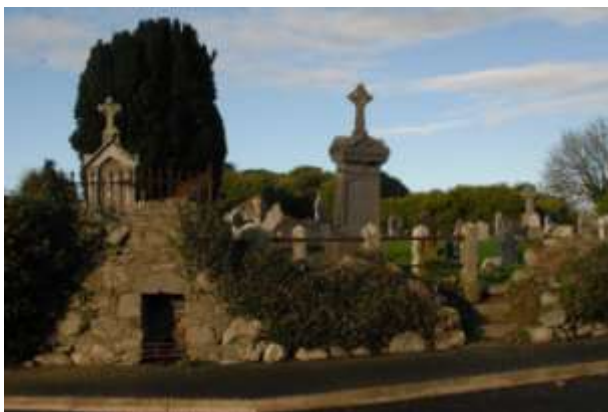
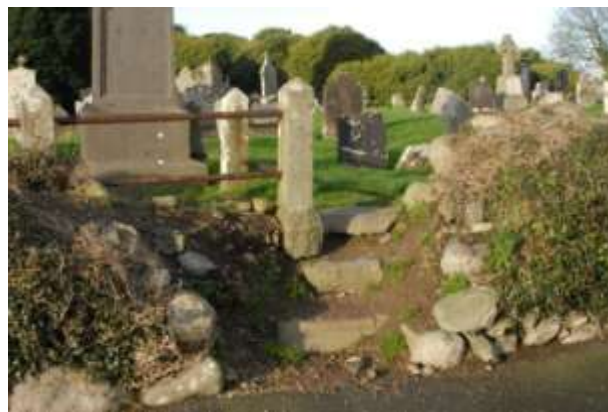
*Above: The impromptu entrance into the graveyard from the car park is leading to undermining and erosion of a burial at the south end of the graveyard, and exacerbating the breach through the enclosure wall at this point.*

- **Repairs to the church should be considered as an urgent and immediate priority.**
- The enclosure wall is largely of drystone construction, but is vulnerable to invasive vegetation which can destabilise the masonry. The **breach in the south end of the enclosure** (used as access from the adjacent car park) which threatens not only the archaeologically significant enclosure wall, but also poses the risk of exposing human remains as the burial plot is eroded and **should be repaired immediately**. The **drystone stile adjacent to the main entrance gates should also be repaired**.

**It is recommended that the vegetation from the southern end of the graveyard immediately adjacent to the car park be entirely removed.** It is likely that collapsed drystone rubble is contained within the vegetation and this should be retained in a safe location on site to allow repair of the breach.

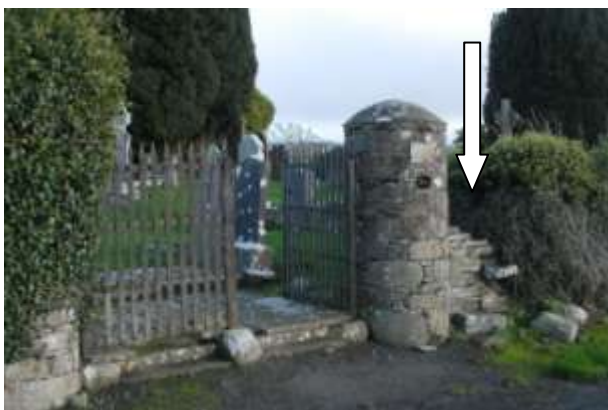
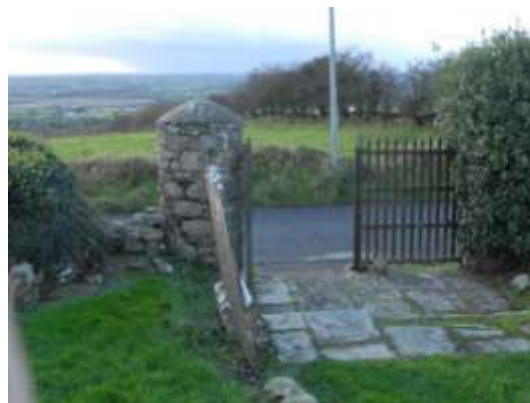
*Above: The principal entrance is of relatively modern date and is formed by flanking drum pillars hung with iron gates and hard paving, with a stile (arrowed) adjacent.*

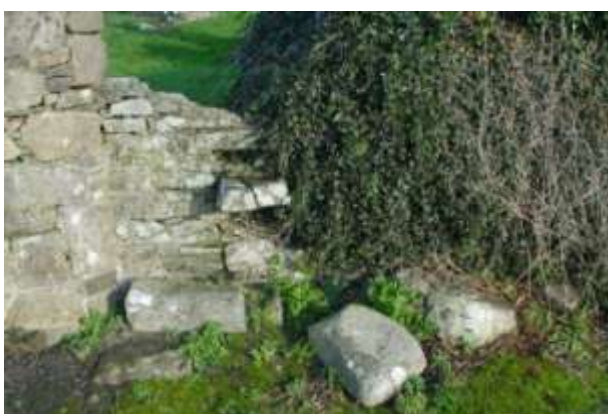
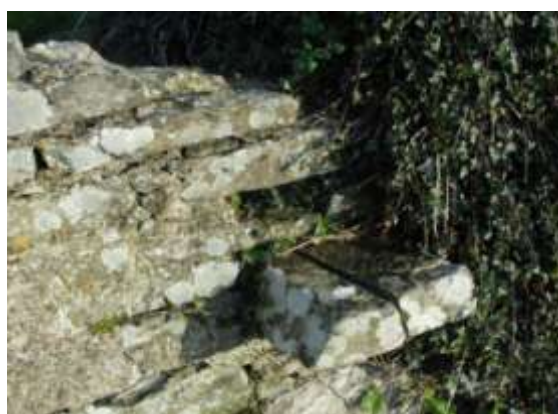
*Above: The stile has collapsed but is repairable.*

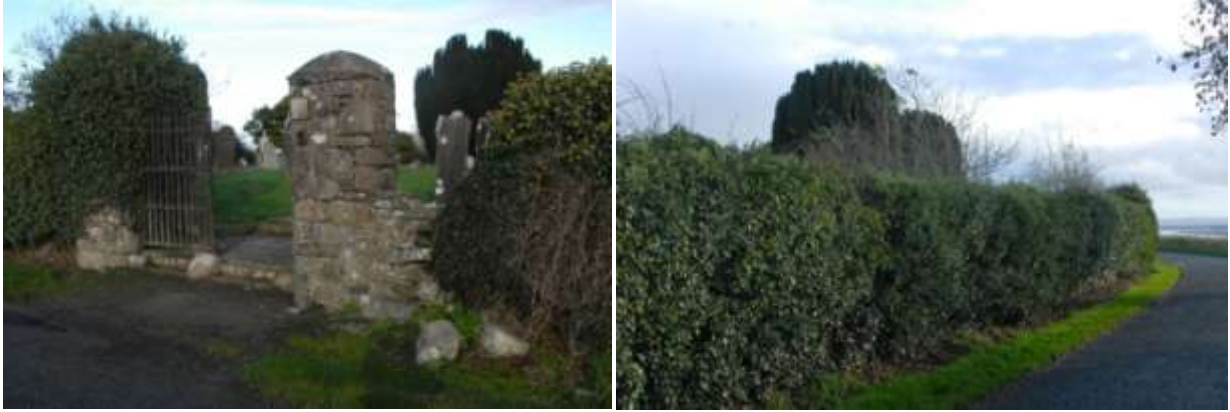
*Above: The west wall of the graveyard is almost entirely obscured by vegetation.*

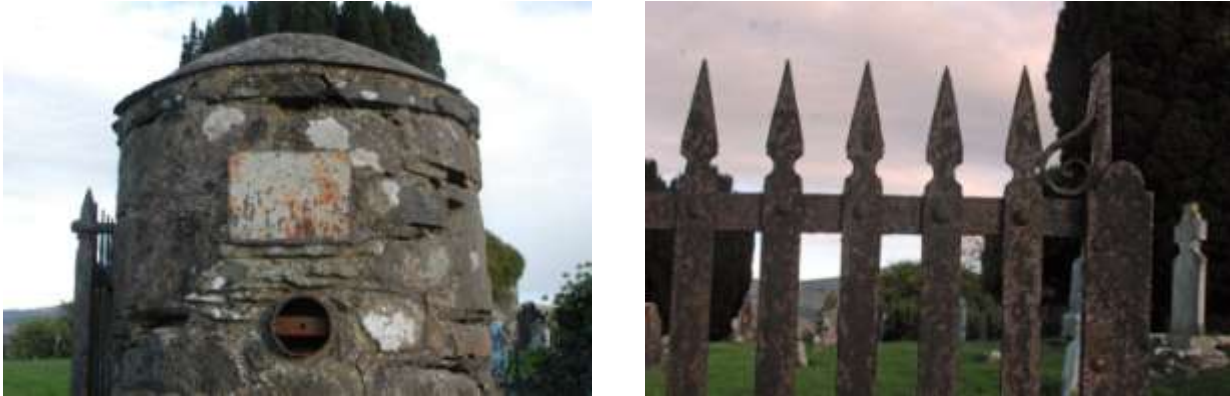
*Above: The pillars require minor joint filling (left) while the gate requires rust treatment and repainting if it is to be retained (right).*

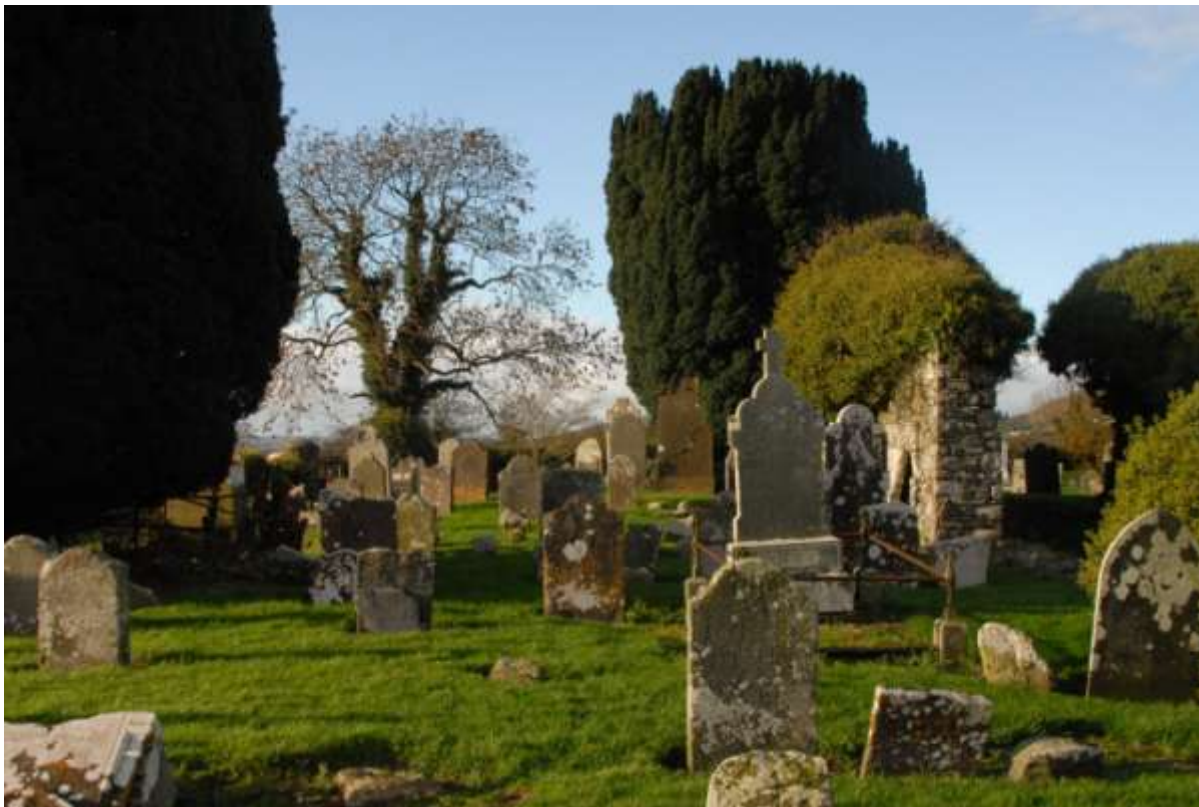
A number of the memorial slabs are broken, with the detached fragments normally placed at the base of or immediately adjacent to the base of the slab. This excellent practice should be continued as it allows good potential for repair. However, while it is relatively straightforward to re-attach the slabs, **it is recommended that these works be postponed until the more urgent works to the church and the enclosure wall are complete.**

Above: General view of memorials in Faughart graveyard.

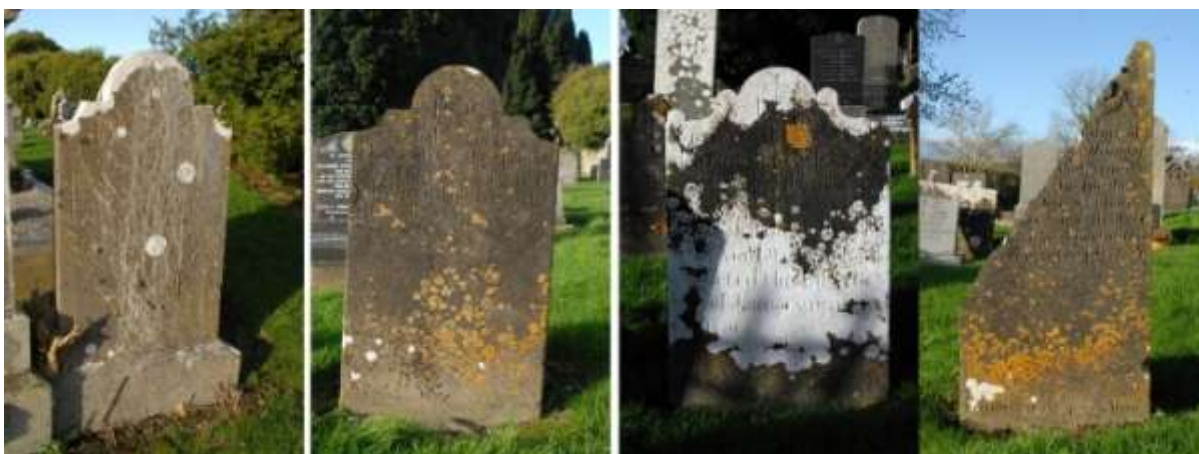
Above: The majority of the memorials in the graveyard are upright slabs bearing lichen biofilm, though occasional memorials (left) show recently removed plant growth. A small proportion of slabs (right) show cracking and loss of the upper parts of the stone.

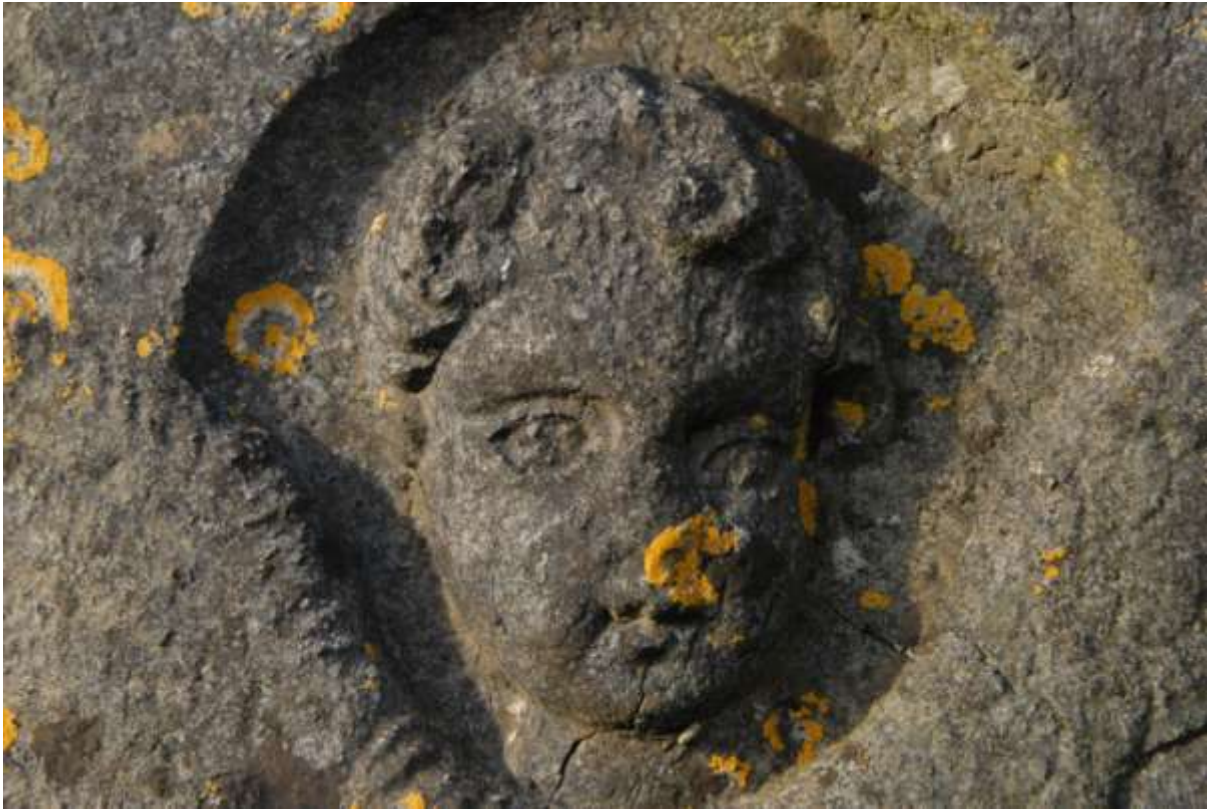
*Above: The degree and severity of stone weathering depends on the nature of the stone from which the slab was carved. This limestone for example shows cracking and surface dissolution while lichen development is beginning to obscure the surface of the memorial.*

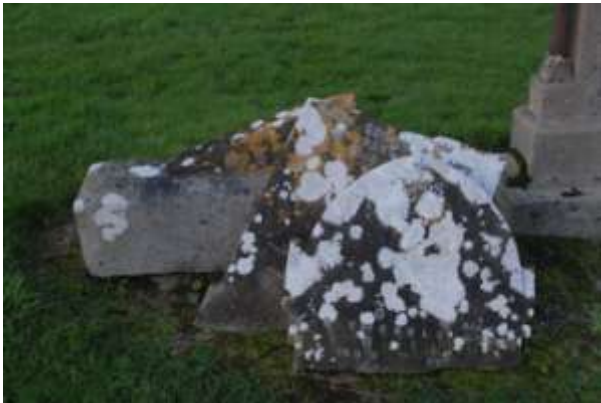
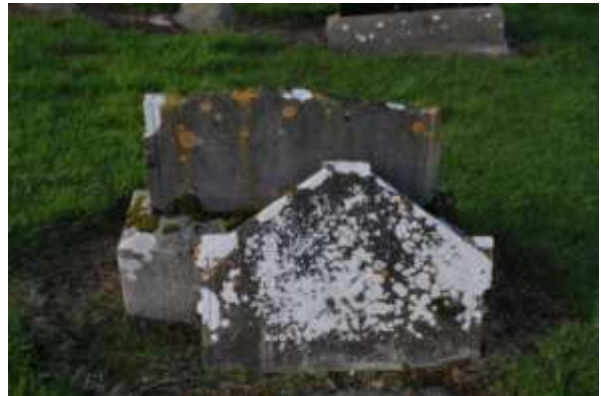
*Above: Broken fragments of memorials should be left as found, adjacent to the base of the slab.*

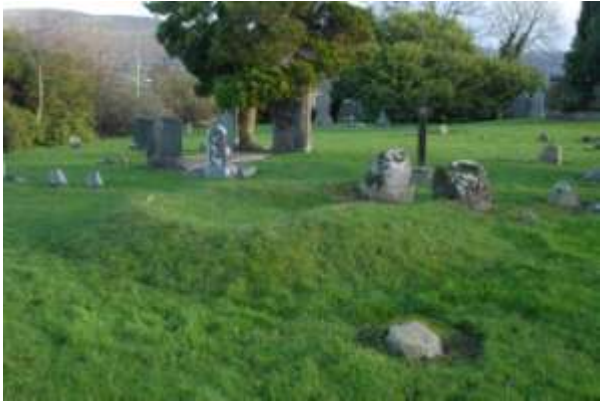
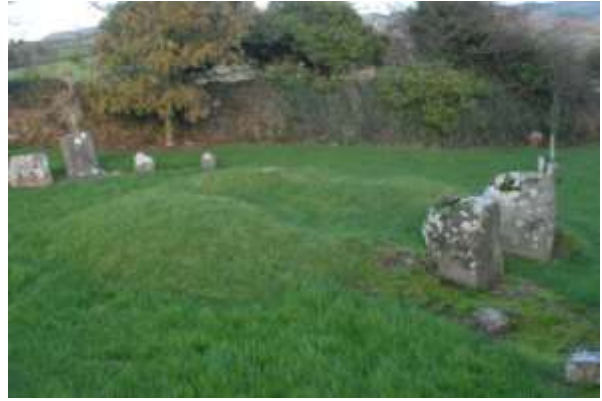
The monument appears to be in reasonable condition and requires no urgent or immediate works.

*Above: General views of the horsehow-shaped Saint Brigid's Bed.*

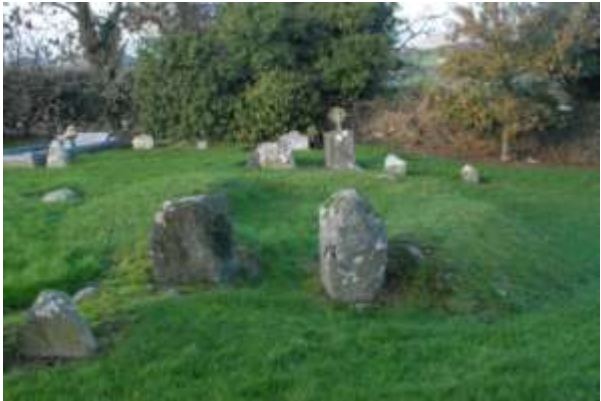
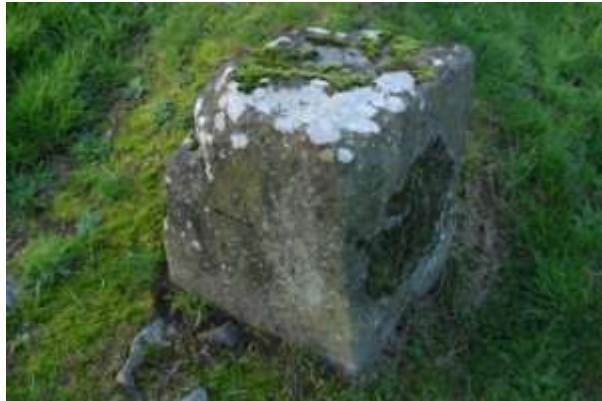
*Above: The monument appears in reasonable condition and does not require any immediate or urgent works.*
