## LOUTH COUNTY COUNCIL

### APPROPRIATE ASSESSMENT SCREENING REPORT

PROPOSED PLAYGROUND,

ST. DOMINIC'S PARK, DROGHEDA, CO. LOUTH

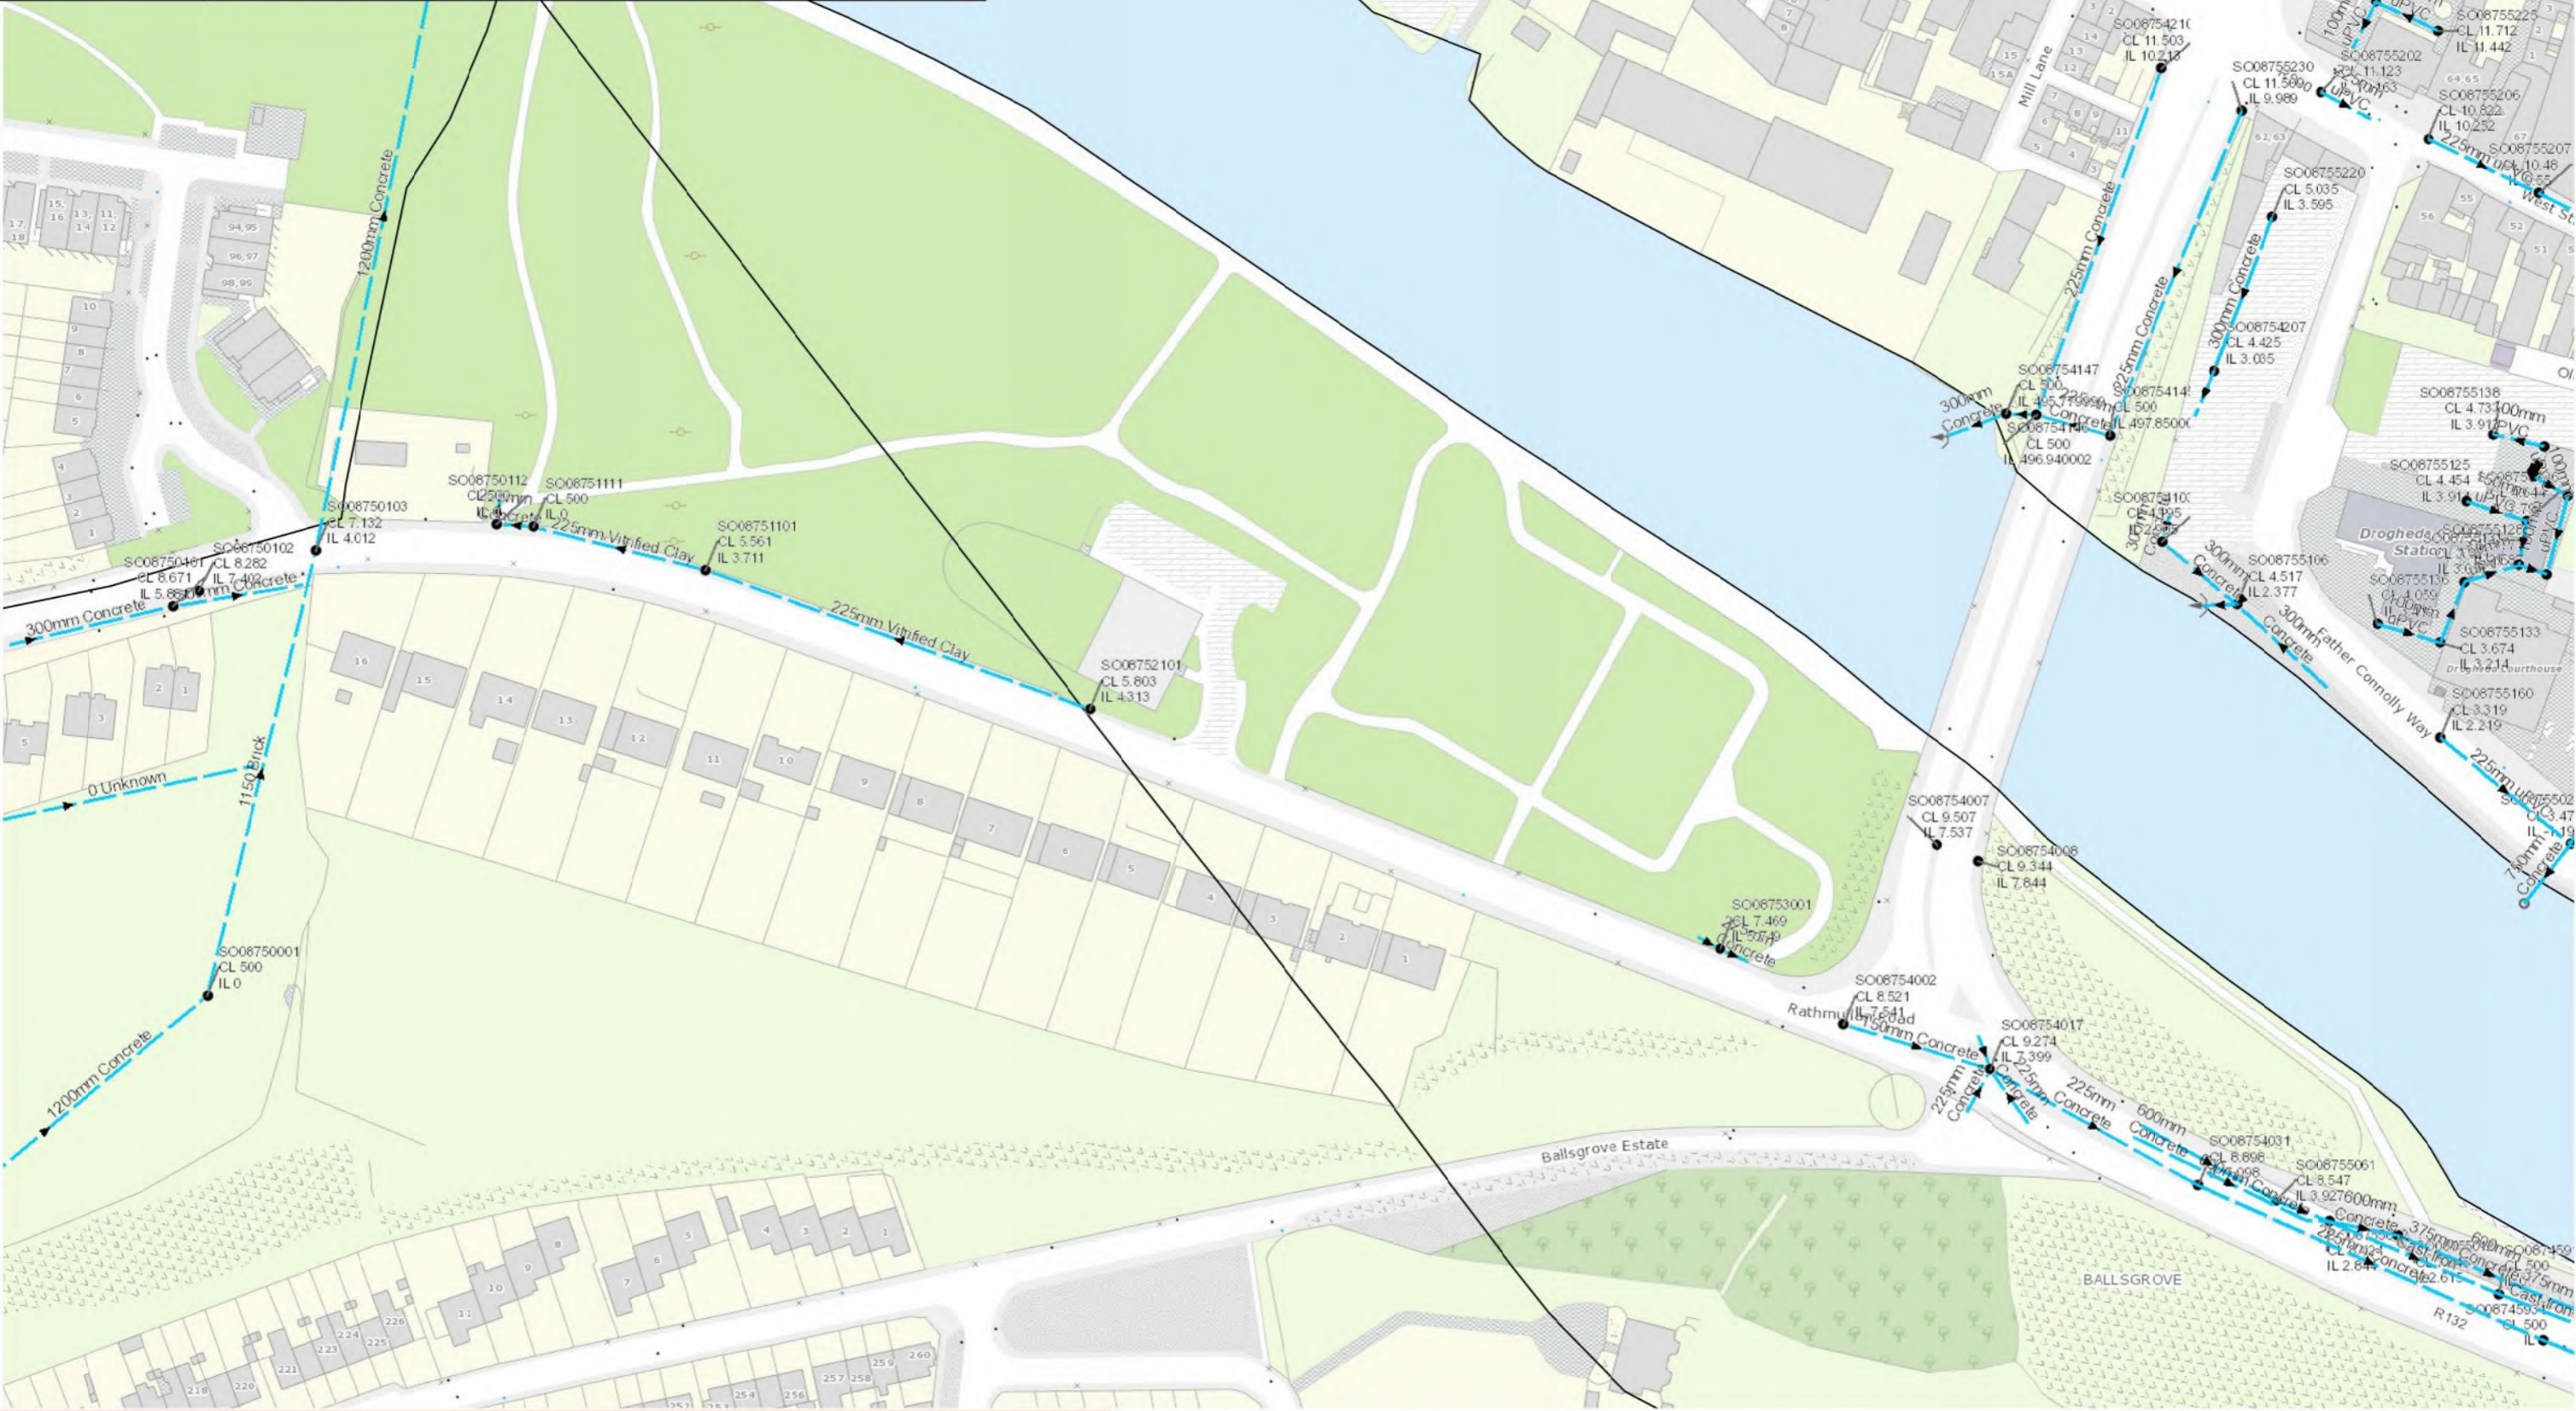
**IRISH WATER NOTICE**  
 Irish Water gives this information as to the position of its underground network as a general guide only on the strict understanding that it is based on the best available information provided by each Local Authority in Ireland. It should not be relied upon in the event of excavations or other works being carried out in the vicinity of the network. The onus is on the parties carrying out the works to ensure the exact location of the network is identified prior to mechanical works being carried out. Service pipes are not generally shown but their presence should be anticipated. © Irish Water

- IW Storm Layers**
- IW\_Storm\_SurfaceFittings
  - IW\_Storm\_OpenDrains
  - IW\_Storm\_Chambers
  - IW\_Storm\_SurfaceWaterMains
  - IW\_Storm\_Culvert
  - IW\_Storm\_Clean\_outs
  - IW\_Storm\_Detention\_Areas
  - IW\_Storm\_Discharge\_Points
  - IW\_Storm\_Inlet

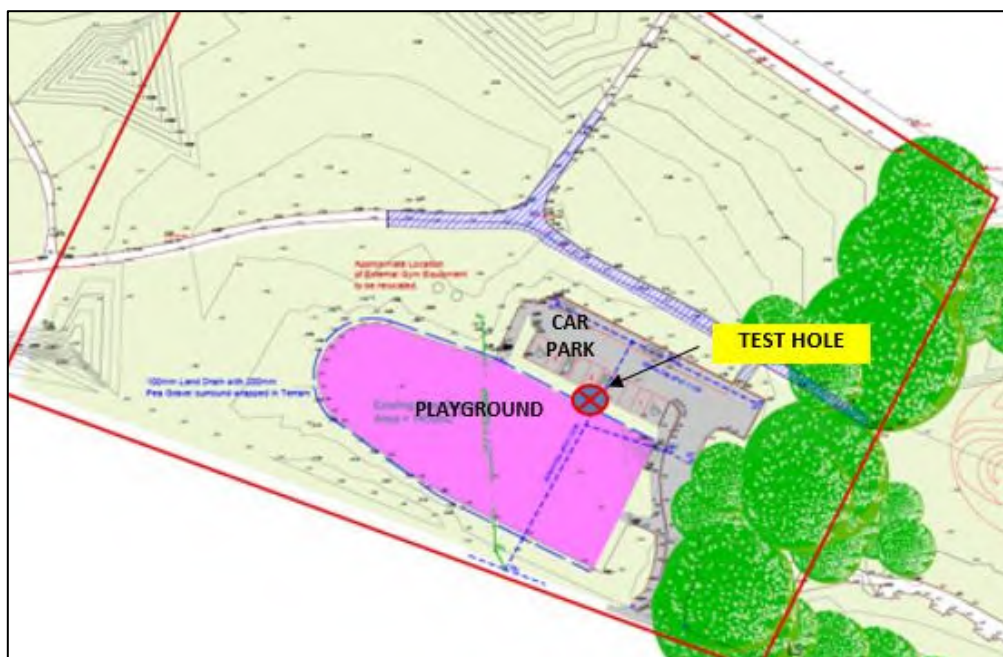
**Fig. 3.1 – Test Hole Location**

3.1 The infiltration characteristics of the underlying sub-soil at the site was determined by excavating a test hole (2.3m x 0.8m x 1.7m deep) within the site and carrying out an infiltration test in accordance with BRE 365. The test hole was located within the strip of grass to the north of the existing playground and south of the existing car park as shown on Fig.3.1. Views of the test hole are shown on Fig. 3.2

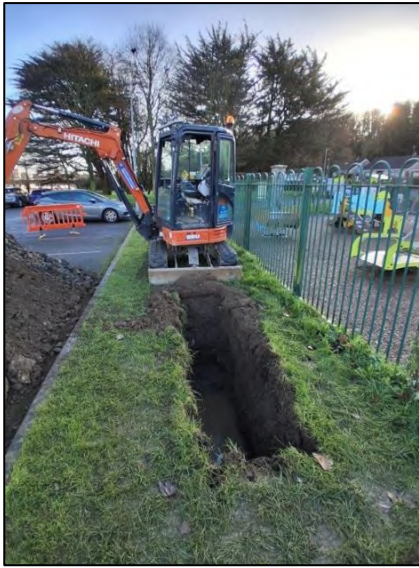
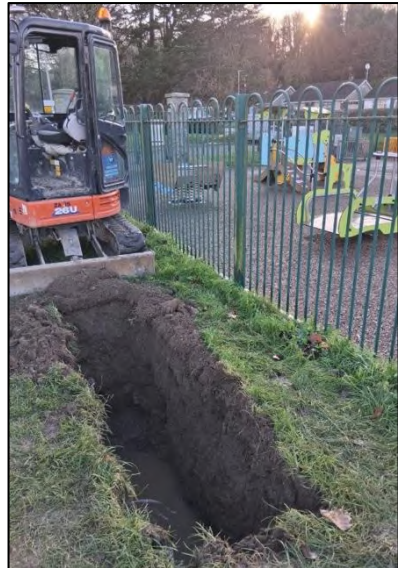
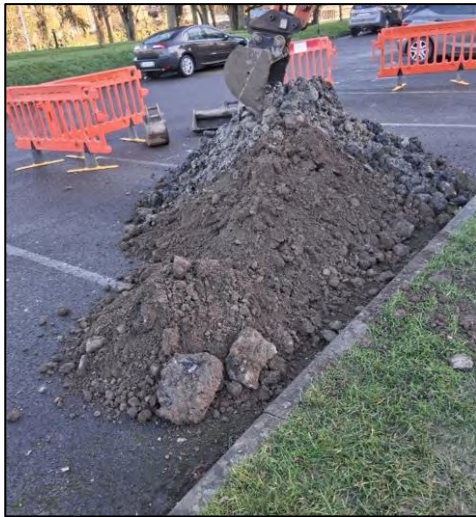
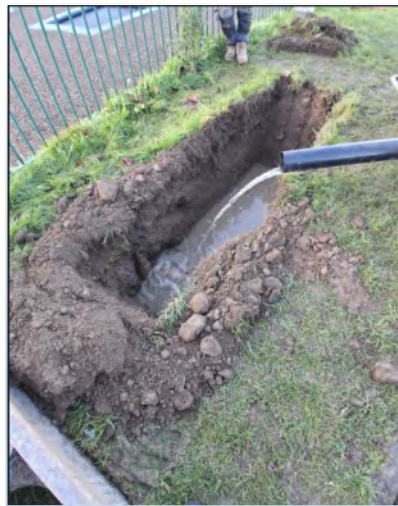
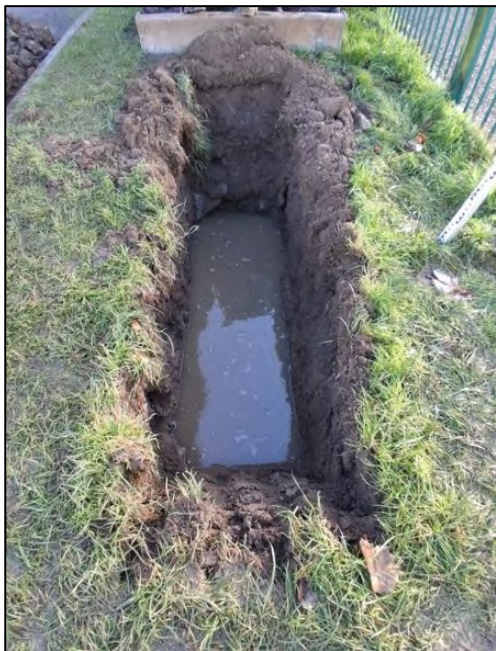
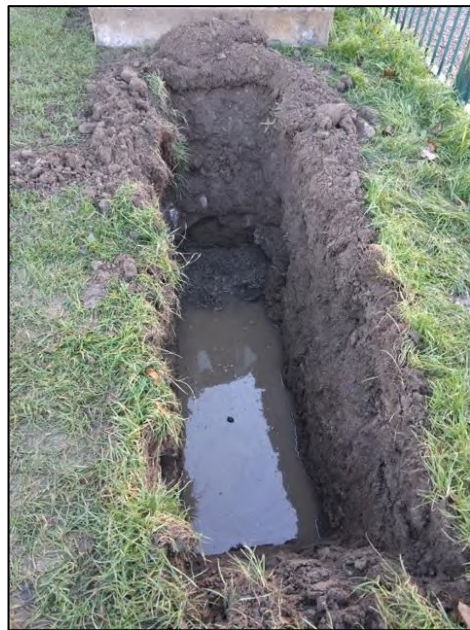
**Fig. 3.2 – Views of Infiltration Test Hole**

3.2 The subsoil was found to comprise of  
0m – 0.30m Topsoil  
0.3m – 1.3m Gravelly clay with cobbles  
1.3m – 1.7m Silty Clay

3.4 The initial drop of water occurred within the gravelly clay layer of the subsoil with the reduction in infiltration rate happening once the water level dropped into the lower silty clay layer. In essence, the test results show reasonable infiltration within the upper layers of the subsoil (< 1.3m) and more modest infiltration within the lower layer of the subsoil (>1.3m)

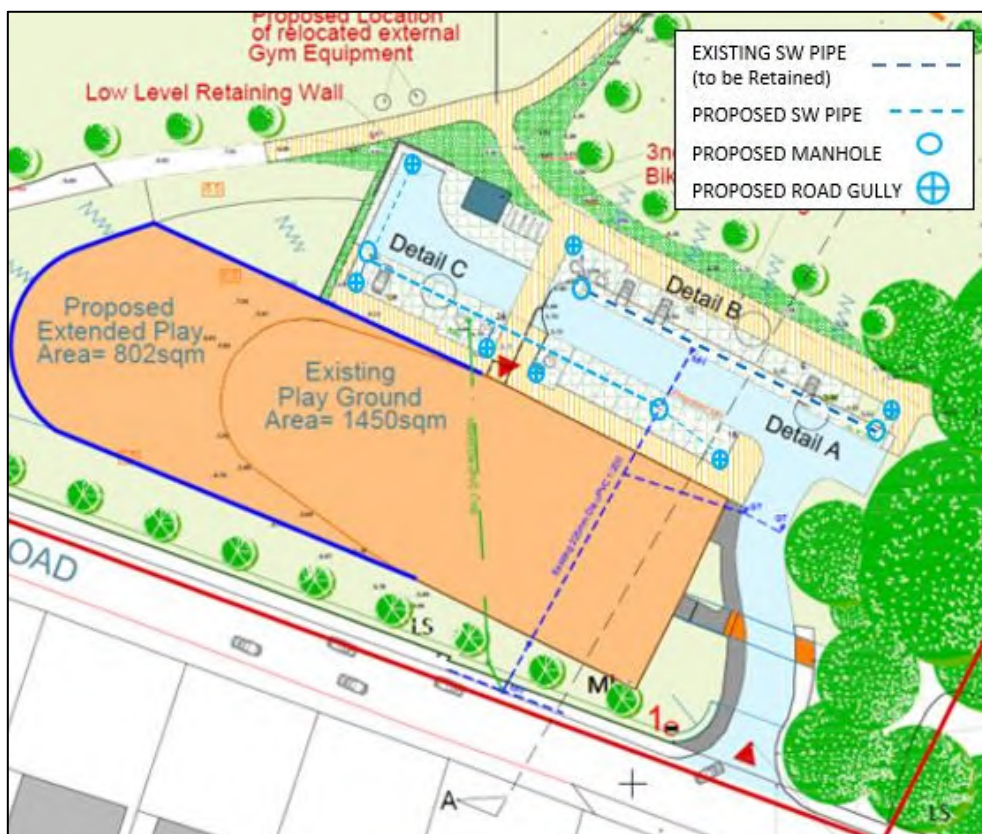
Fig.7.3 – Proposed Alterations to Existing SW Drainage Network (Schematic Only)

7.6 It is recommended that the existing surface water drainage piped network is retained and extended, as shown on Fig.7.3, to offer an emergency overflow route for run-off in the event of the performance of the permeable paving being reduced and/or to cater for extreme events during which permeable paving system is overwhelmed by extreme rainfall or the infiltration capacity of the surface has deteriorated due to build up of grit/silt.

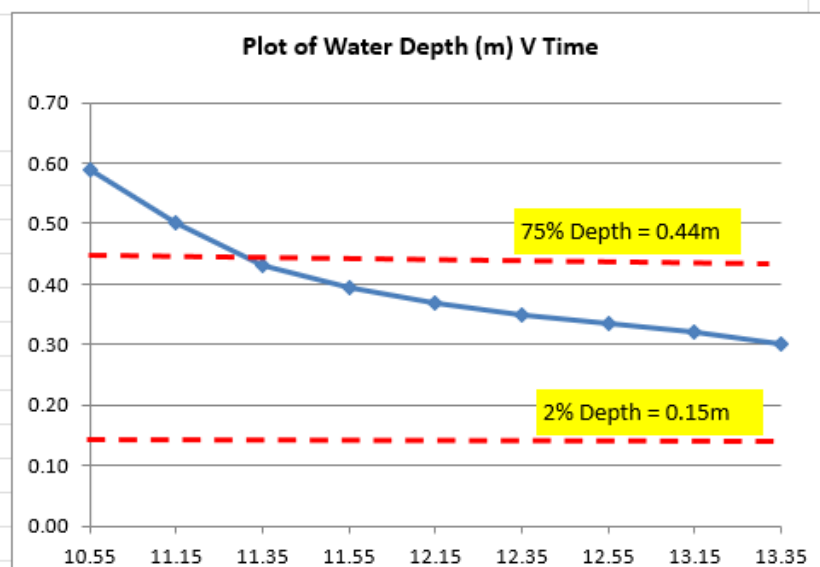
3.5 Calculations , carried out in accordance with BRE365, estimate the infiltration rate in each layer to be as follows:
