## **Rockview Farm**

### **Flood Risk Assessment**

Tobin Consulting Engineers

Final Report

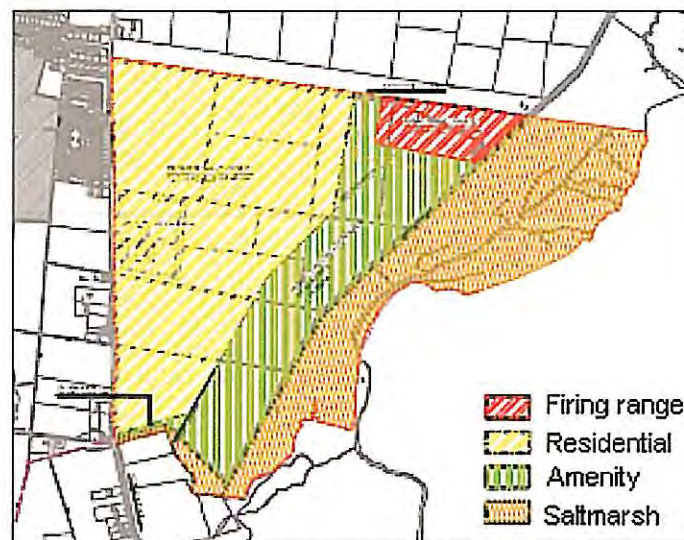
**Figure 1-3 – Overview of Proposed Site Development**

The site and general overview of the proposed development is shown in Figure 1-3 below. All of the area shown hatched including the saltmarsh but excluding the firing range is in ownership of Topfloor Properties. Only the green and yellow hatched areas are proposed for development. The developments proposed roughly entail amenity areas in the strip (green hatched) adjacent to the existing embankment and residential areas (yellow hatched) on the rest of the lands. The firing range and the saltmarsh will be maintained as they are. More details of the specific development can be found within the LAP.

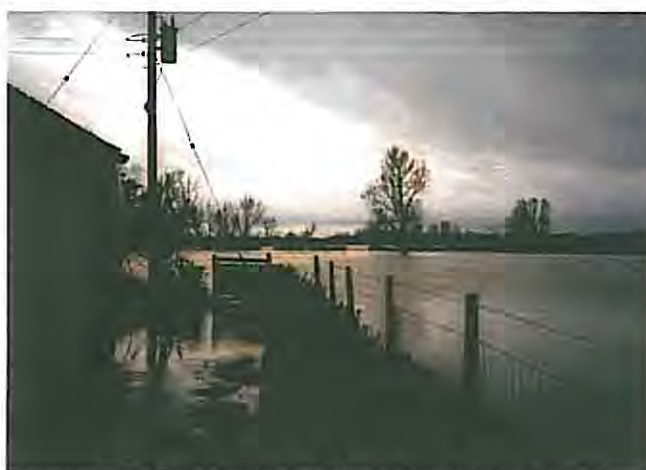
**Figure 1-5 – Flooding on 1<sup>st</sup> February 2002 as seen from Shore Road**

Historically there are records of coastal flooding having occurred at locations adjacent to the Rockview Farm site. However, it is believed that coastal flooding of the Rockview Farm site has never occurred. There is no evidence of breaches having occurred in the embankment at the site. The only recorded breaches in the embankment occurred during the February 2002 event and these were all located to the north of the site. The location of the breaches was recorded by a

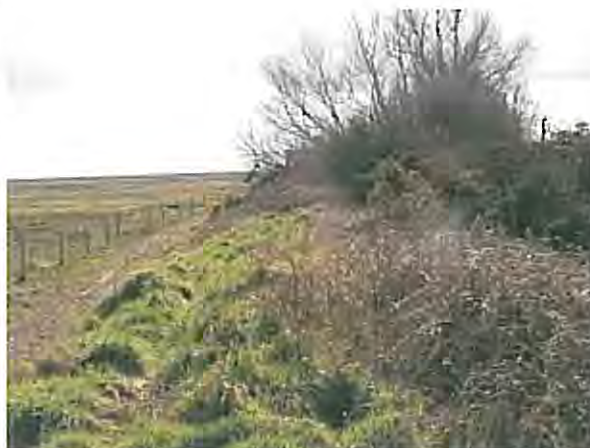
**Figure 3-1 Heavy vegetation on the embankment**

The start of the embankment is very heavily vegetated with grass, bushes, bramble and trees as shown on Figure 3-1 (chainage 20) making the shape and condition hard to assess. Over the remainder of the section the vegetation is similar with grass mainly on the front slope and thick brambles on the crest and back.

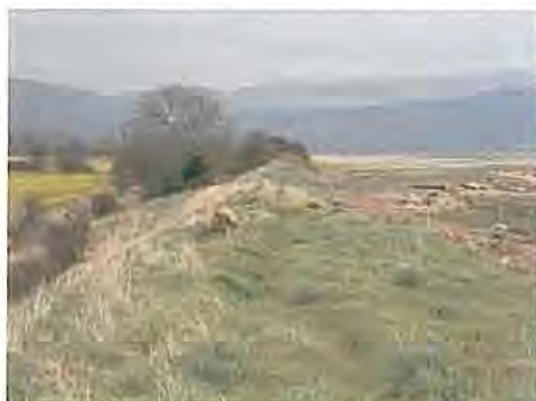
***Chainage 1300 looking north***

South of the drainage ditch outfalls the embankment profile changes significantly. The embankment becomes wider, more trapezoidal and more regular. Figure 3-3 shows the changes in the embankment around chainage 1300. The front face of the embankment is generally in a good condition over this stretch but is a bit steep. The ground along the front toe of the embankment is high, which gives the impression that the embankment is low. The crest is wide and between 3 to 5m. The back face is steep for most of the section but in a fairly good condition. There is a berm between the toe of the rear slope

and the drainage ditch of between 2 to 3 metres over all of this section. Most of this section of embankment is vegetated with grass and only a limited number of bushes.

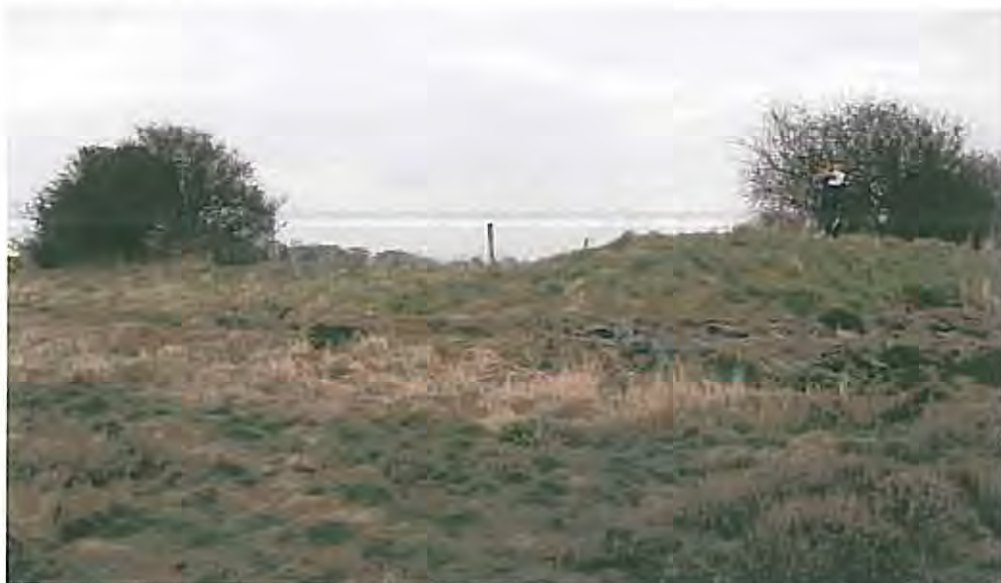
**Figure 3-4 Connection of the two embankments**

Over the last 50 metres of this section the condition of the embankment becomes much better. From chainage 2050 a smaller embankment extends perpendicular from the back of the main embankment towards the west. Figure 3-4 below shows the connection between the two embankments. The smaller embankment is referred to as section 5 and is described next.

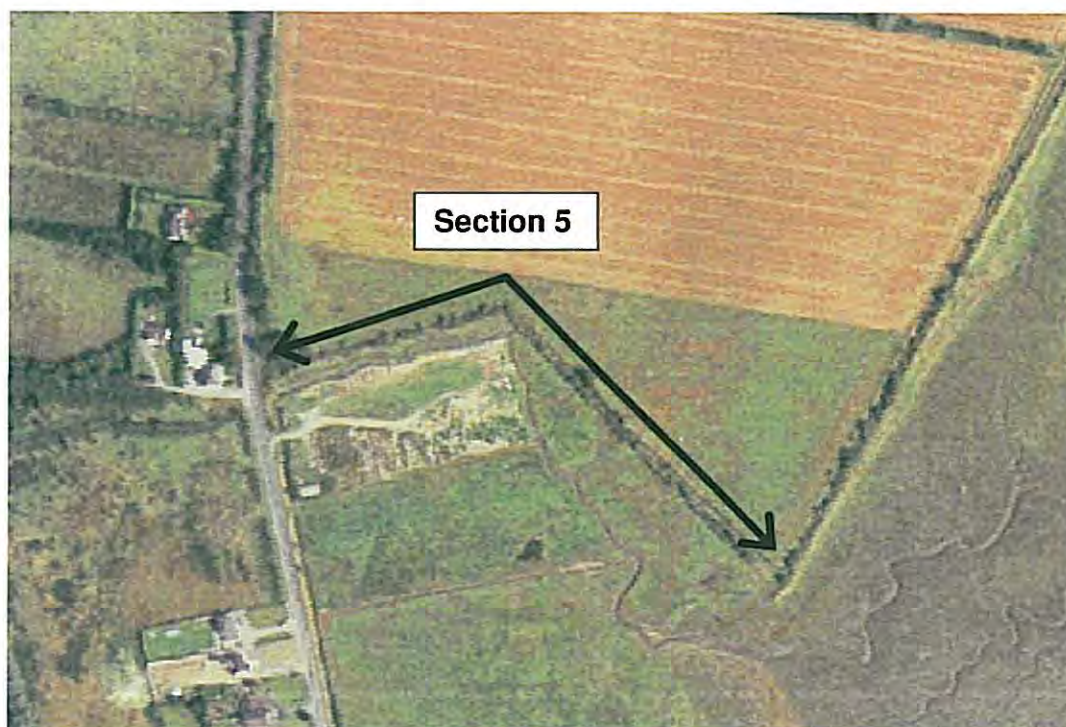
**Figure 3-5 Location of section 5**

This section of embankment is smaller and lower than the main coastal embankment extending from north to south. The ground levels in front of the embankment are high making the embankment look lower. There is heavy vegetation over most of the section making it extremely hard to view the core and assess the condition of the embankment. Figure C13 shows a typical cross-section through the embankment at chainage 2201. The shape of the embankment is trapezoidal. The front face is not too steep, but heavily covered in bushes as shown on Photo 59. The crest is around 1.5 to 2m wide and also covered in heavy vegetation, as can be seen on Photo 60. The back face is shown on Photo 61. It is steep and runs straight into a wide ditch at this location. In some places there is a small berm present between the toe of the back face and the ditch. Photo 62 shows the hinterland that is not in use at the moment.

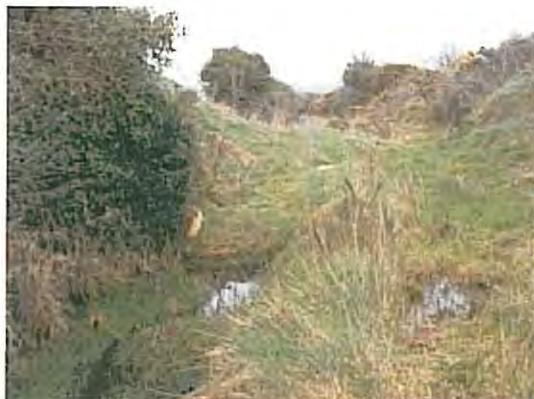
***Blockage of drainage ditch***

conditions. The situation chainage 835 at the back of the embankment is shown in Figure 3.6 below.

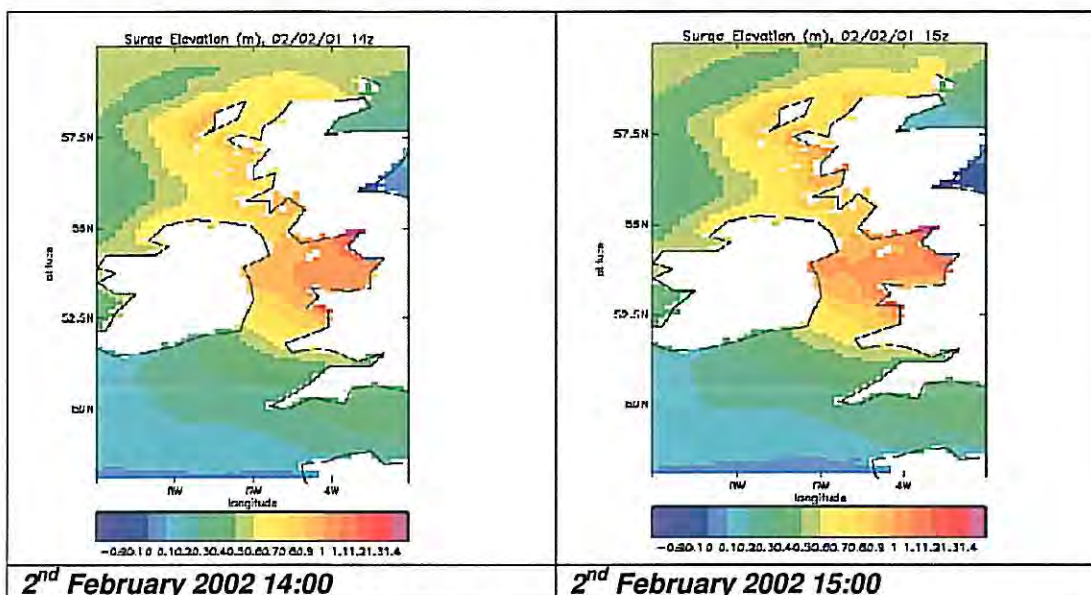
**Figure 4-1 Surge Plots UK Met Office Surge Model – February 2002 Event**

The storms in question included the event of the 1<sup>st</sup> February 2002 and the event of the 27<sup>th</sup> October 2004. Figure 4-1 below shows the surge output plots from the 1<sup>st</sup> February 2002 event. The colour bands on the plot represent the surge levels at 0.1m intervals. Whilst the plots are not of very high resolution, it can be seen that for the Dublin and Dundalk area, over the peak of the event, both areas either in the same colour band or are at most one colour band different ( $\leq 0.1\text{m}$  difference)

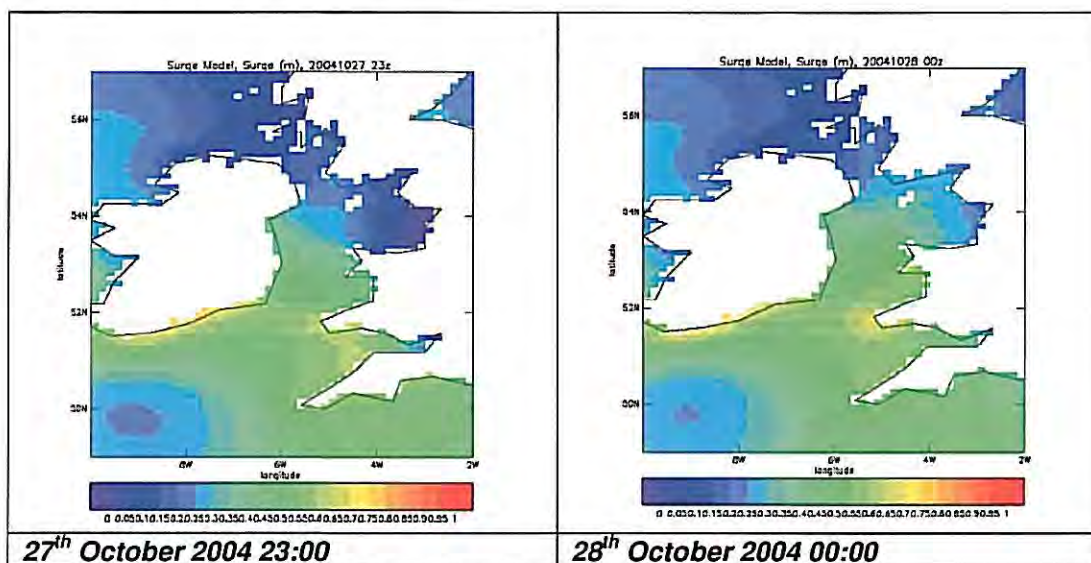
**Figure 4-2 - Surge Plots UK Met Office Surge Model – October 2004 Event**

and 2 bands. However, half hour after high water the areas appear to fall more within the same band. As such it is concluded that the surge on this occasion was similar between both sites and not more than 0.1 to 0.15m in difference.

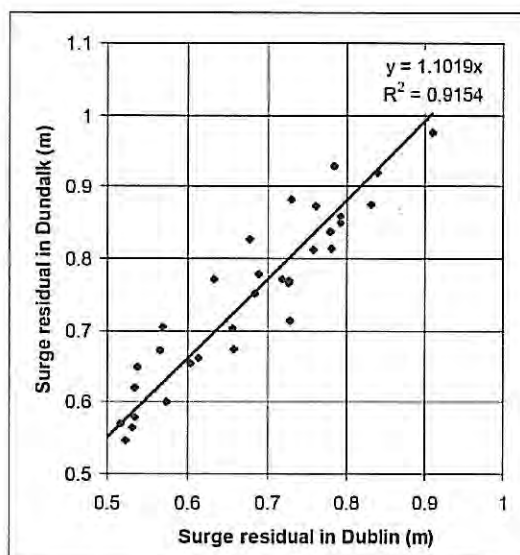
**Figure 4-3 – Correlation of Surge Residual for Dublin and Dundalk<sup>3</sup>**

Based on the results of the tidal surge modelling work for Ireland completed by RPS, an analysis of 25 storm surges was undertaken with surges greater than 0.5m. The surge residuals were extracted from the model for Dublin and Dundalk and plotted against each other, see Figure 4-3.

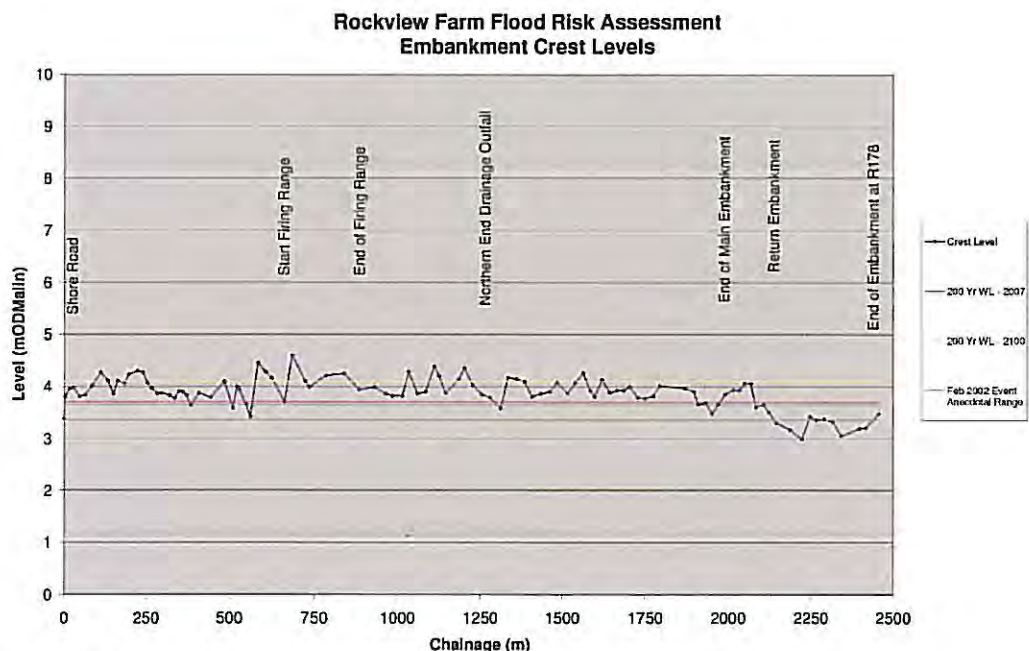
**Figure 5-1 – Longitudinal Section of Coastal Embankment**

The highest crest levels taken from the coastal walk topographic survey completed in December 2002 were taken and a longitudinal section produced from Shore Road to the Blackrock Road (R172). This longitudinal section is shown in Figure 5.1 below.

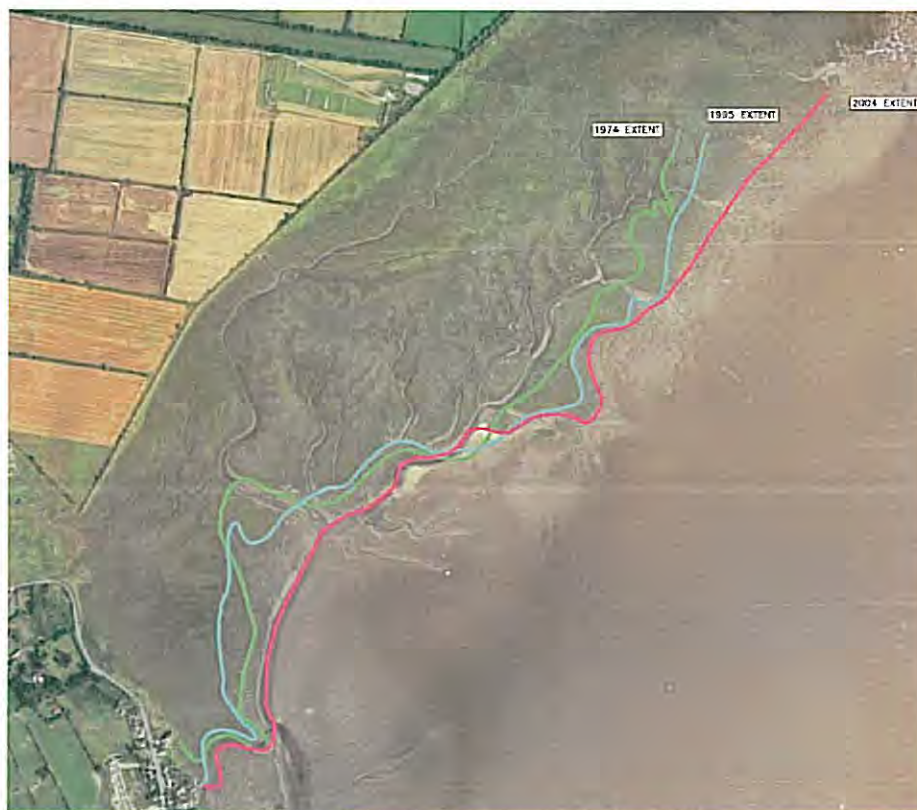
**Figure 5-2 Saltmarsh evolution over the years 1974, 1995 and 2004**

Figure 5.2 below shows the extent lines for each of these three dates on the 2004 aerial photograph. From the figure it can be seen that from 1974 to 1995 the saltmarsh accreted in most places with the exception of south of the project site. From 1995 to 2004 there has been a slight increase in the extent of saltmarsh over the whole frontage except for a small spot in the centre.

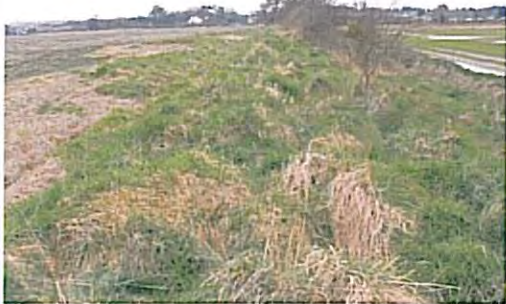
Photo 49 – chainage 1717  
Uneven crest bad condition and grass  
berm in distance

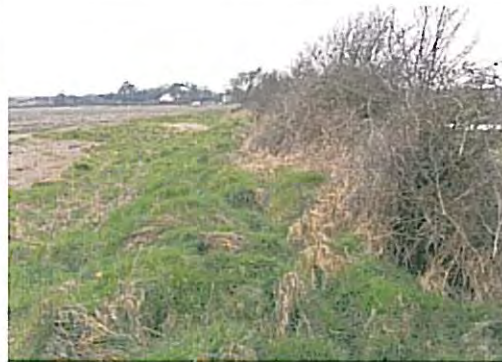
Photo 50 – chainage 1746  
Start of heavy vegetation

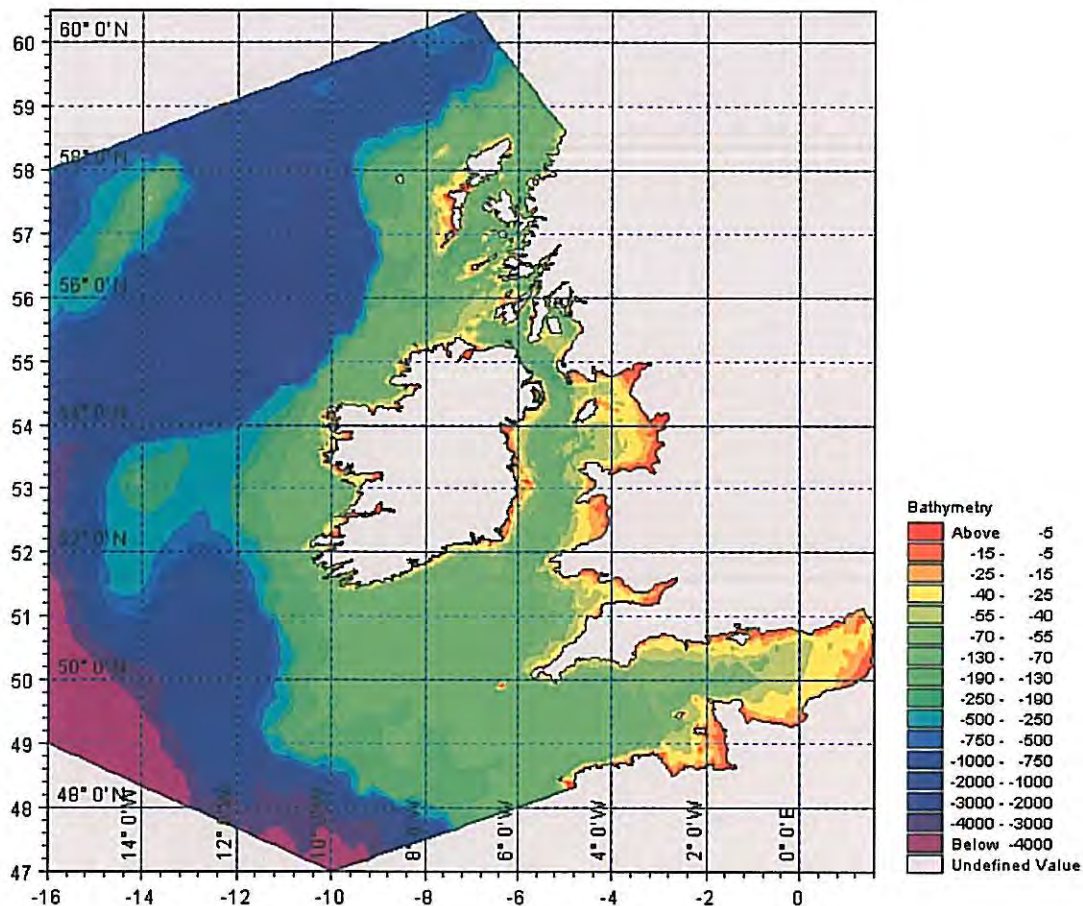
**Figure 2.1: Extent of Tidal Surge Model for Ireland**

The RPS Consulting Engineers' tidal surge model for Ireland stretches from the Northwestern end of France including the English Channel to Dover to 16° West into the Atlantic, including the Porcupine Bank and Rockall. In the south it reaches from the Northern part of the Bay of Biscay to just south of the Faroes Banks in the North. Overall the model covers the Northern Atlantic Ocean up to a distance of 600km from the Irish Coast as illustrated in Figure 2.1.

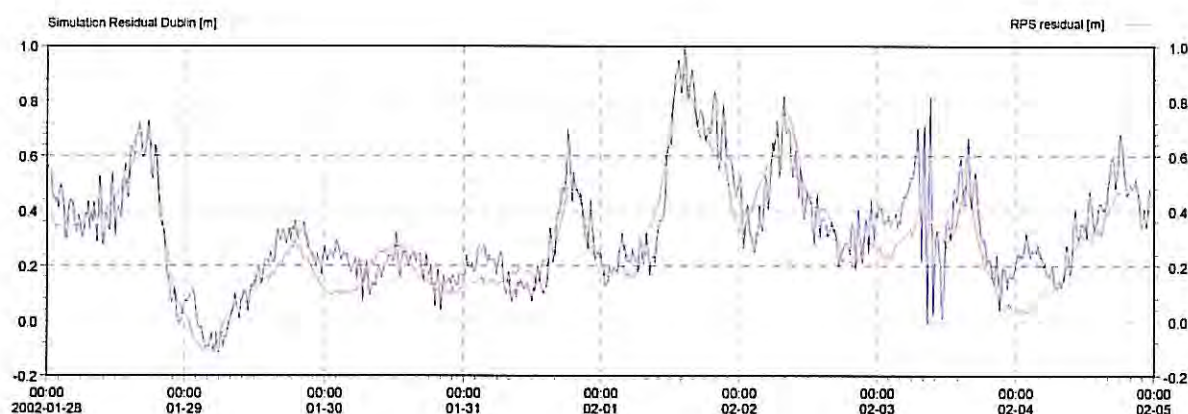
**Figure 2.2: Validation of Tidal Surge Model – Surge Residual Dublin Feb 2002**

The tidal surge model was validated against measured data mostly from UK NTSLF tide gauges. An example of the surge model simulation compared with measured surge residuals is shown in Figure 2.2; where the surge residual extracted by RPS from the measured water level is shown by the blue trace and the red trace indicates the simulated value at the same location in Dublin Bay. Figure 2.3 shows the comparison of surface elevation between the simulation (red trace) and measured values (blue trace) within Dublin Bay for the same period.

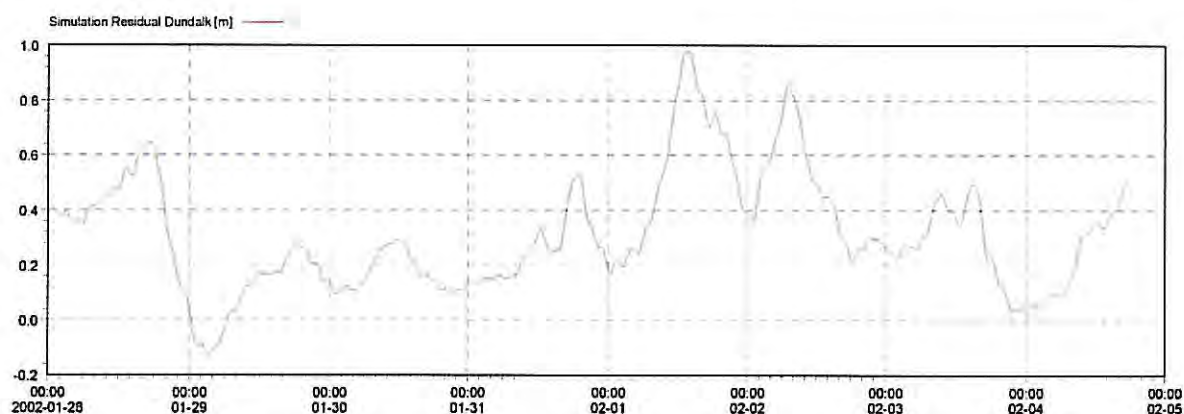
**Figure 3.1: Simulated Storm Surge Residual Dundalk Feb 2002**

The tidal surge model for Ireland was used to undertake a number of storm surge simulations; using the tidal and surge model and applying meteorological data from the ECMWF operational surface analysis and forecast in addition to the tidal conditions for the relevant period. The following analysis is based on 25 storm simulations with surge values above 0.5 metre covering the period 1990 to 2005, whereby the surge residual was extracted from the surge simulation for both the entrance to Dublin Harbour and Dundalk Bay. An example is given in Figure 3.1 which shows the simulated surge residual for Dundalk during February 2002 (Figure 2.2 and Figure 2.3 showed the validation plots for Dublin at this time).

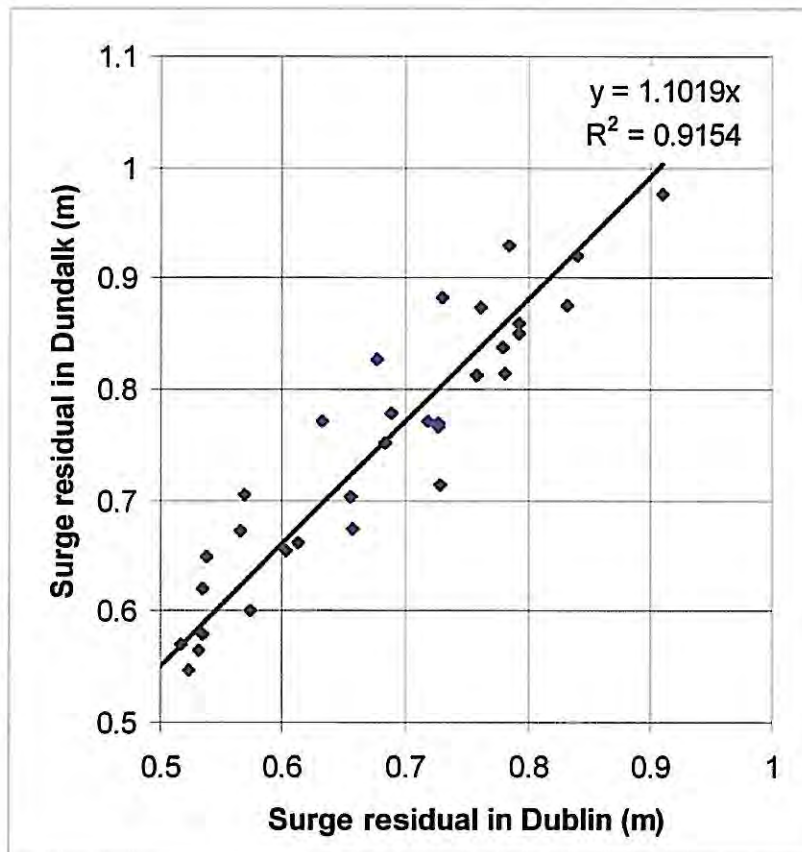
**Figure 3.2: Correlation of Surge Residuals for Dublin & Dundalk**

The correlation between the different storms is illustrated in Figure 3.2. Using linear regression, a factor of 1.1 was estimated for surge water levels in Dundalk Bay relative to Dublin Harbour. It has to be noted, that the scatter in the surge residual diagram is greater above the diagram (for Dundalk) compared to Dublin.

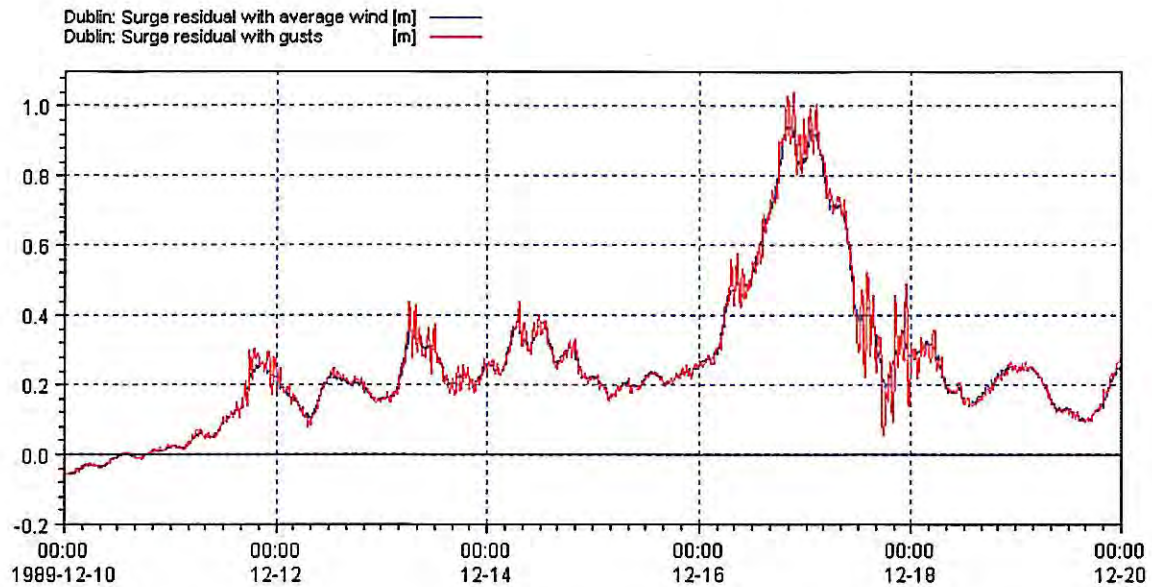
**Figure 3.3: Surge Residual Illustrating Seiching in Dublin Bay**

Figure 3.3 shows the comparison of surge residual for Dublin Bay with average wind (blue trace) and with the influence of gusts (red trace). The surge residual using the 3 hourly wind data resulted in a maximum elevation of 0.94, whereas with the 30 minute wind data a maximum elevation of 1.04 was simulated.
