**Retirement Village at Dundalk Stadium  
Amended Louth Draft County Development Plan 2021-2027**

## Condition Survey Report

**Summary:** Condition Survey Report  
for Original Bar and Stables  
Dundalk Stadium.

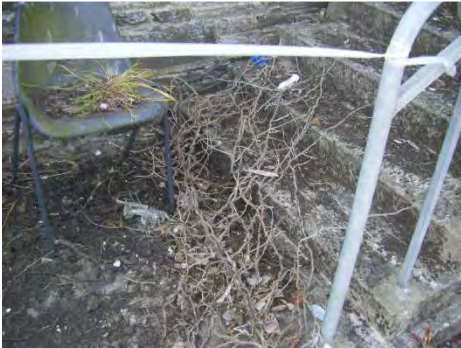
As Above	High
4.1.6	The steps leading up to the front entrance door are unsightly and in need cleaning.

All rubbish and debris to be removed, steps to be washed down and all gaps between the steps joints are to be re-pointed with cement.	High

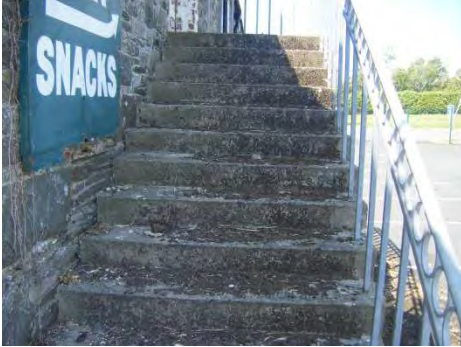
Ref No:	Condition:	Picture:	Repair:	Priority:
4.1.7	As Above

As Above	High
4.1.8	The door is in poor condition and is in need of immediate repair. The base of the door does not reach the floor inside leaving a passage for moisture and vermin.

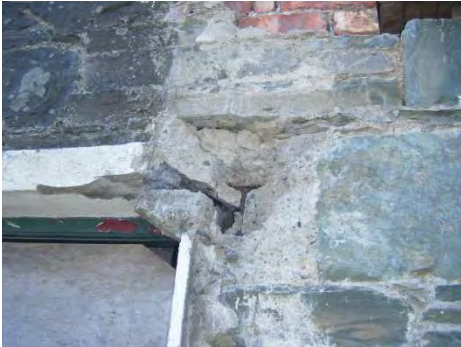
As Above	High
4.1.17	As Above Picture illustrates damaged as a result of demolition works.

As Above	High
4.1.18	As Above Picture illustrates damaged as a result of demolition works.

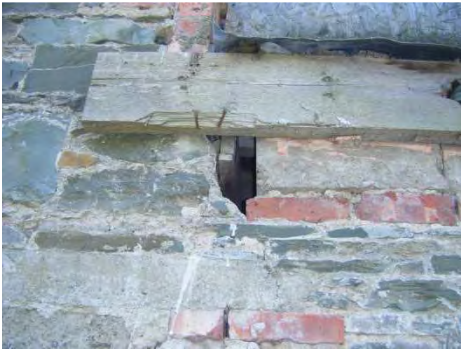
Ref No:	Condition:	Picture:	Repair:	Priority:
4.1.19	As Above. Picture illustrates damaged as a result of demolition works.

As Above	High
4.1.20	As Above. Picture illustrates damaged as a result of demolition works.

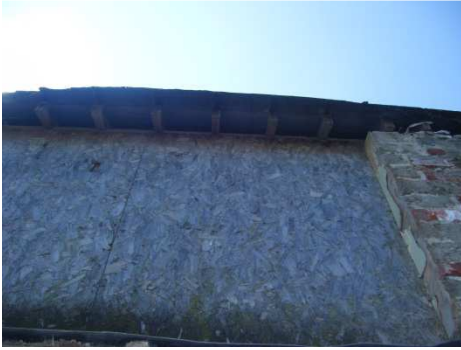
As Above	High
4.1.21	Regarding the existing blocked up area.

This blocked up rear area can be unblocked and a new double glazed window unit fitted to prove natural light and ventilation.	Optional

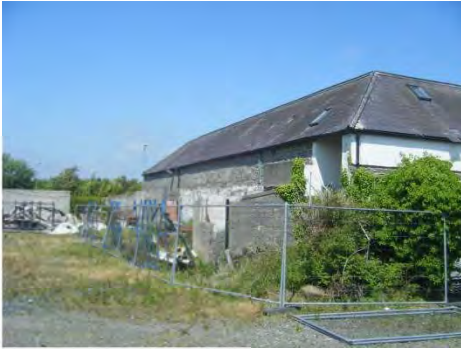
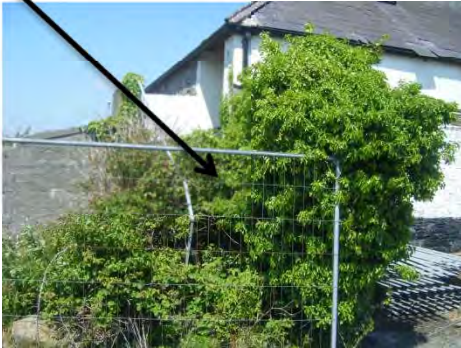
Waste material to be removed off site.	Med
4.2.2	The fire escape to is not accessible due to extensive over growth.

All of the saplings, trees and over growth to be removed off site and a clear escape pathway to be maintained.	High

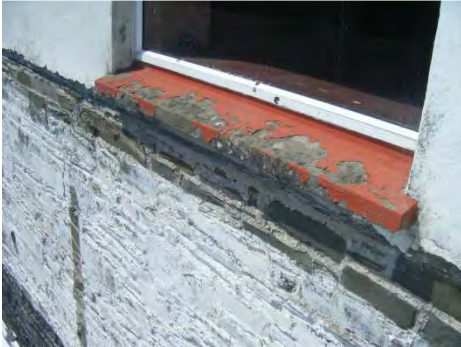
Ref No:	Condition:	Picture:	Repair:	Priorit
4.3.3	As Above

As Above	High
4.3.4	Timber surrounding window in poor decorative condition.

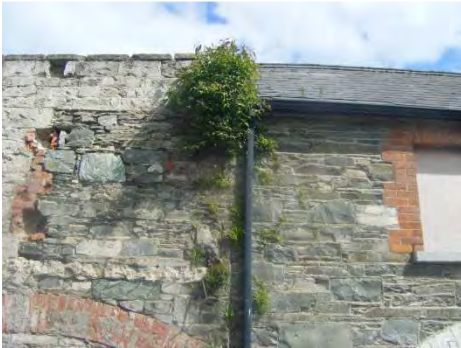
These blocked up areas can be un-blocked and reinstated as previous or alternatively a new double glazed window unit fitted to prove natural light and ventilation.	Optional
4.4.3	Weeds are growing out of the main Guttering.

Clean out all gutters	High

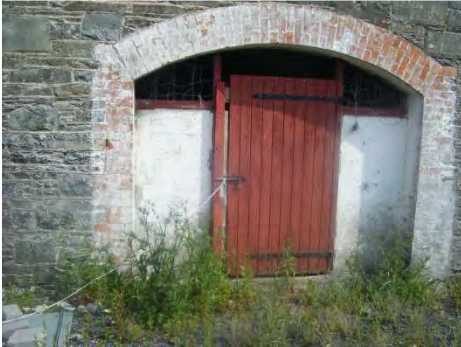
<p>Strip old paint, sand down, repair gaps &amp; notches and re-paint.</p> <p>The door locking mechanisms also need to be replaced.</p> <p>The existing wall surface needs to be cleaned and painted with breathable emulsion exterior paint.</p>	High
4.4.6	As Above

As Above	High

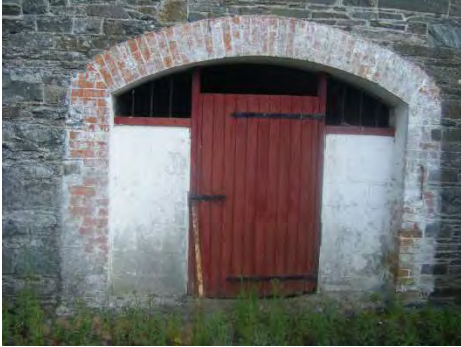
Ref No:	Condition:	Picture:	Repair:	Priority:
4.4.7	As Above

As Above	High
4.4.8	Existing steel correlated door is unsightly.

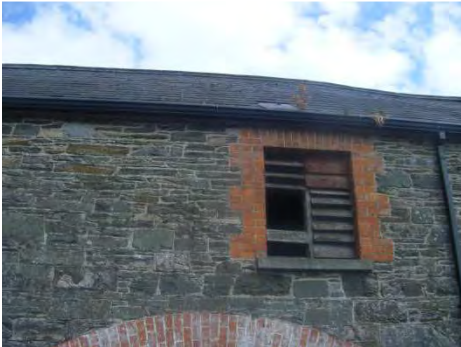
Remove timber and replace with new. Strip door and Re-paint and finish or remove existing and replace with matching stone mirroring surrounding area.	High
4.4.9	Existing timber shutter windows in poor condition. Large areas are missing pieces.

<ol style="list-style-type: none"><li>1: Replace timber panels with new. Clean down the existing frames and paint</li><li>2: Remove the existing windows and frames and replace with new Upvc double glazed window units.</li></ol>	High

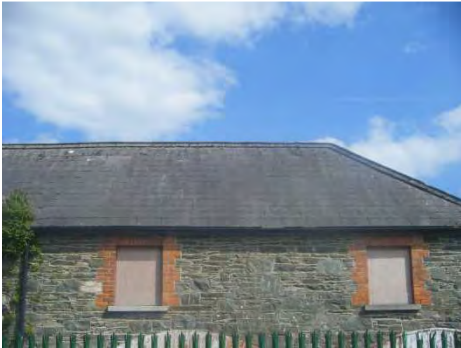
Ref No:	Condition:	Picture:	Repair:	Priority:
4.4.10	As Above	 	As Above	High
4.4.11	All the windows are blocked up and the glass is broken. This impedes natural daylight and ventilation entering the room.	 	Unblock the windows and either; <b>1:</b> Replace glass panels with new. Clean down the existing frames and paint <b>2:</b> Remove the existing windows and frames and replace with new Upvc double glazed window units.	High
4.4.12	As Above

As Above	High

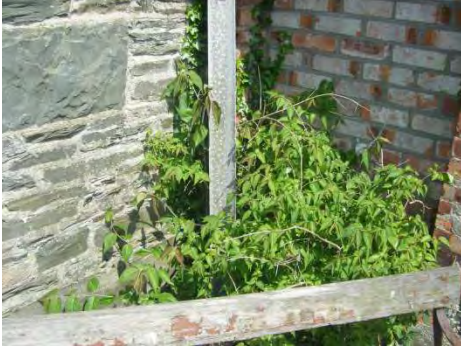
Ref No:	Condition:	Picture:	Repair:	Priority:
4.5.3	Extensive over growth along entrance path.

All of the saplings, trees and over growth to be removed off site and a clear escape pathway to be maintained.	High
4.5.4	Deterioration of mortar joints.

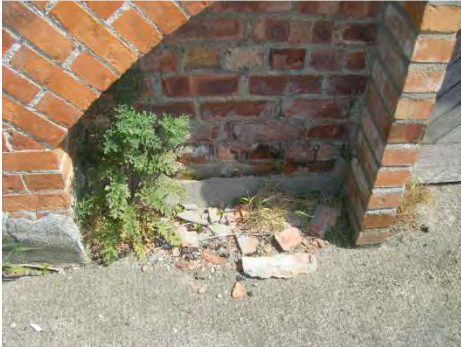
Rake out the joints on which movement has taken place and then repoint.	High
4.5.5	The plinth surround is in very poor condition and requires repair.

Remove all detached, cracked, crumbling or aking plaster. Brush down background to remove dust and loose particles. Apply appropriate surface and replace plinth.	High

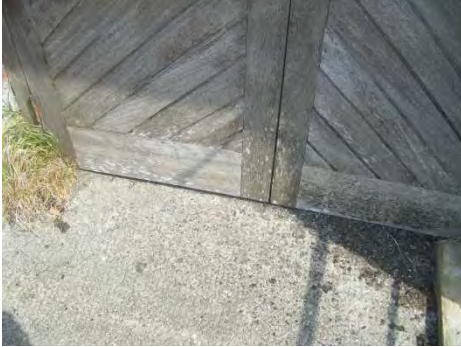
Ref No:	Condition:	Picture:	Repair:	Priority:
4.5.6	The door is in poor condition and is in need of immediate repair. The base of the door does not reach the floor inside leaving a passage for moisture and vermin.

Should the door be refurbished then the door should be sanded down, any cracks sealed with suitable wood filler and the door to be re-painted. The door should also be draught proofed.	High
4.5.7	Consideration will need to be given to the very poor condition of the existing handrails.

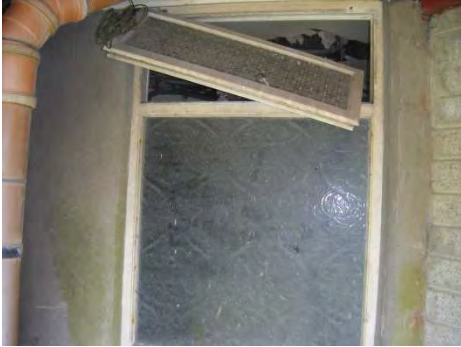
Ref No:	Condition:	Picture:	Repair:	Priority:
4.5.11	Single glazed, top hung casement window is in poor condition.

<ol style="list-style-type: none"><li>1. Window need to be cleaned inside and out. Window requires maintenance to ensure that they can open and close properly. Re-instate all missing and damaged latches and hinges to the window. OR</li><li>2. Replace with new Upvc double glazed window units.</li></ol>	High

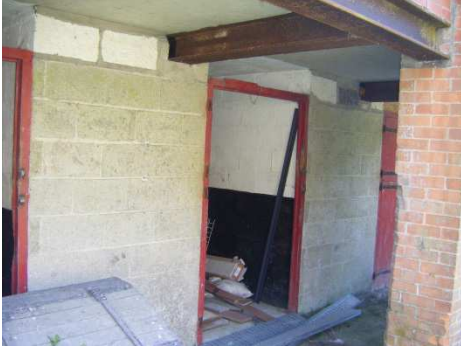
Ref No:	Condition:	Picture:	Repair:	Priority:
4.5.14	Stable doors are in poor condition with a vast amount missing altogether in places

Ref No:	Condition:	Picture:	Repair:	Priority:
4.5.16	See Ref no. 4.5.14

Existing external doors and frames need to be replaced and painted.	High
4.5.15	This door does not open or close properly. Rear external exit doors are in very poor condition with wet rot on the lower part of the door and frame.

See Ref no. 4.5.14	High
4.5.17	AS Above

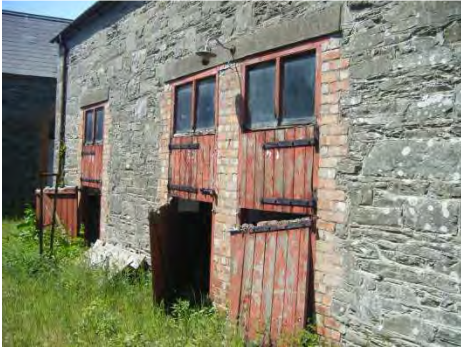
As Above	High
4.5.18	Doors on centre structure are in extreme poor condition with evidence of wet rot.

Existing external doors and frames need to be replaced and painted.	High

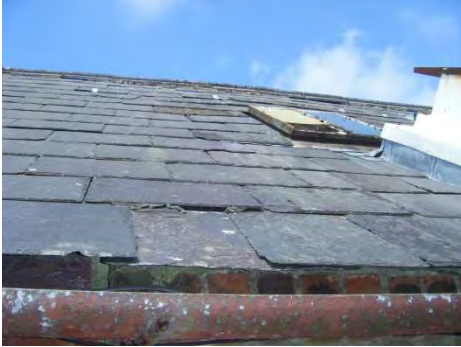
Ref No:	Condition:	Picture:	Repair:	Priority:
5.1.1	The main roof slates appear to be in good condition, however upon closer inspection of the natural roof slates some slates appear to be slipping from there fixed position.

A competent building contractor should be retained to overhaul any defects associated with the main roof as previously described.	High
5.1.2	As Above

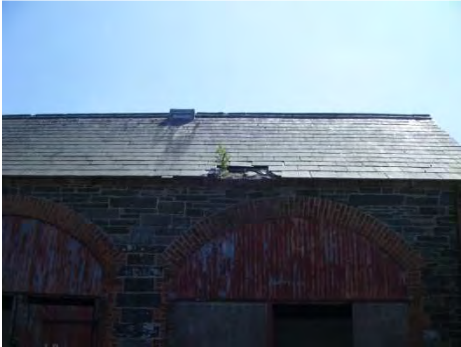
As Above	High
5.1.3	As Above

As Above	High

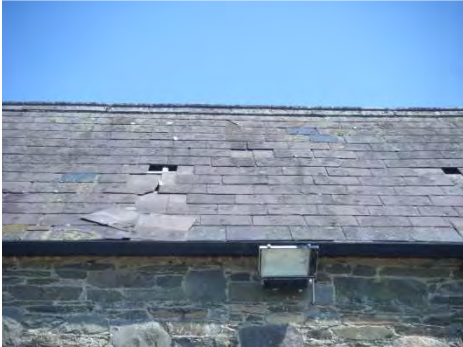
Ref No:	Condition:	Picture:	Repair:	Priority:
5.1.4	As Above

As Above	High
5.1.5	As Above

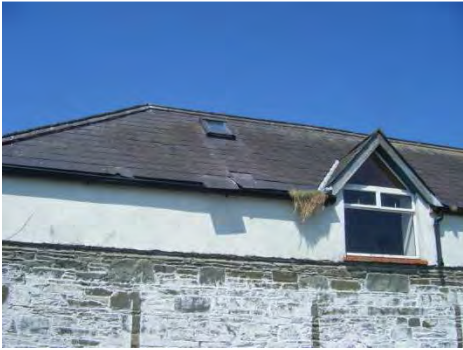
As Above	High
5.1.6	As Above

As Above	High

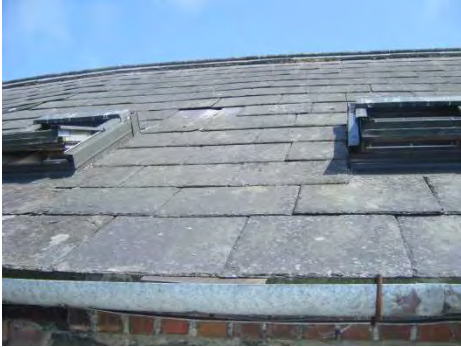
Ref No:	Condition:	Picture:	Repair:	Priority:
5.1.7	<p><b>Closer inspection of the defective guttering:</b></p> <p>The Cast iron guttering has completely failed.</p>

<p>These cast iron gutters need to be replaced immediately.</p> <p>Further investigation will be necessary to determine the extent of any deterioration of the main roof timbers within the vicinity of the leaking guttering.</p>	High
5.1.8	<p>Clear indication that there is a serious defect of the Roof as it is starting to sag/bow in areas.</p>

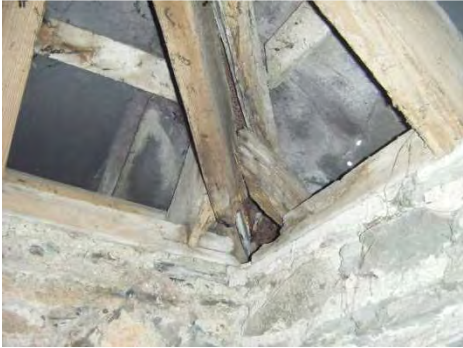
Ref No:	Condition:	Picture:	Repair:	Priority:
5.1.10	Again picture shows extent of timber decay

Where the timbers show signs of wet rot damage, they should be removed and replaced with new treated timbers. The remaining timbers should be treated with an anti-fungal spray within a 1 metre radius of the affected area.	High
5.1.11	As Above

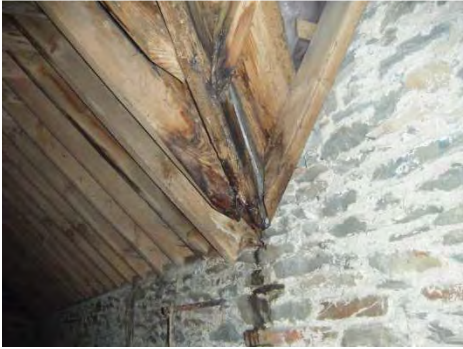
As Above	High
5.1.12	As Above

As Above	High

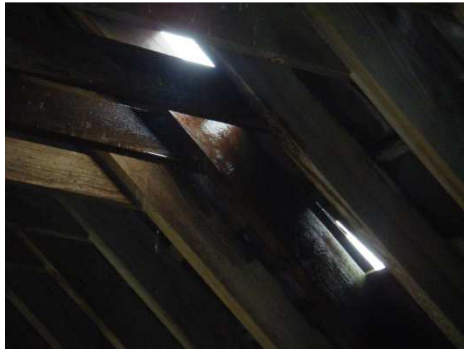
Ref No:	Condition:	Picture:	Repair:	Priority:
5.1.13	Picture illustrates the there is no felt covering under natural roof slates which is common for the structures of this age. It also shows clearly where some slates appear to be slipping from there fixed position.

<b>Note:-</b> The client should expect that part or all of the main roof covering and partial timber rafters, may need to be replaced and should take account of this.	High
5.1.14	As Above

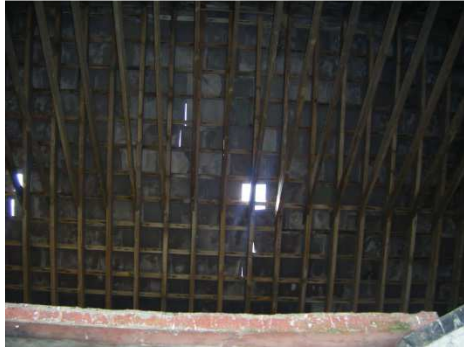
As Above	High
5.1.15	As Above

As Above	High

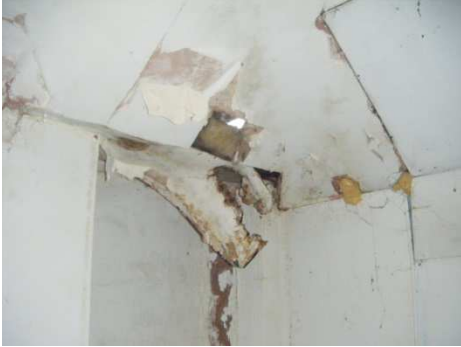
Ref No:	Condition:	Picture:	Repair:	Priority:
6.1.1	There is a major leak on the front elevation part of the roof/ceiling and will need to be investigated further.

The source of water ingress needs to be rectified. The client should retain a competent building contractor to investigate and re-roof the damaged main roof covering. All defective timbers need to be removed and replaced with new treated timber rafters and slating laths.	High
6.1.2	The cast Iron roof vent has rusted right through and is in very poor condition.

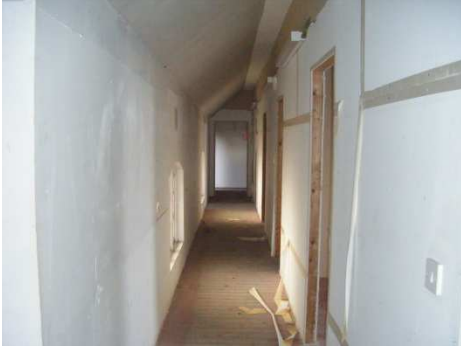
Ref No:	Condition:	Picture:	Repair:	Priority:
6.1.4	<p>Interior dividing walls are in poor unfinished state.</p> <p>The timber floorboards are in relatively good condition but they are dirty and in need to be cleaned. Also they have some holes and gaps that need to be fixed.</p>

<p>Finish interior walls with skim plaster and insert new joinery and ironmongery and finish. Clean down remaining walls and ceiling and repaint same making good. Alternatively remove dividing partition walls and reinstate as was. Clean down remaining walls and ceiling and repaint same making good.</p> <p>Repair the gaps in the floor boards.</p> <p>Sand, clean down and cover with new carpet or other floor finish as agreed by the client.</p>	High

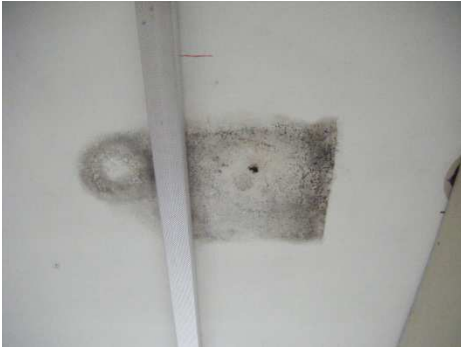
6.1.5	<p>Deterioration of slate roof has led to clear leakage areas and evidence of damp penetrating ceiling plaster.</p>

<p>Carry out all necessary remedial works ensuring the roof is now watertight.</p> <p>Fully insulate the space between the roof joists. Cut out affected area and replace with 12mm foil backed plasterboard, tape joint, plaster skim and paint.</p>	High

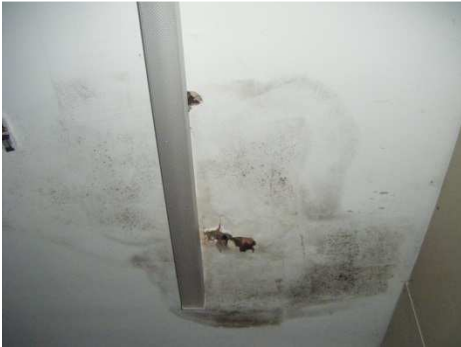
6.1.6	<p>As Above</p>

<p>As Above</p>	High

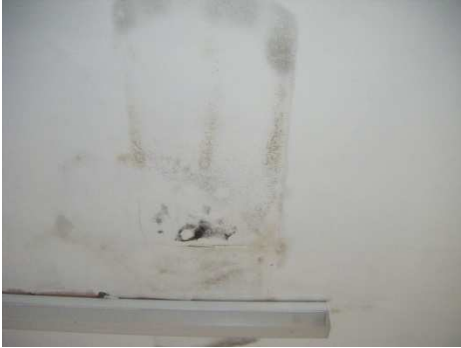
Ref No:	Condition:	Picture:	Repair:	Priority:
6.1.7	As Above

As Above	High
6.1.8	Bathrooms on First floor are grubby and unsightly. The sanitary fittings are dirty and there is evidence of vermin present.

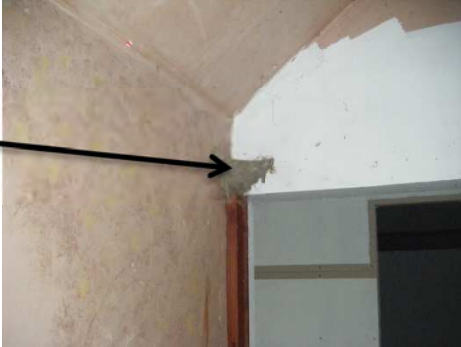
Remove all rubbish and cart away. Clean and repair existing sanitary ware or re-fit new sanitary ware (if required by the client). Clean down walls and ceilings, repaint.	High
6.1.9	A number of bird nests can be found in the property.

Remove nests and clean down walls and ceiling and repaint same making good.	High

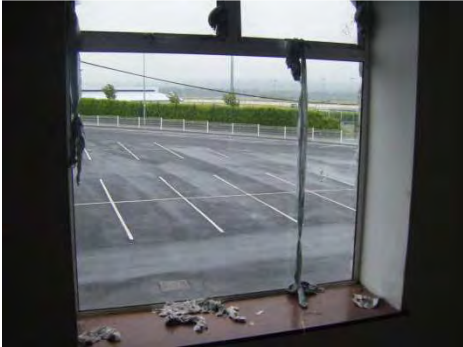
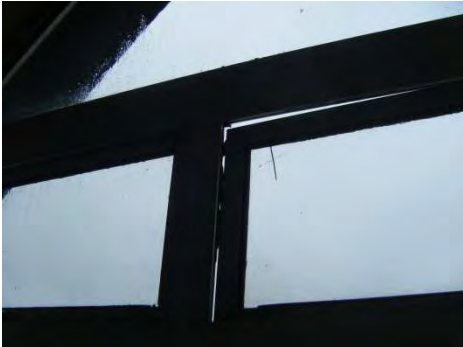
Ref No:	Condition:	Picture:	Repair:	Priority:
6.1.10	<p>Windows are in very poor condition. Some are windows do not have any locking mechanisms and brackets and seals have failed.</p> <p><b>Note:-</b> These windows are very much out of date single glazed and in relatively poor condition.</p>

<p>Window need to be cleaned inside and out. Window requires maintenance to ensure that they can open and close properly. Re-instate all missing and damaged latches and hinges to the window.</p> <p><b>Recommend:-</b> Replace windows with double glazed units to</p> <ol style="list-style-type: none"><li>1. improve heat retention</li><li>2. Increased security.</li></ol>	High
6.1.11	<p>Window opening sealed with duck tape. Hazardous mould is growing around the area and falling onto window board.</p>

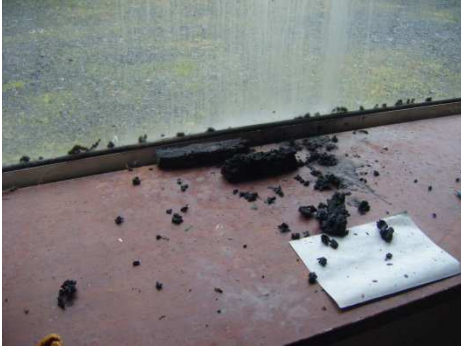
Ref No:	Condition:	Picture:	Repair:	Priority:
6.1.12	As Above

As Above	High
6.1.13	Plaster work damaged.

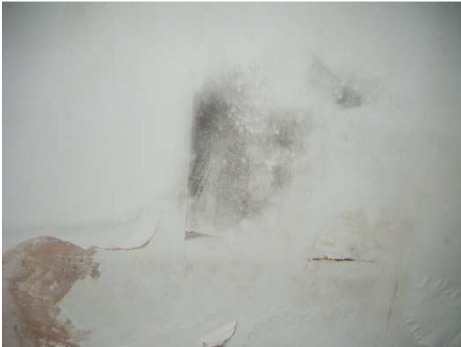
This section of plaster work needs to be removed, re-slabbed skimmed and painted.	High
6.1.14	Spalling plasterwork is detaching from the wall surface and evidence moisture present. The wall finish is in very poor decorative condition.

Remove all loose plaster within this damaged area, clean down loose masonry dust to achieve a good bonding surface. Re-plaster with sand and cement undercoat and skim making good. Paint the newly plastered surface following a period of drying out	High

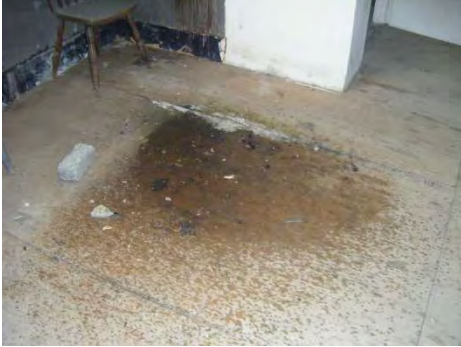
Ref No:	Condition:	Picture:	Repair:	Priority:
6.1.15	The ply floor covering shows extensive staining resulting from the continuous moisture ingress.

<p>The source of water ingress needs to be rectified. It was found that the water ingress was caused by a broken roof light. Remove the ply floor finish and cart away, inspect the underlying floor boards and joist timbers.</p> <p>Should the timbers show signs of wet rot damage, they should be removed and replaced with new treated timbers. The remaining timbers should be treated with an anti-fungal spray within a 1 metre radius of the affected area.</p>	High

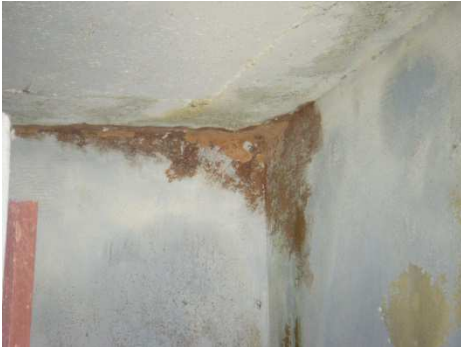
6.1.16	Wall is showing evidence of damp penetration. The paint is peeling and mouldy.

<p>Strip back the plasterwork, re-plaster the walls with sand and cement &amp; final skim coat and paint.</p>	High

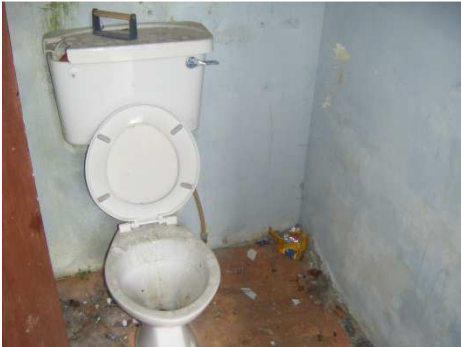
6.1.17	<p>The sanitary fittings are dirty and need to be replaced.</p> <p>The room is in need of redecoration.</p> <p>There is no natural light (window) or extractor fan for necessary ventilation.</p>

<p>Remove all sanitary fittings and cart away and replace with new fittings.</p> <p>Remove the existing floor covering and replace with new.</p> <p>Break out a new hole in wall and fit new mechanical extractor fan.</p> <p>Clean down all surfaces and repaint.</p>	High

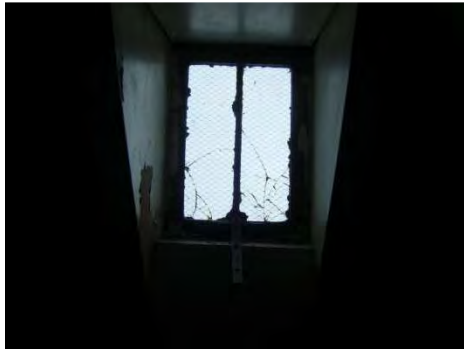
Ref No:	Condition:	Picture:	Repair:	Priority:
6.1.20	Overall the roof lights are in quite poor condition. The glass panel in the roof light has slipped down and allowing direct rain water ingress.

Ideally remove the defective rooflight window units and frames to the rear and cart away. Replace with new Upvc double glazed roof light, fit new 5lb lead flashing to ensure a water tight seal.	High
6.1.21	As Above

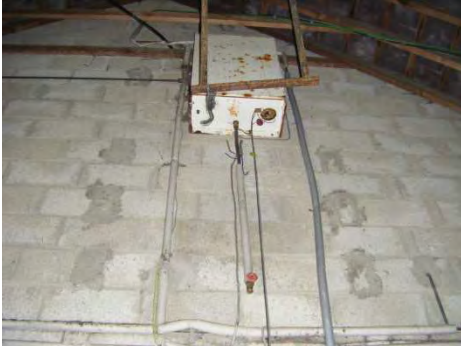
Ref No:	Condition:	Picture:	Repair:	Priority:
7.1.1	From what can established this is a redundant water tank.

<p>Remove and cart away redundant water tank and all ancillary timber and pipe work.</p> <p>An alternative water supply / head tank will need to be arranged to provide water supply to the 2<sup>nd</sup> floor toilet if the client intends to maintain this toilet.</p>	High

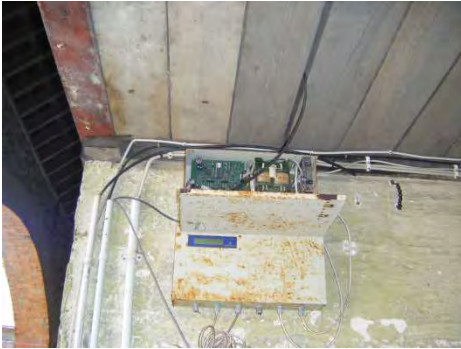
7.1.2	All electrical wiring will require further investigation by a competent electrician.

<p>A competent electrician shall be retained to inspect and assess all electrical wiring and existing fittings in this building.</p> <p>The existing fuse boxes and ECB boards will have to be assessed to ensure they do not pose a risk to health and safety.</p>	High

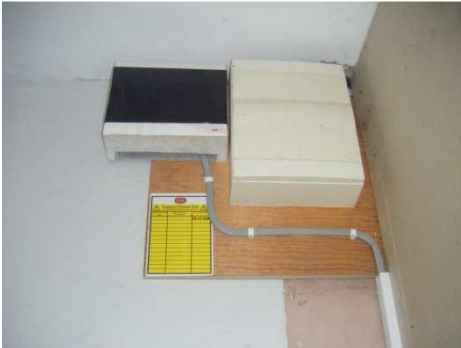
7.1.3	However the presence of a temporary Electrical box indicates that the previous supply is not adequate to service the property. Although there is a temporary system in place, this is exactly that a temporary system that will have to be update to ensure safe and effective use.

<p>Prior to tenant occupation of this building, all electrics must be tested and certified to ensure that the electrical system do not pose any health &amp; safety or fire hazard risk.</p>	High

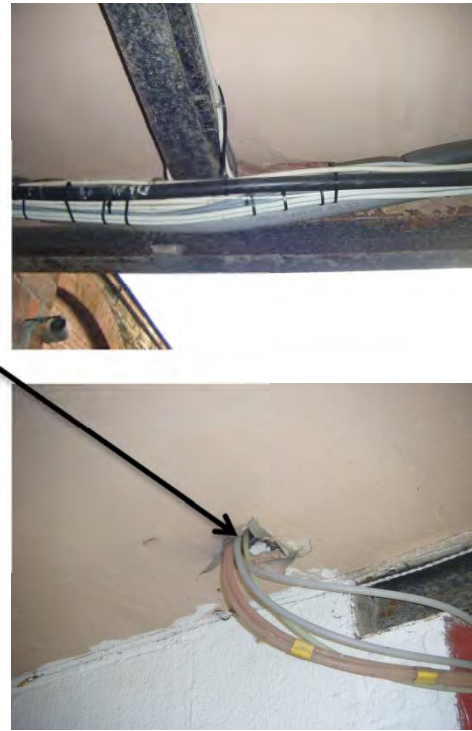
Ref No:	Condition:	Picture:	Repair:	Priority:
7.1.4	Temporary electrical wiring is unsightly and often tracked through areas of convenience causing further damage.

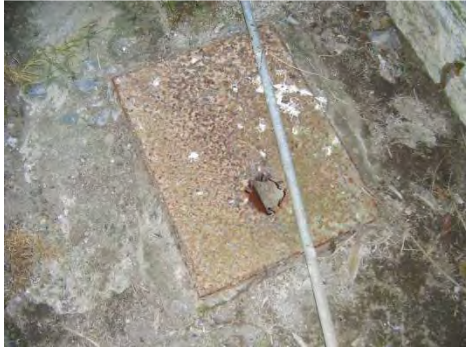
Ref No:	Condition:	Picture:	Repair:	Priority:
7.1.6	<p>All drainage and sewerage services throughout the building will have to be further investigated by a competent plumber.</p> <p>The foul and surface drains such as manholes, gully traps and associated pipe work should be inspected to ensure they are in an efficient and safe working order.</p>

<p>A competent plumber is to be retained to inspect and assess all drainage and sewerage services throughout the building.</p> <p>Prior to the use of the building, all drainage and sewerage services must be attended to ensuring that they are in full working order and that there are no health and safety risks to the inhabitants.</p>	High

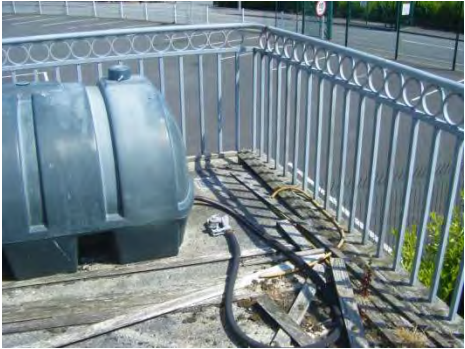
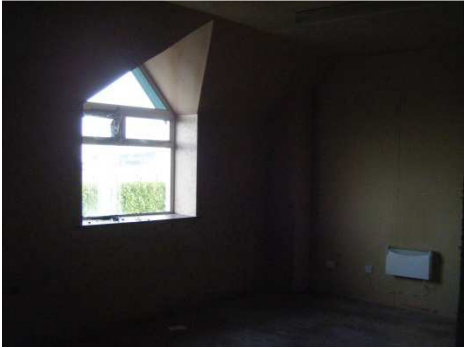
7.1.7	<p><b>Heating:-</b></p> <p>Note:- Although an oil storage tank is visible on site it is unclear whether the property is equipped for its distribution.</p> <p>However:</p> <p>Electric radiators are installed in some locations but again these are where only a temporary solution installed by the construction team and again will need to be updated.</p>

<p>A competent plumber is to be retained to inspect and assess all hot and cold water services, heating pipework and appliances in the building.</p> <p>Prior to the use of the building, all plumbing and heating appliances must be attended to ensuring that there is no health and safety threats to the inhabitants.</p>	High
