**Declaration**

| Name of Building: | 1 and 2 Paradise Place | National Grid co-ordinates: | | |

Section 57 Declaration – Works to a Protected Structure

Reference No: S57 DB23-02

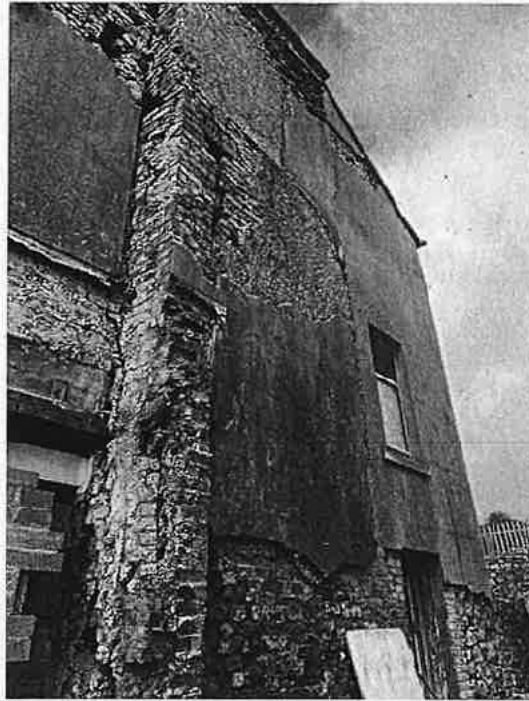
- Large sections of the gable wall should be considered 'failed' and the current condition is dangerous.
- The gable wall and the front wall at corner have been moving over years and several repair measures were carried out previously to make good.
- Brick in the vicinity timber beam has failed due to overloading and other brickwork is crumbling.
- Without intervention measures the gable wall and the front wall at the south east corner will continue to move and crack and will lead to sections of wall collapsing.

This poor condition of the structure is evident in the photographs attached to the said reports.

The Repair Methodology has prepared by ACO Architectural Conservation Professionals and details deconstruction and reconstruction works proposed. These are set in the description of the nature and scale of the development proposed under Section 10 above.

The works proposed are essential to safeguard the gable and front corner of this building from collapsing and hence the longevity of this protected structure. I am satisfied that the works are consistent with conservation principles and best practice guidance. The historic fabric of this building is to be re-used in the reconstruction of the chimney projection and gable. The proposed use of engineering brick where any existing brick is damaged is reasonable. It is stated that the internal chimney breasts will not be affected by the works proposed:
