Declaration

Louth County Council:

Address:		Location:	
Name of Building:	Corn Exchange	National Grid co-ordinates:	E N
Address 1:	Fair Street	O.S. Map Type:	
Address 2:	Drogheda	Map Sheet:	
Address 3:	Co Louth	Site Number:	
Eircode:	A92 P440

The referrer has sought a Section 57 declaration as per the Planning and Development Act 2000 (as amended) in respect of works to a protected structure known as the Corn Market at Fair Street, Drogheda.

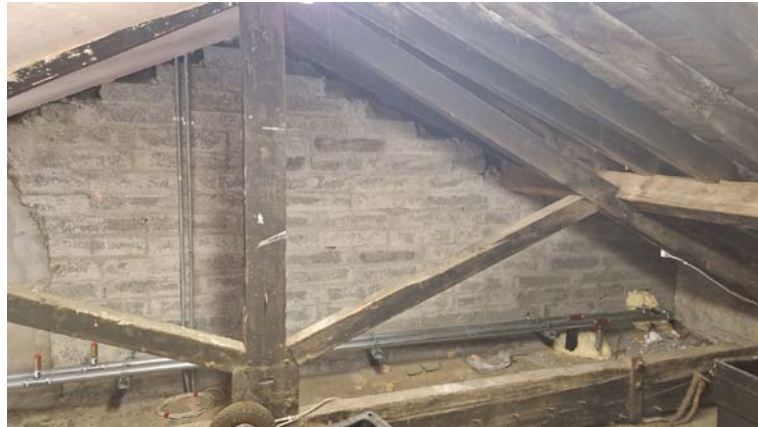
Photograph 1 – King Post and party wall

- 225mm block wall with timber traversing from the boiler room to the adjoining office area. The fire compartmentation within this area should be reviewed to ensure adequate fire compartmentation if provided from the boiler room to the office area.

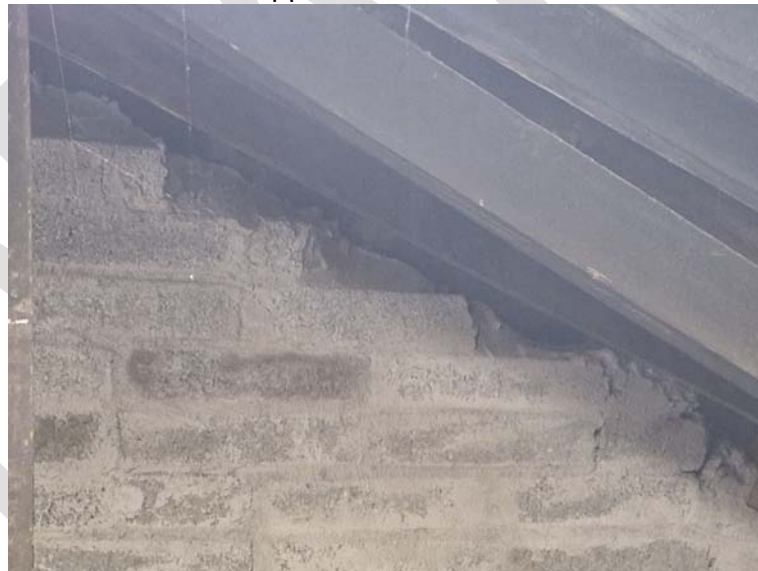
- The block work should be fire stopped at the underside of the roof.

Photograph 2 – Adequate fire stopping to be provided

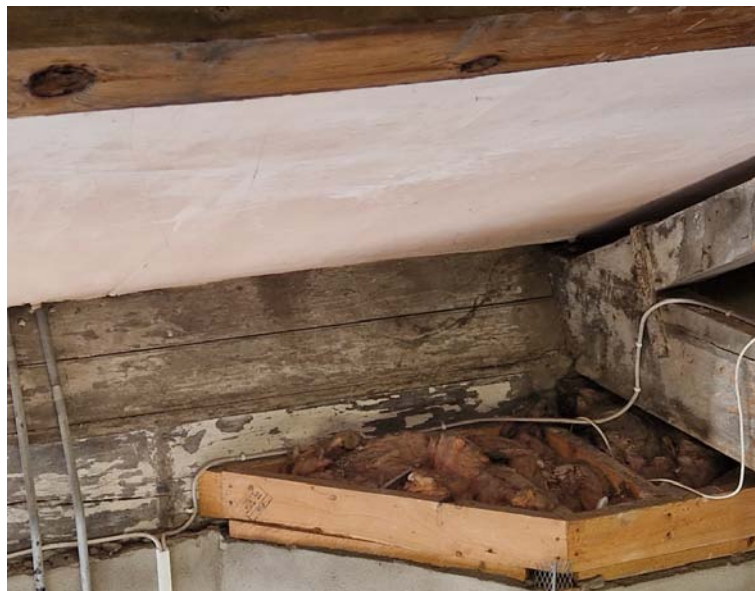
- The metal work to the king posts should be stripped back and repainted.
- The timber work should be treated with a suitable timber preservative.

Photograph 3 – Metal and timber treatment to be provided

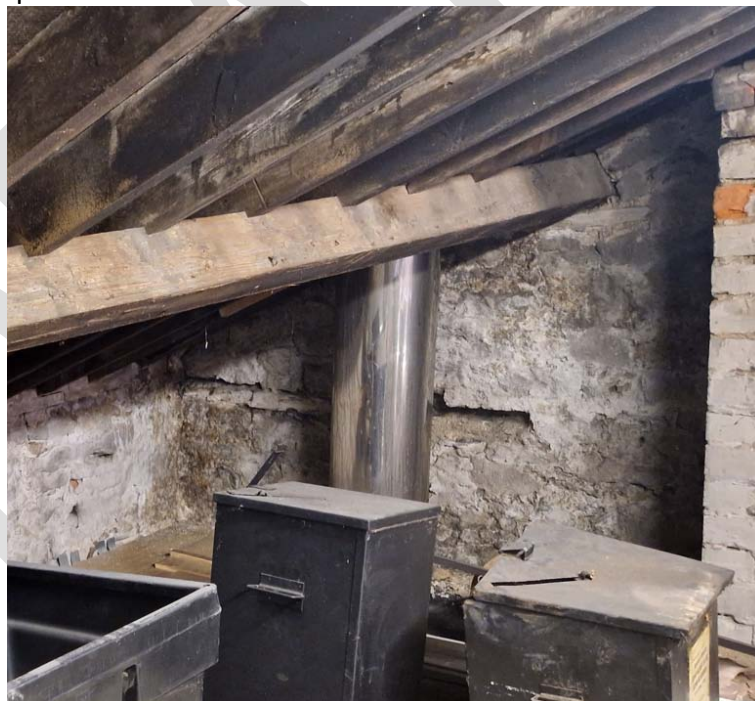
- The flue should be reviewed to ensure that it is not in proximity to combustible material as it penetrates the roof.

Photograph 7 – Fire stopping required

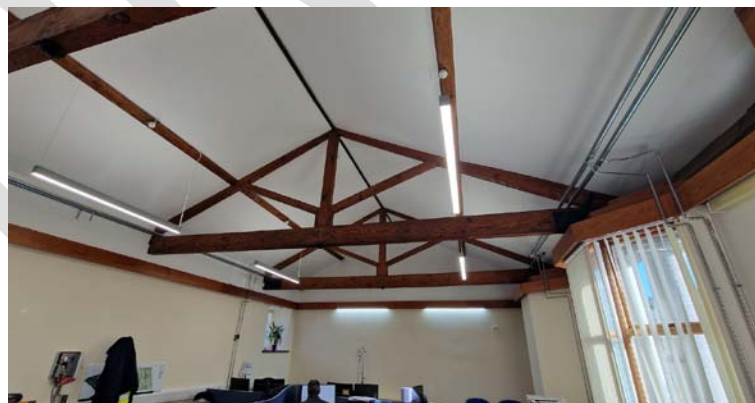
- The underside of the rafters to the engineer's office has been plaster boarded for the majority of the building. At the locations where inspection could be undertaken the void between the plasterboard and the underside of the roof covering has been filled with insulation. This results in the timber being unable to breathe adequately and can result in deterioration of the roofing timbers. It is recommended that during any refurbishment works that the roofs be insulated allowing for a minimum 50mm of air gap between the insulation and the underside of the roofing.

Photograph 11 – Plasterboard to rafters

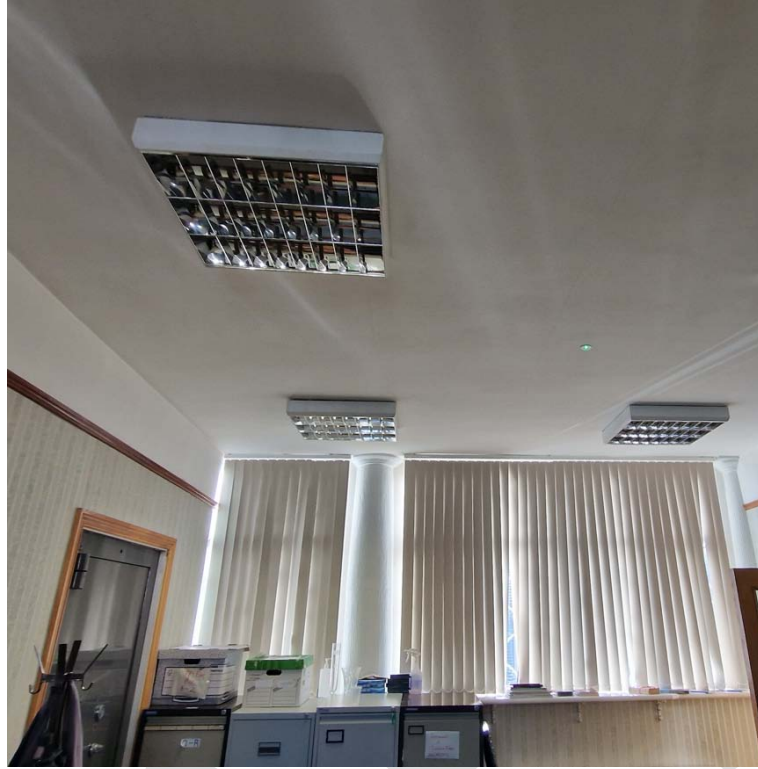
- Within the housing capital office there was no access to the attic of the property.

Photograph 15 – Plasterboard ceiling

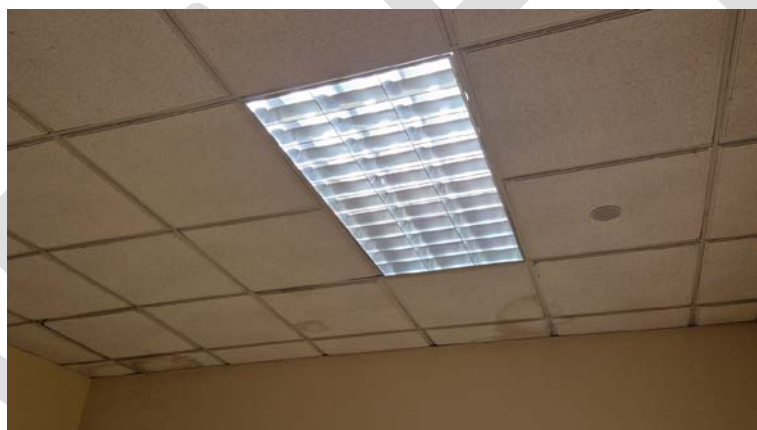
- Within the interview room and adjacent room staining was noted to the ceiling tiles. This indicates that there has or is a leak. No access was achievable due to the chicken wire and insulation. As part of the refurbishment works the leaks to the roof should be repaired.

Photograph 21 – Water staining on ceiling tiles

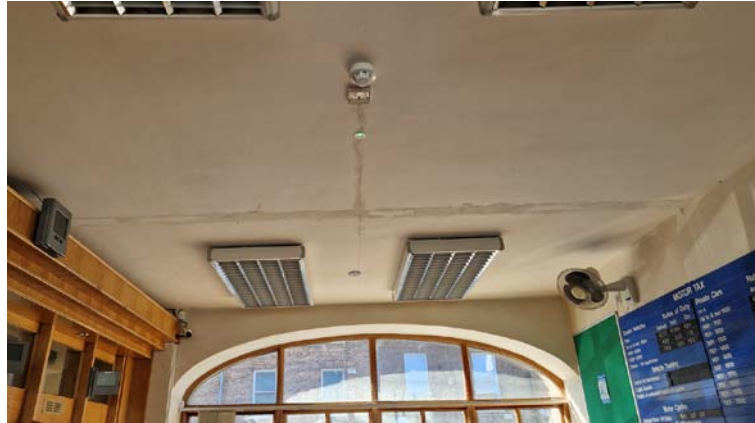
- Within the accounts office the ceiling is cracked and should be repaired. No access to the attic was available.

Photograph 25 – cracked ceiling

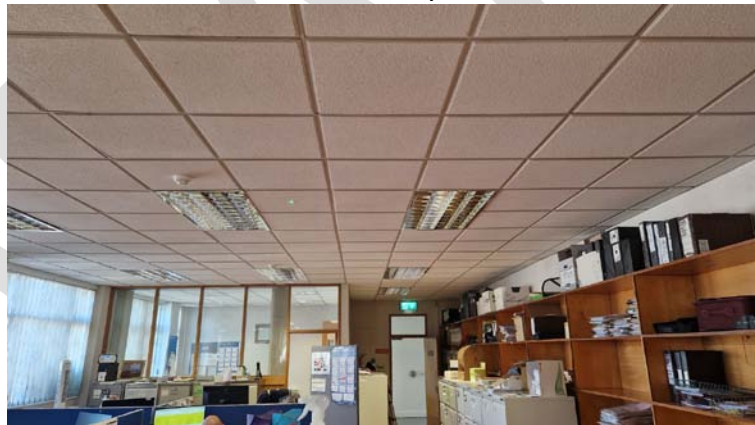
- A suspended ceiling existed within the majority of the eastern return of the building. Above the suspended ceiling was chicken wire supporting insulation, no access to the attic could be gained. The depth of insulation that was noted would not meet current standards. Over the years insulation has been dislodged as works by electricians and plumbers has been under taken. The entire roof area should be stripped of insulation and reinsulated in accordance with current standards incorporating appropriate air tightness and ventilation to attic spaces. Adequate access to all attics should be provided and these accesses should be readily identifiable.

Photograph 26 – Eastern return

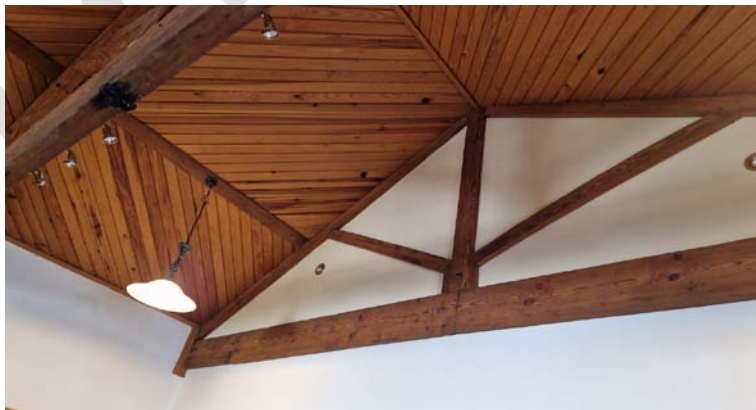
- An ornate timber ceiling exists within the kitchen/canteen area. It could not be established if insulation existed in this area.

Photograph 28 – Ornate Ceiling

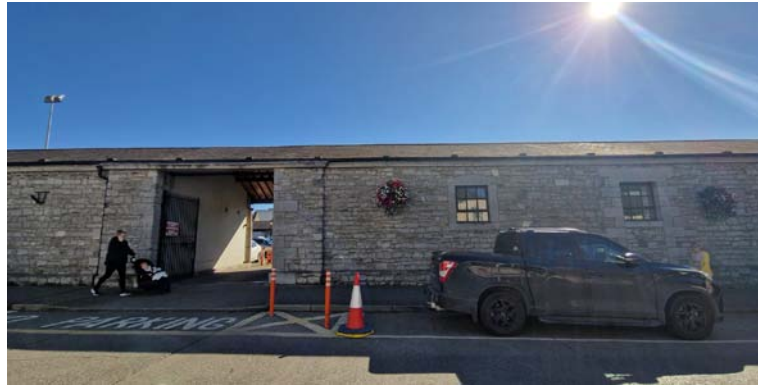
- The ridge line of the building appears reasonably well aligned and no significant deflection was noted. This would signify that the structure of the roof is in good condition.

Photograph 31– Roof exterior

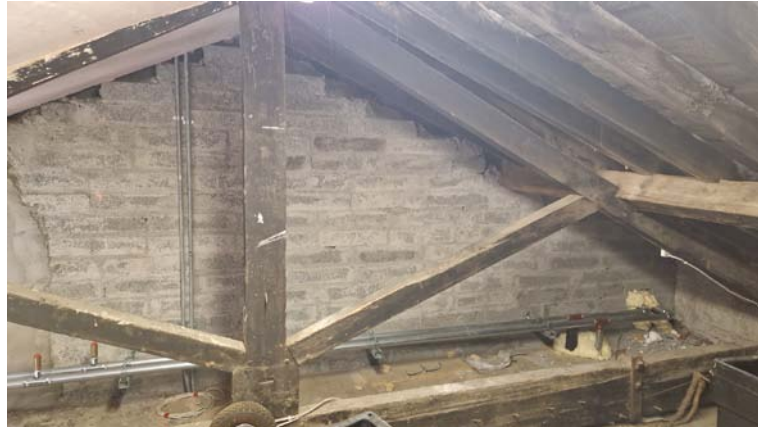
Photograph 1 – King Post and party wall

- 225mm block wall with timber traversing from the boiler room to the adjoining office area. The fire compartmentation within this area should be reviewed to ensure adequate fire compartmentation if provided from the boiler room to the office area.

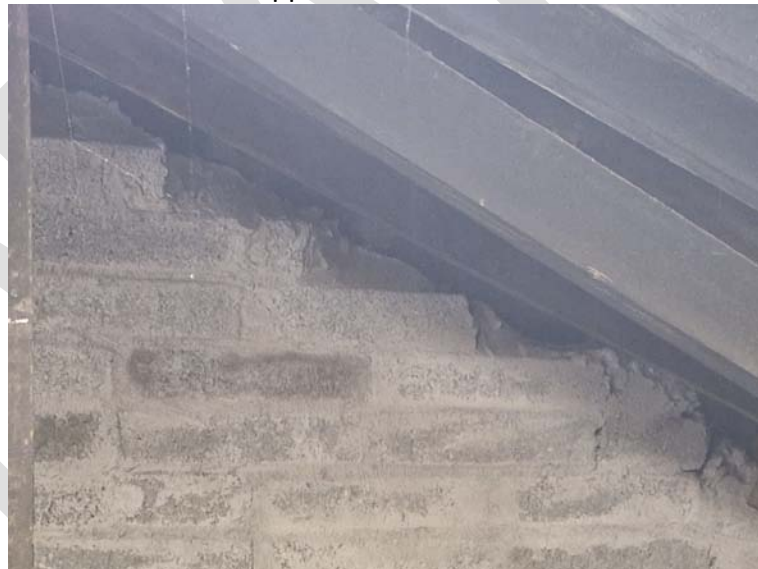
- The block work should be fire stopped at the underside of the roof.

Photograph 2 – Adequate fire stopping to be provided

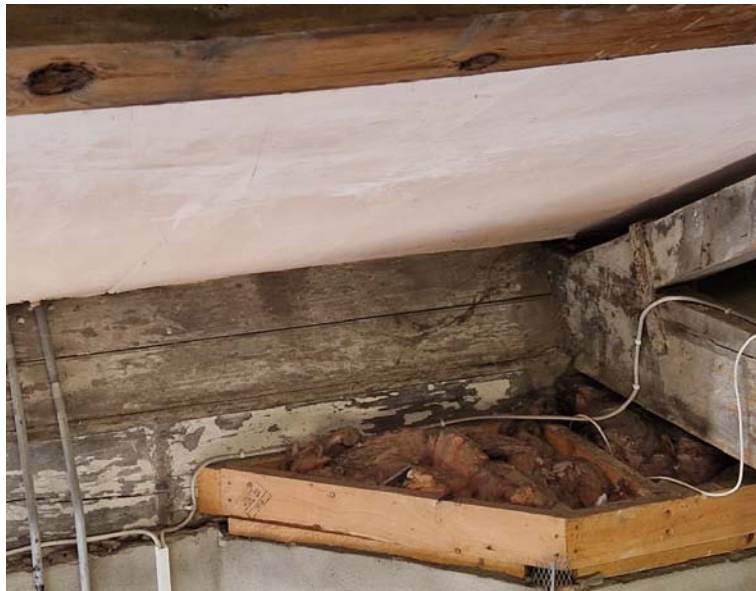
- The metal work to the king posts should be stripped back and repainted.
- The timber work should be treated with a suitable timber preservative.

Photograph 3 – Metal and timber treatment to be provided

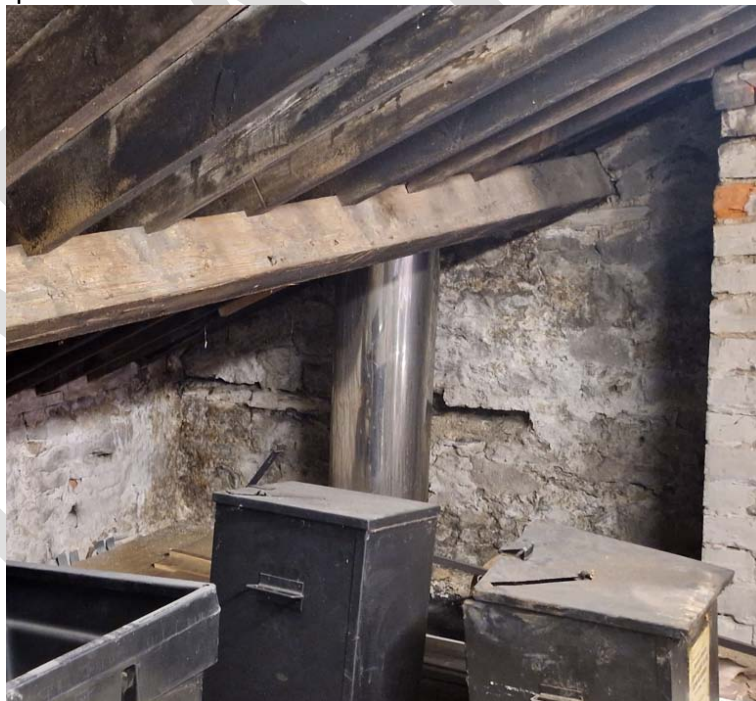
- The flue should be reviewed to ensure that it is not in proximity to combustible material as it penetrates the roof.

Photograph 7 – Fire stopping required

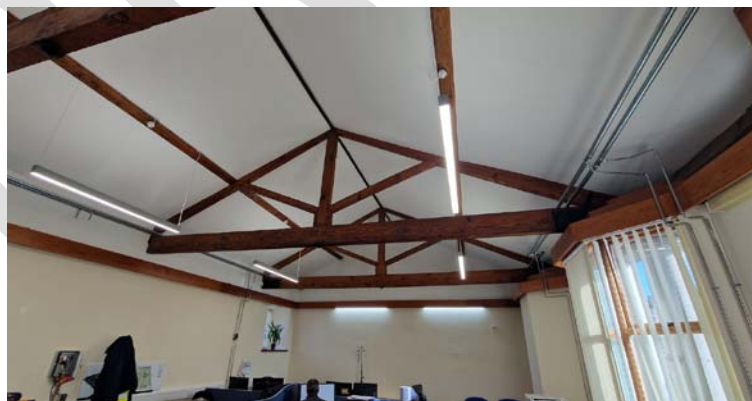
- The underside of the rafters to the engineer's office has been plaster boarded for the majority of the building. At the locations where inspection could be undertaken the void between the plasterboard and the underside of the roof covering has been filled with insulation. This results in the timber being unable to breathe adequately and can result in deterioration of the roofing timbers. It is recommended that during any refurbishment works that the roofs be insulated allowing for a minimum 50mm of air gap between the insulation and the underside of the roofing.

Photograph 11 – Plasterboard to rafters

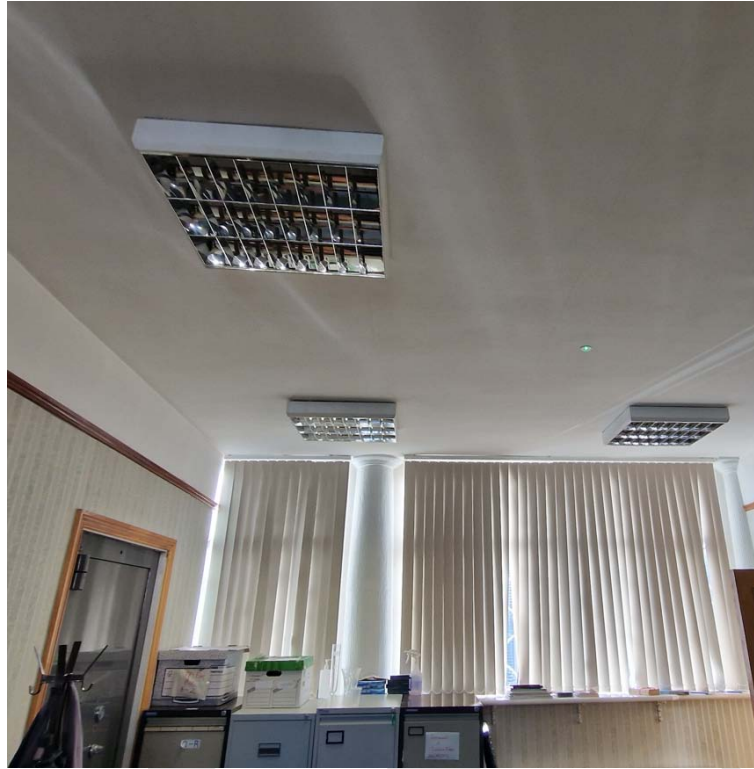
- Within the housing capital office there was no access to the attic of the property.

Photograph 15 – Plasterboard ceiling

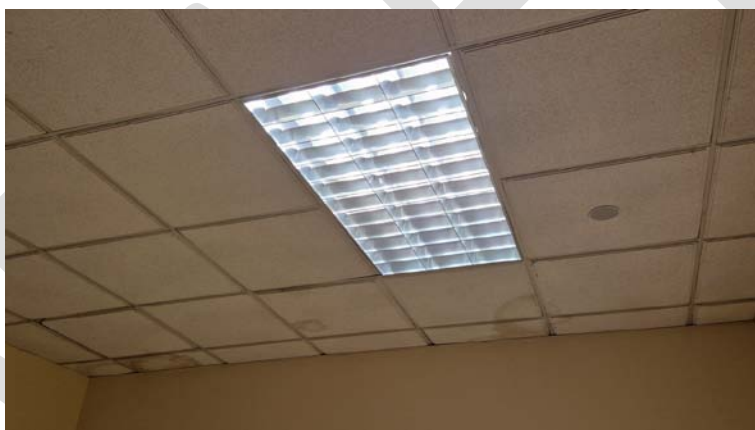
- Within the interview room and adjacent room staining was noted to the ceiling tiles. This indicates that there has or is a leak. No access was achievable due to the chicken wire and insulation. As part of the refurbishment works the leaks to the roof should be repaired.

Photograph 21 – Water staining on ceiling tiles

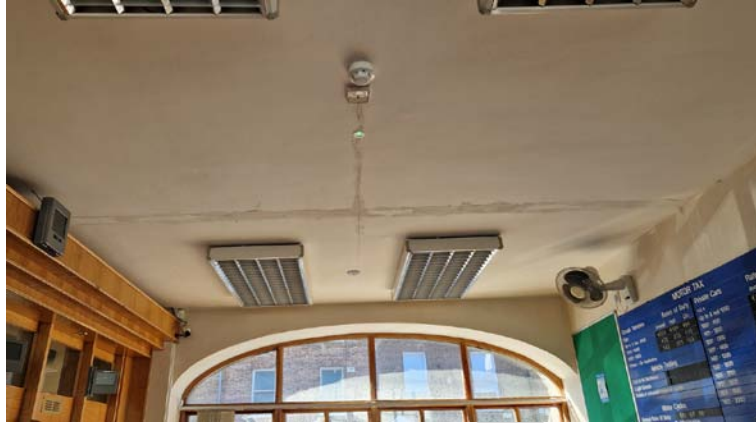
- Within the accounts office the ceiling is cracked and should be repaired. No access to the attic was available.

Photograph 25 – cracked ceiling

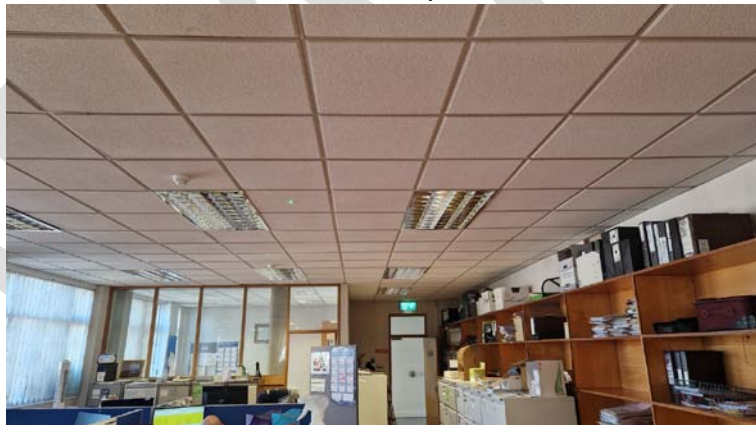
- A suspended ceiling existed within the majority of the eastern return of the building. Above the suspended ceiling was chicken wire supporting insulation, no access to the attic could be gained. The depth of insulation that was noted would not meet current standards. Over the years insulation has been dislodged as works by electricians and plumbers has been under taken. The entire roof area should be stripped of insulation and reinsulated in accordance with current standards incorporating appropriate air tightness and ventilation to attic spaces. Adequate access to all attics should be provided and these accesses should be readily identifiable.

Photograph 26 – Eastern return

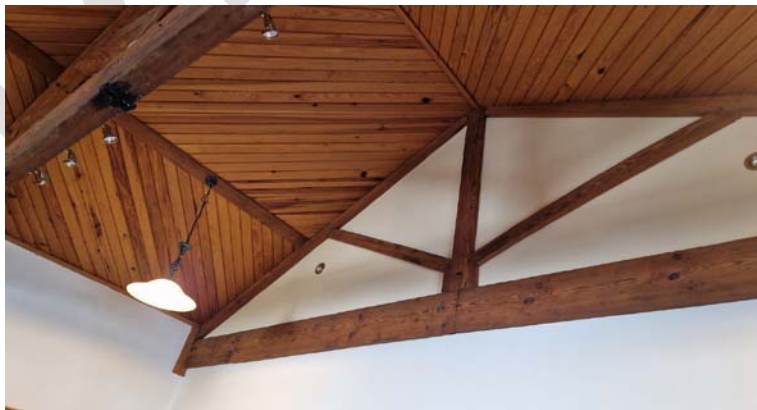
- An ornate timber ceiling exists within the kitchen/canteen area. It could not be established if insulation existed in this area.

Photograph 28 – Ornate Ceiling

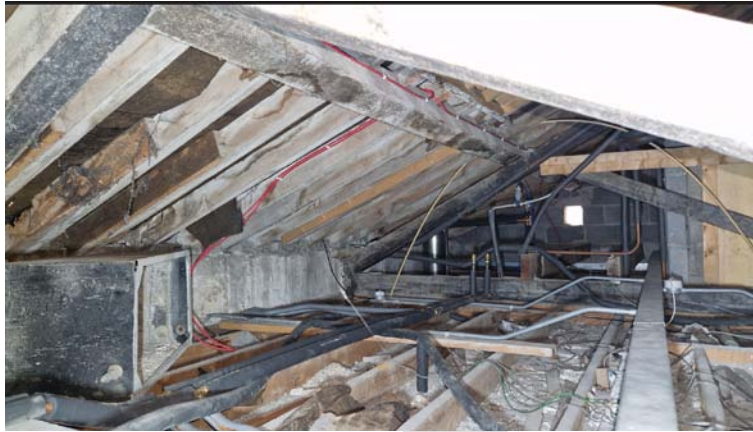
Photograph 29 – Kingpost strut

- The timbers in the locker area appeared to have damp staining. This would signify moisture ingress. It is recommended that any roof leaks be repaired as part of the future refurbishment works. The attic area should be cleared of all debris.
